THE ENTREPRENEURIAL LANDSCAPE
OF A TURNPIKE TOWN:
AN ARCHITECTURAL SURVEY OF
BUCKLAND, VIRGINIA

ORLANDO RIDOUT V, ALFREDO MAUL, AND WILLIE GRAHAM
BUCKLAND, VIRGINIA
2005

A Project of the Buckland Preservation Society

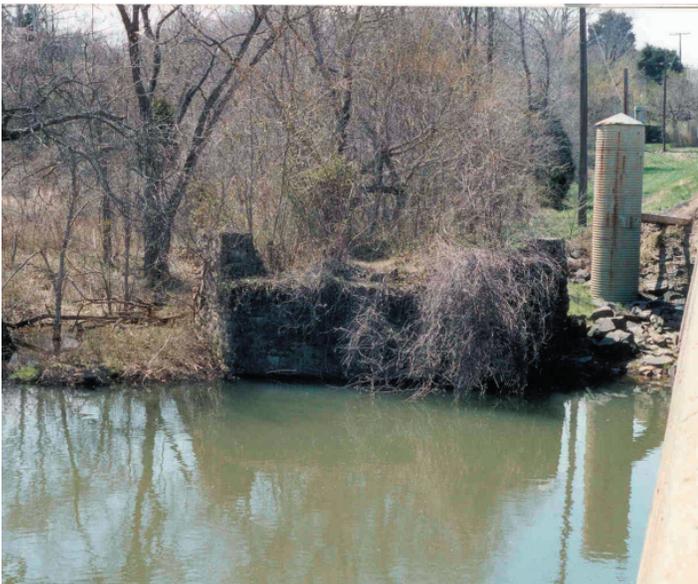
FIGURE 12. *Stone bridge abutment at Broad Run, Buckland. This abutment dates to the construction of a timber bridge across Broad Run in 1808, and later served as the support for an iron bridge built in 1890 and replaced in 1927. The road bed of the early turnpike survives for approximately 70 yards to the west of the abutment. Buckland Preservation Society, 2004.*

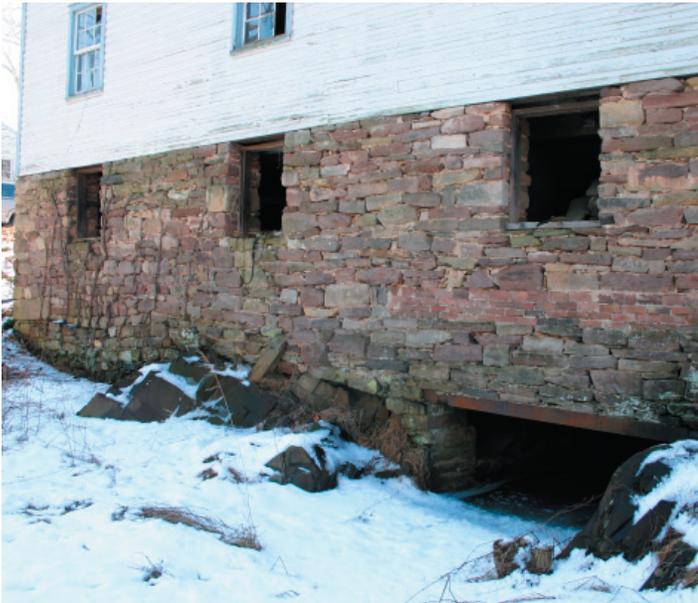
FIGURE 1-4. Stone foundation and tail-race portal, east elevation. The sills for the frame superstructure are recycled from the first-period mill, as demonstrated by a careful examination of the window openings. The bottom faces of the sills are exposed above these openings, and reveal hand-hewn surfaces and vacant mortises, indicating they have been recycled for this building.

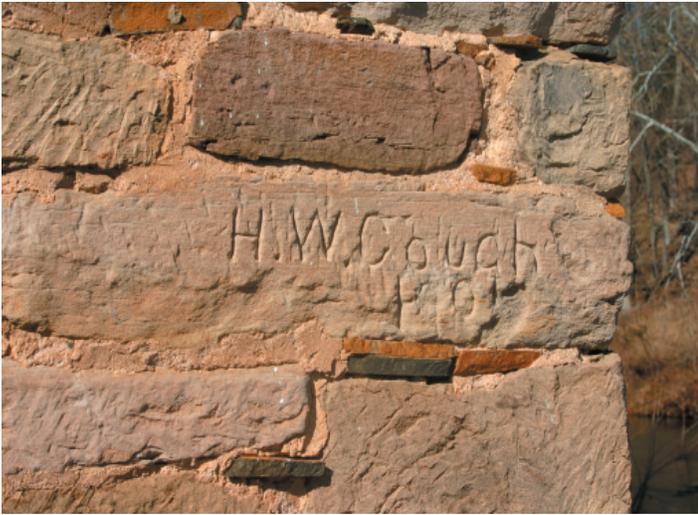
FIGURE 1-5. Cornerstone at east end of south façade. H. W. Gough is believed to be the builder rather than the owner or miller. Here, the last digit of the date has spalled off, but a second stone on the east wall is marked 1904.

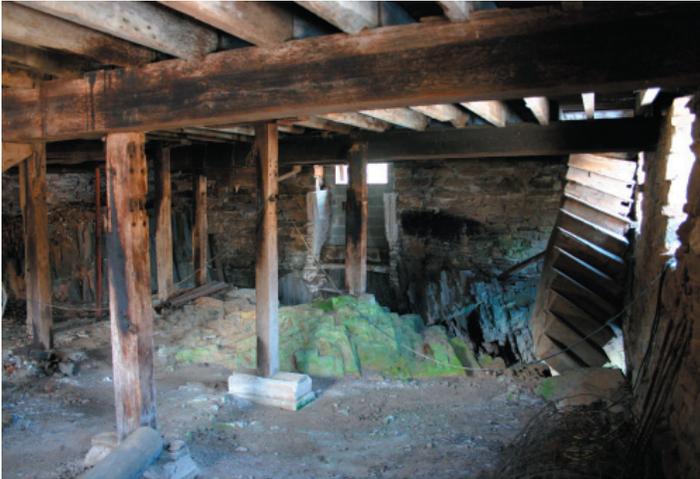
FIGURE 1-6. *View looking north into the northeast corner of the cellar level, showing the wheel or turbine pit cut from stratified bedrock, and the partially collapsed stair to the first floor cantilevered across the pit. Water was delivered to the wheel or turbine through the opening at left (later reduced and converted to a window) and flowed out of the building through the portal under the stairs. Grease stains on the far wall, a chopped-out joist, and grease-stained vertical posts offer some clues to the location and alignment of the missing drive system.*

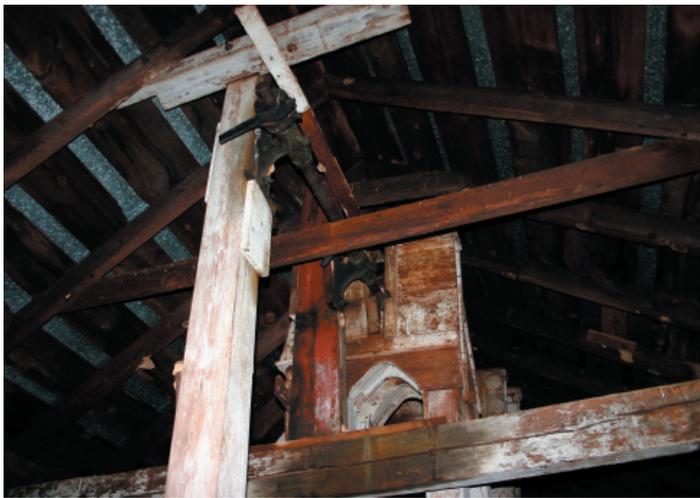
FIGURE 1-13. *View of the north end of the drive shaft, which extended for most of the length of the third story. In this view, two iron pulleys have broken off, leaving remnants of the spokes. Note the mixture of framing material—hewn and whitewashed timbers from an earlier structure, and circular-sawn, unfinished rafters joined at the ridge with mitered and nailed joints rather than mortise-and-tenon joints.*

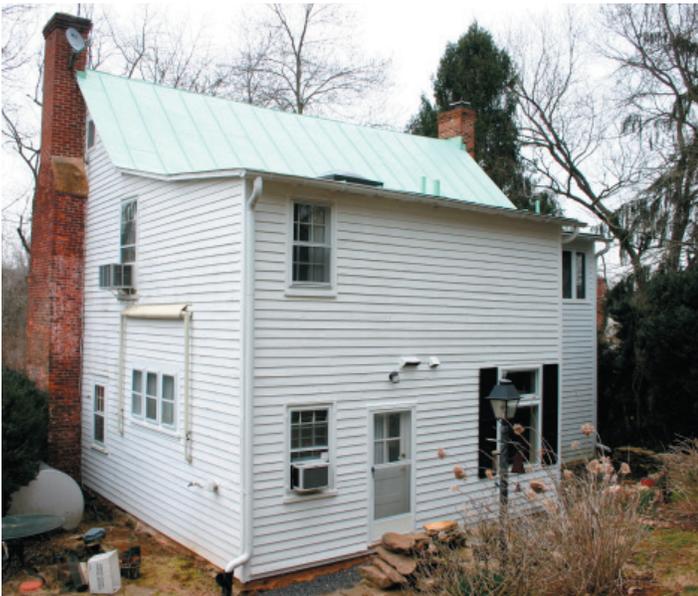
FIGURE 3-2. View from the northwest. The two-story rear wing probably dates to the 1850s reorganization of the house into a center-passage plan. The lower portion of the chimney at the left or north end dates to the 1790s, extended in the 1820s, and with a cap rebuilt in the 1970s. The south chimney was entirely built in the 1970s.

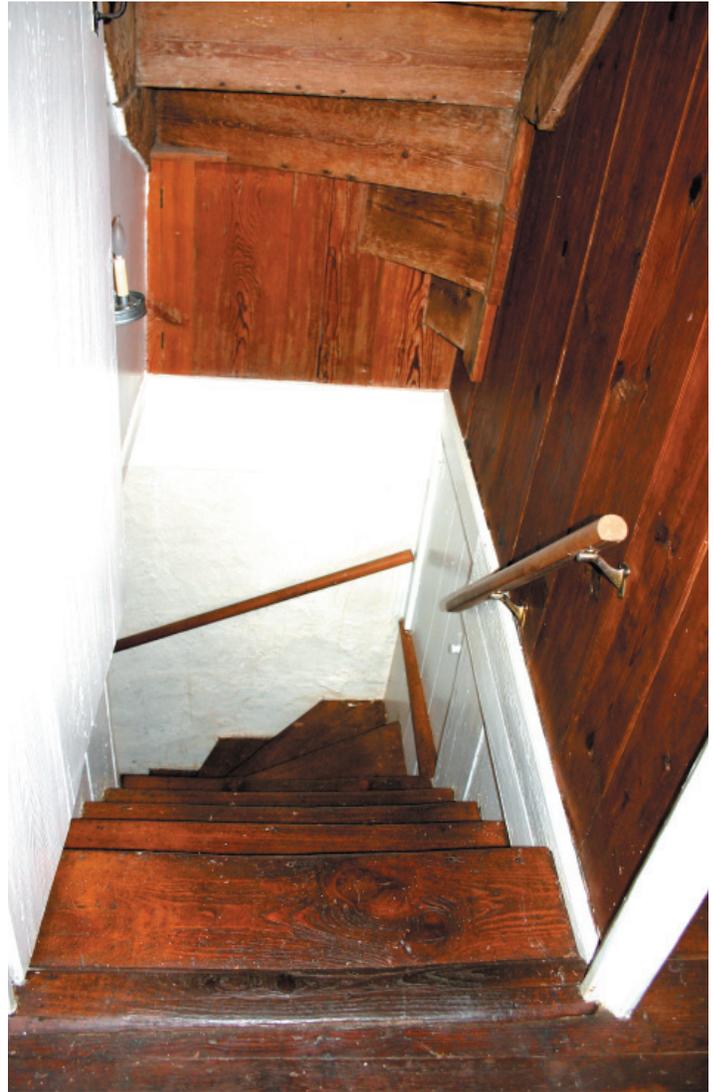
FIGURE 7-7. View of cellar staircase from first-floor passage. The lower run of the cellar stair has been altered, but the upper run, the flanking partitions and the stair to the garret are original.
