Archaeological Investigations

Fauquier and Alexandria Turnpike

44PW1938
Buckland, Virginia

VDHR File No.: 2009-0432
Buckland Historic Transportation Enhancement Project
Project No.: EN06-076-123, P101 UPC 81772

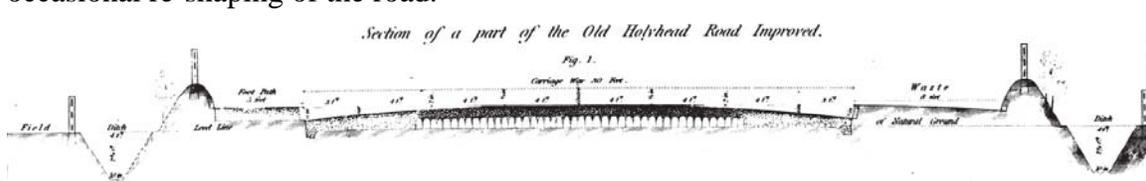
Figure #9: Section of a part of the Old Holyhead Road Improved, showing a Telford road profile. Thomas Telford, 1833.

overlying pavement equal to or above adjacent ground thus avoiding the drainage issues that plagued his French counterpart. Telford began with a flat natural surface. Like the French road builders before him he also utilized a substantial cambered foundation made of large blocks of stone, called a 'pitching,' or 'rock bottom.' The rock bottom was to stretch the entire width of the roadway and was to be composed "of any kind of stones that can be most readily procured, those set in the middle of the road should be 7 inches in depth; at 9 feet from the centre, 5 inches, at 12 feet from the center, 4 inches; and at 15 feet, 3 inches. They should be set with their broadest face downwards, and lengthwise across the road; and no stone should be more than 5 inches broad on its face." The irregularities of upper part of the various sized stone blocks were then to be "broken off with the hammer." The cavities and interstices within this foundation were then to be 'filled with stone chips, firmly wedged, or packed by hand with a light hammer; so that, when the pavement is finished, there may be a convexity of 4 inches in the breadth of 15 feet from the center."¹³

A second or middle layer of smaller stone, applied in the center 18 feet of the roadway, was then place on top of the foundation. This second layer of pavement was to be 6 inches thick and applied in two layers, a 4-inch application, and a 2-inch application. consisted of hard stone, "broken to a size of a cubical form not exceeding 2 ½ inches in their largest dimensions, and should be capable of passing through a ring of that diameter." On either side of the center 18 feet of the roadway, Telford proposed either hard stones or much smaller 'gravel.'¹⁴

Finally a 1 to 1 ½ inch thick surface layer of gravel "free from clay or earth," what Telford described as "pebbles which are from 1 to 1 ½ inch in size, ...all larger pebbles should be broken," was to be applied to the entire width of the roadway.¹⁵

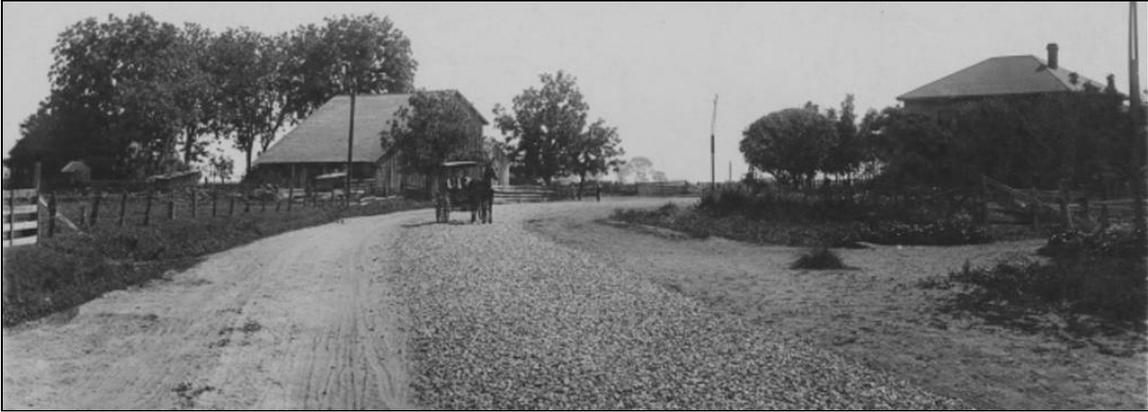
Figure #13: A macadamized road, Nicolaus (California), 1850s. California Digital Library.

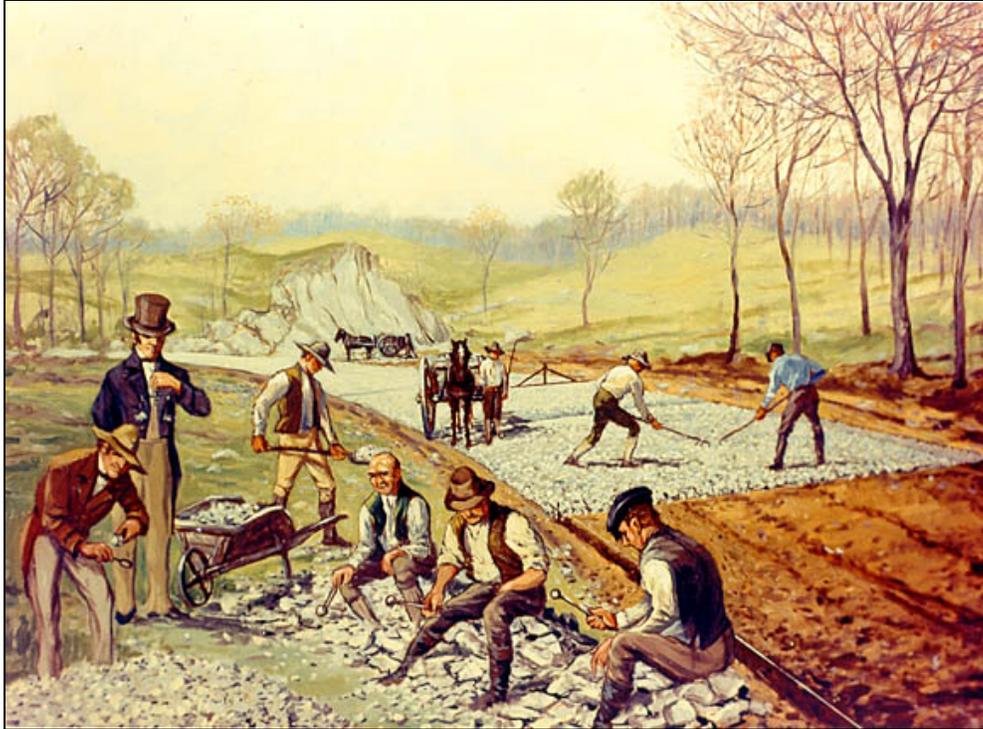
Figure #19: Artist's rendering of first American macadamized road. Carl Rakeman, ca. 1920s.

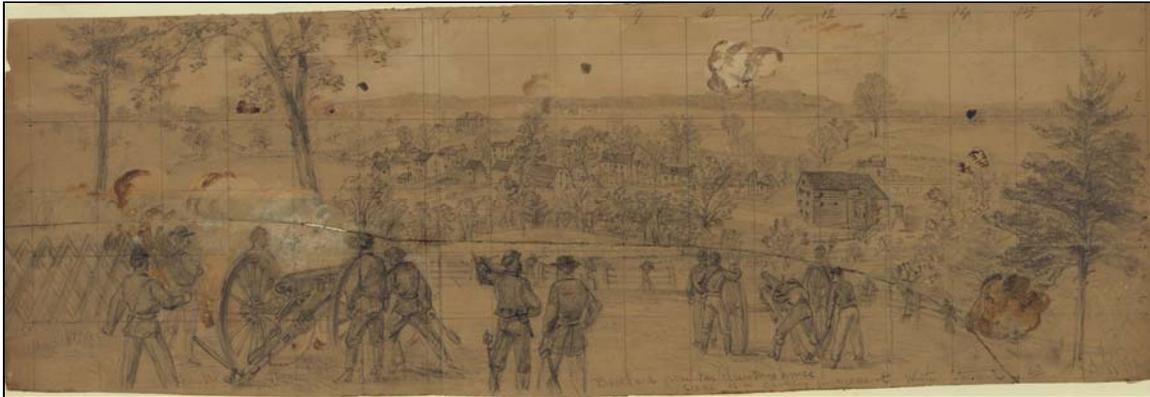
Figure #20: *Buckland from Mr. Hunton's House*, showing town of Buckland from Union artillery position on Cerro Gordo heights. Alfred R. Waud, 1863.

A panoramic depiction of the Battle of Buckland Mills drawn by Alfred Waud on October 19, 1863 shows the town of Buckland from the Federal position on the heights of Cerro Gordo. To the left of the image, the John Trone property can be seen as well as a partially obscured view of the Fauquier and Alexandria Turnpike Road (Figure #20).

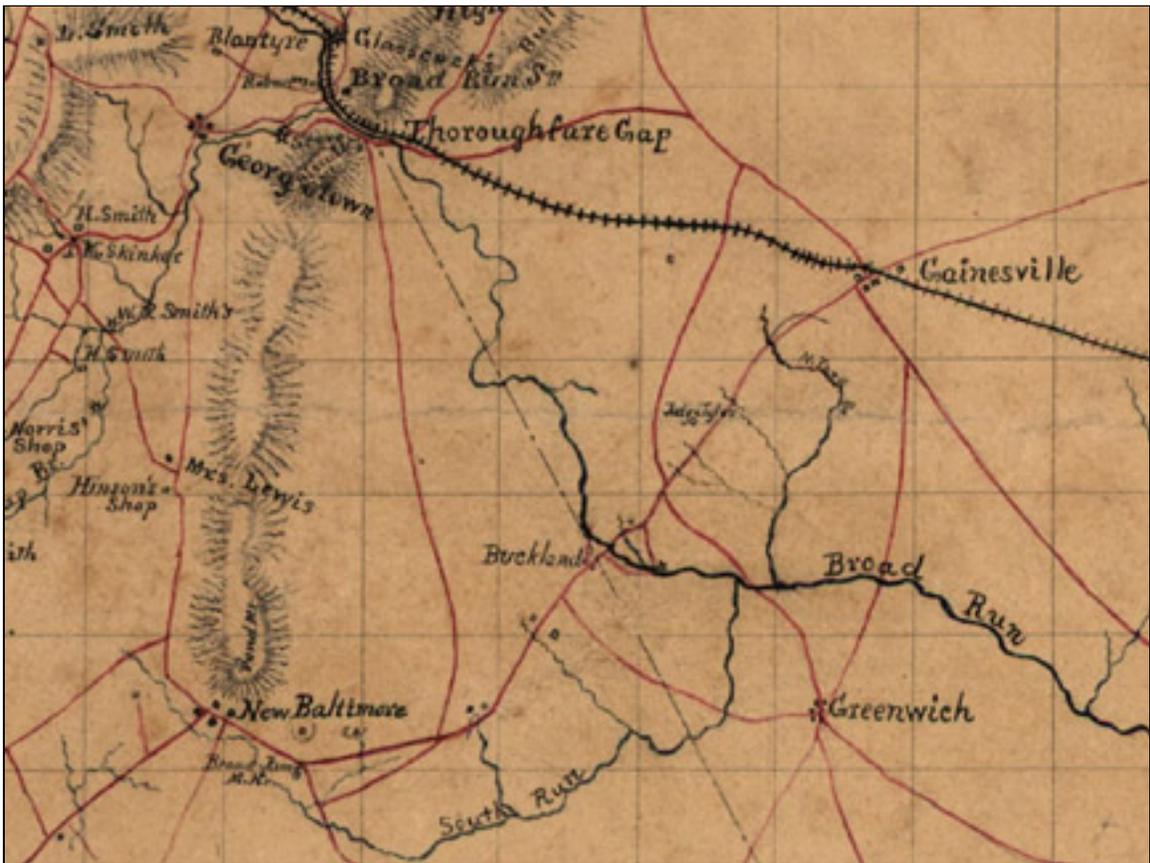
Figure #23: Detail, *A Map of Fauquier County, Virginia*, showing Broad Run, Warrenton Pike and Buckland and vicinity during the Civil War. Jed. Hotchkiss, 1863.

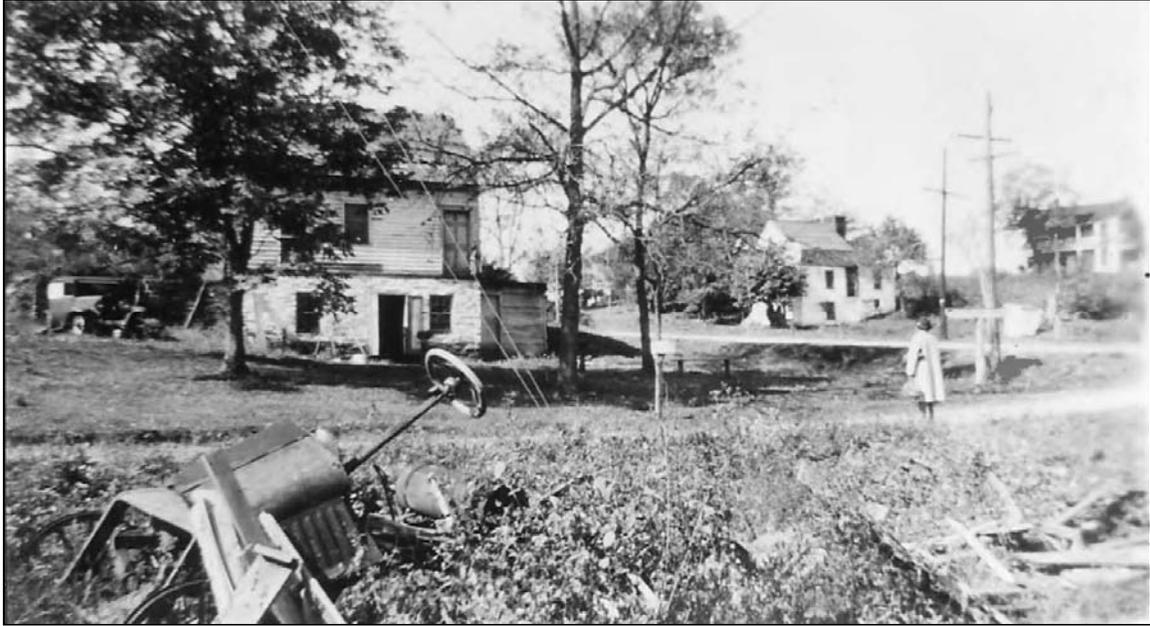
Figure #30: The John Trone House and adjacent east and north yards showing Buckland Mill Road in foreground and former Fauquier and Alexandria Turnpike at right. Buckland Preservation Society, n.d. [post-1927].

Several second quarter of the twentieth century photographs of Buckland were taken by local residents shortly after the construction of the concrete bridge and the improvement of Route 211 in 1927. These photographs document the location and condition of the extant residences, including the John Trone House, as well as the dimensions and condition of Buckland Mill Road and the new concrete Route 211, the former Fauquier and Alexandria Turnpike (Figures #30 - #34).

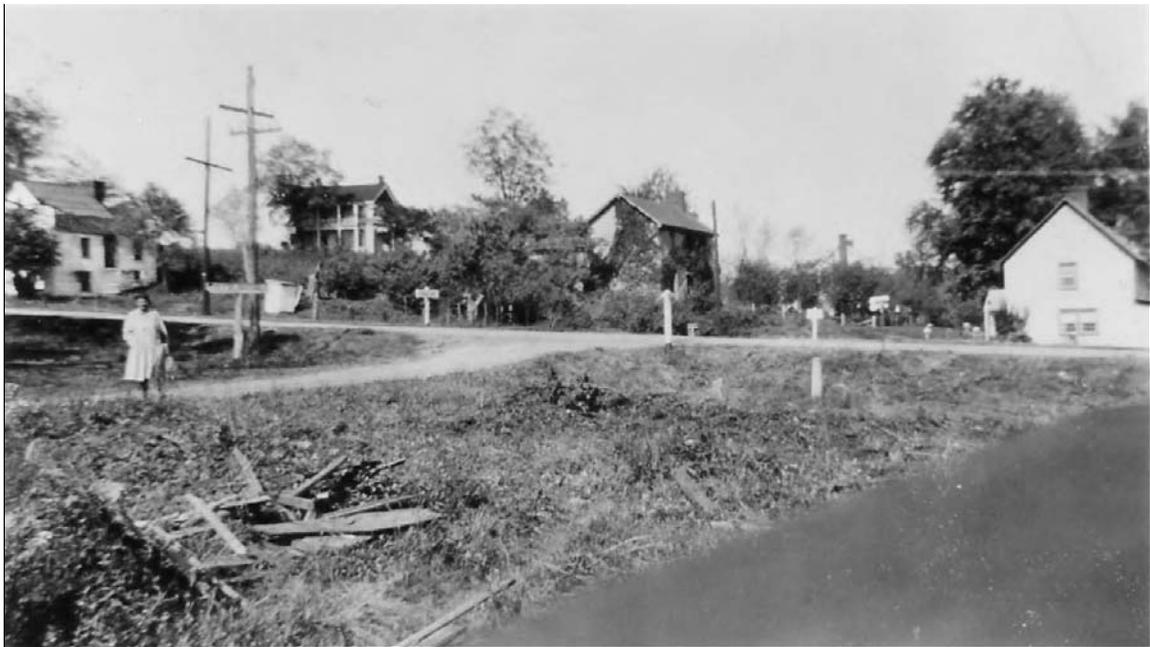
Figure #31: Intersection of Buckland Mill Road (left) and former Fauquier and Alexandria Turnpike. Buckland Preservation Society, n.d. [post-1927].

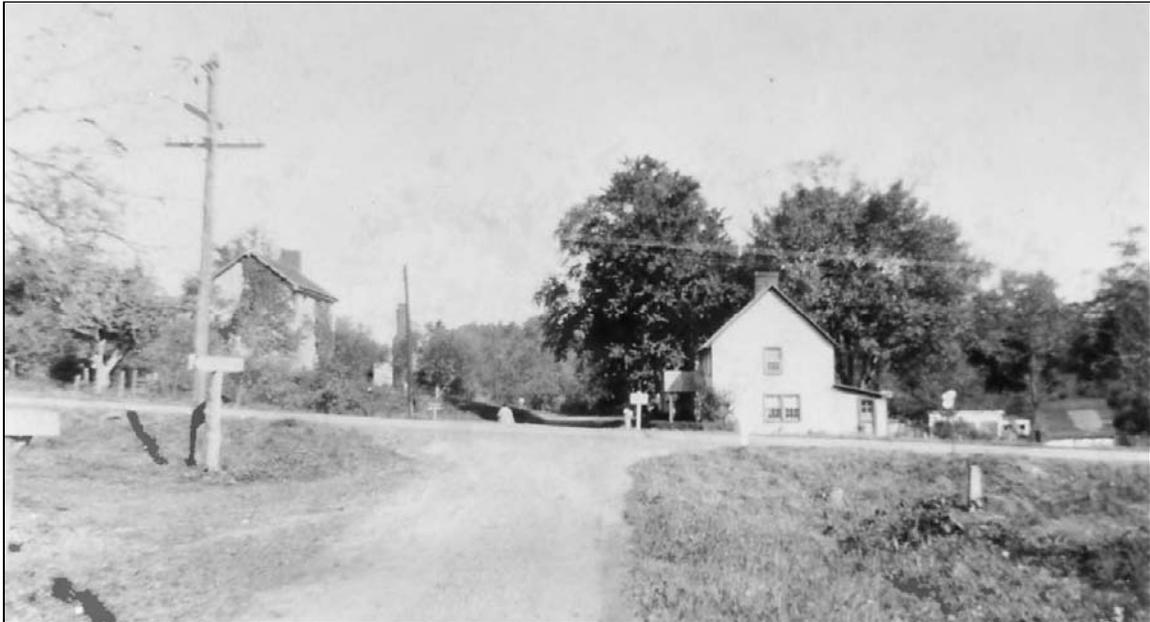
Figure #32: Buckland Mill Road looking north and showing intersection with former Fauquier and Alexandria Turnpike. Buckland Preservation Society, n.d. [post-1927].

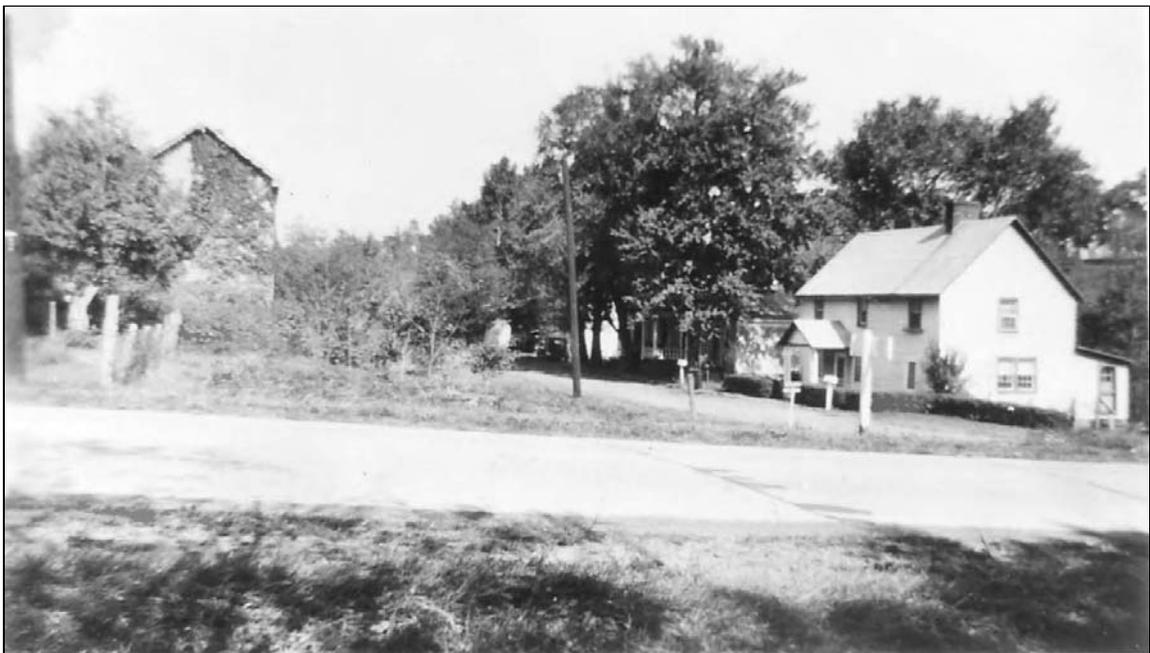
Figure #33: Route 211 (former Fauquier and Alexandria Turnpike) and new concrete surfacing looking north. Buckland Preservation Society, n.d. [post-1927].

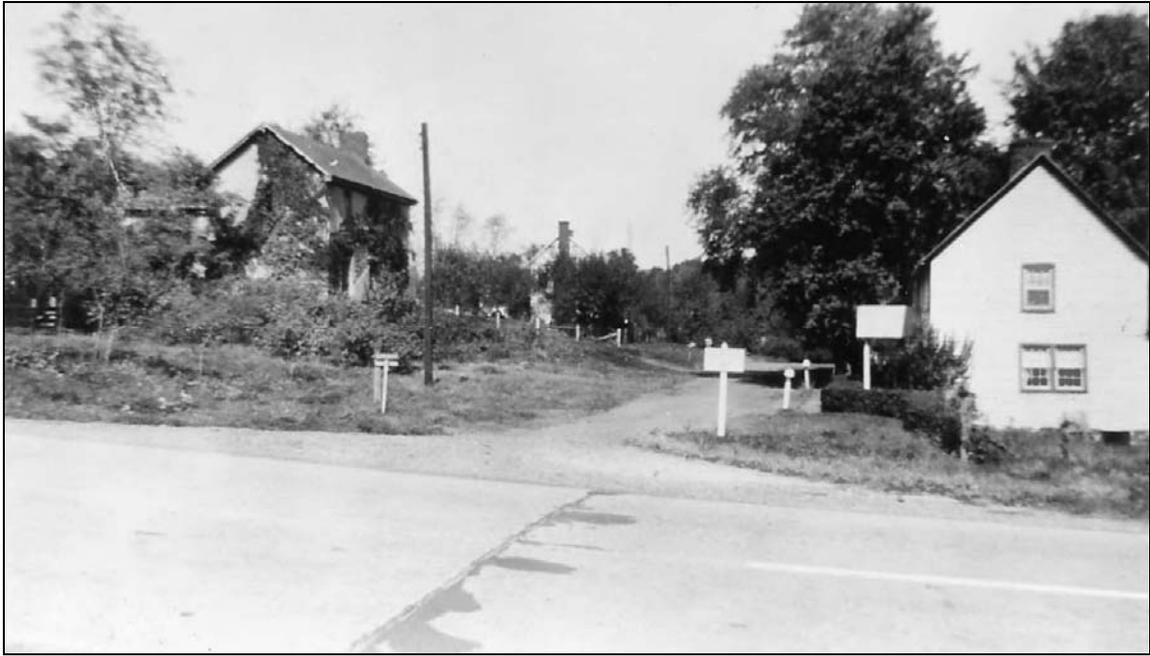
Figure #34: Intersection of former Fauquier and Alexandria Turnpike and Buckland Mill Road, looking north towards Buckland Mills. Buckland Preservation Society, n.d. [post-1927].

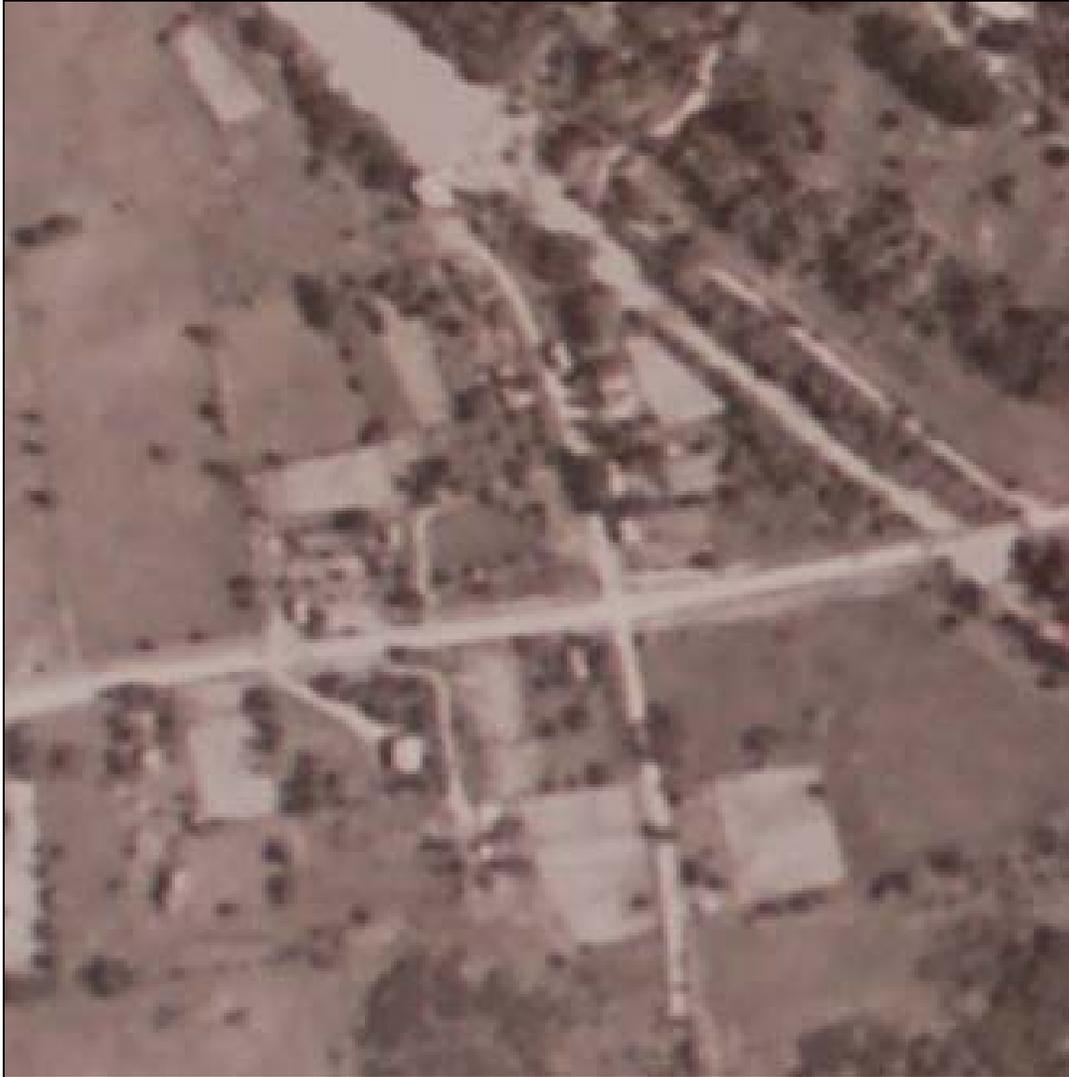
Figure #36: Detail, 1937 aerial photograph of Buckland showing remnant 48-lot town, Broad Run at top, and the intersection of Buckland Mill Road and Warrenton Pike at center.

A 1937 aerial photograph of a portion of Prince William County shows the Buckland vicinity only a decade after the construction of the new concrete bridge and 18-foot-wide macadamized road. The photograph remnant parcels that may date to the original 1798 48-lot town plan, many of which are defined by fences and their associated vegetative growth (Figure #36).

A 1926 State Highway Commission plan for the construction of a new concrete bridge at Buckland and the improvement of Route 21 (former Fauquier and Alexandria Turnpike) documents the presence of a 'frame building' (F.D.) at the corner of Rt. 684 (Buckland Mill Road) and Route 21 (Figure #47). The dwelling appears to be located in the northeast corner of Lot #6, possess a rectangular footprint, and is oriented in an east-west direction. According to the scale provided for the plan, the structure sits approximately 475 feet west of the western bridge abutment at Broad Run. Sometime between the 1926 State Highway Commission plan and the 1937 aerial photo of Buckland (Figure #36), the frame dwelling on the Trone House property was demolished.

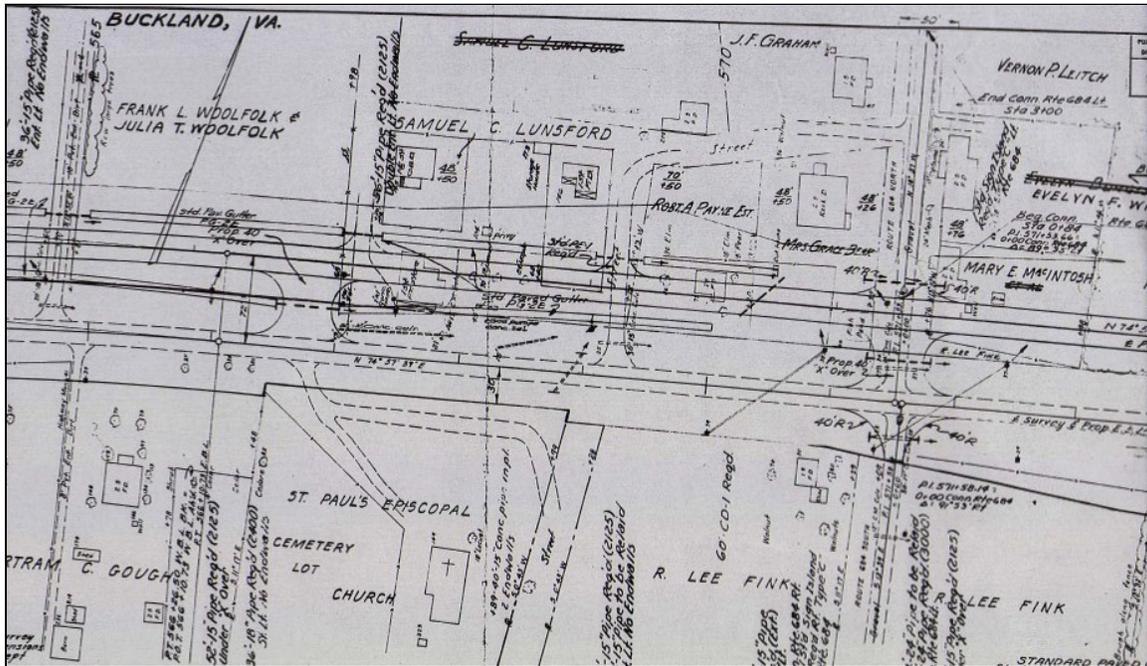
Figure #37: Detail, plan for widening Route 29, showing proposed expansion and condemnation of properties to the north of existing road. Virginia Department of Highways, 1952.

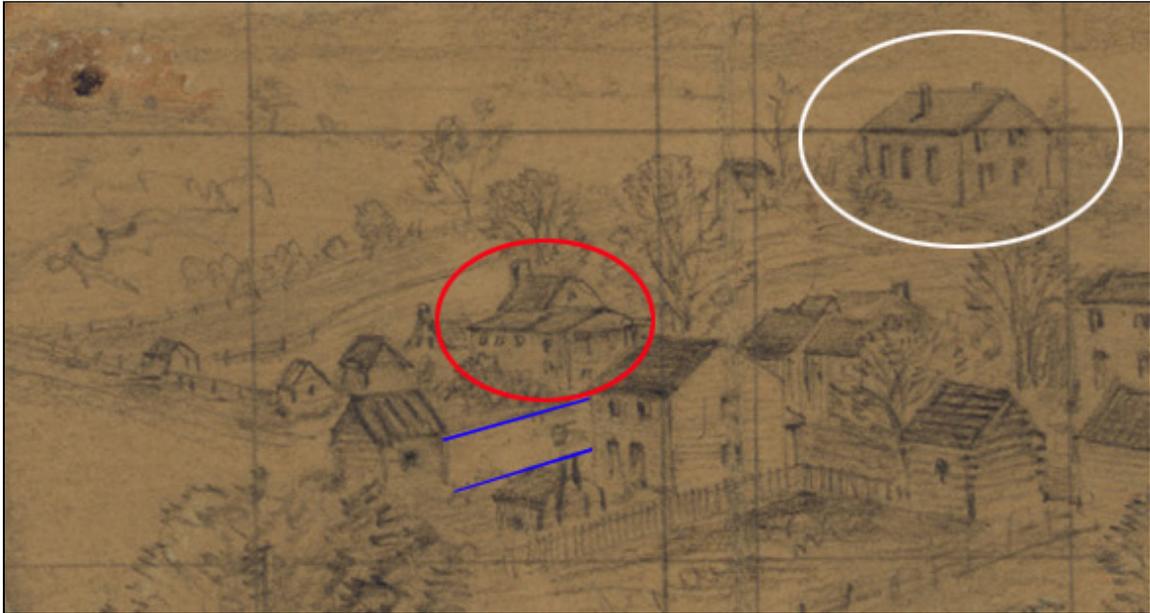
Figure #45: Detail, *Buckland from Mr. Hunton's House*, showing Trone House and what is believed to be the Stagecoach Inn (circled in red), the Methodist Church (circled in white), and the course of the Fauquier and Alexandria Turnpike road (outlined in blue). Alfred R. Waud, 1863.

believed to be the Stagecoach Inn may have occupied the vicinity of lots 5 and 6 from the second quarter of the nineteenth to the second quarter of the twentieth centuries. An 1863 sketch of the Battle of Buckland Mills by Alfred R. Waud shows a structure believed to be the Stagecoach Inn. The structure is represented as a two-story frame building, oriented on a north-south axis, adjacent to the south side of the Fauquier and Alexandria Turnpike Road. The structure appears to be located off the northeast corner of the John Trone House (Figure #45).

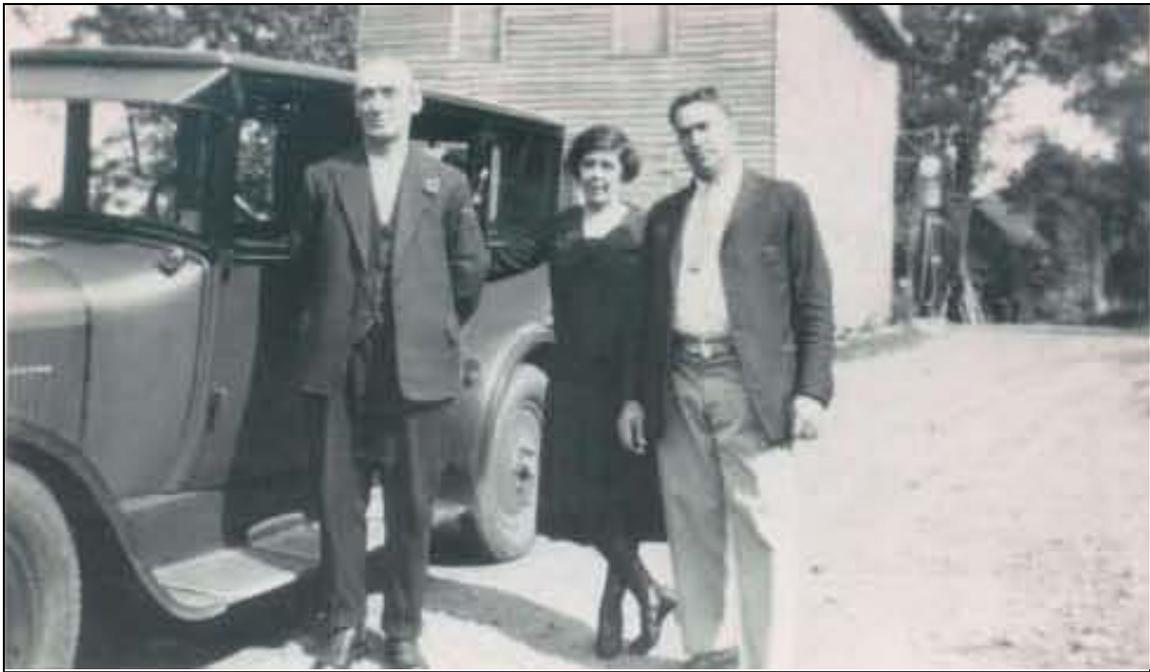
Figure #46: Buckland Mill Road looking north towards intersection with turnpike showing what is believed to be the Stagecoach Inn in the background. Courtesy, Buckland Preservation Society.

A first quarter of the twentieth century photograph is also believed to show the Stagecoach Inn structure. The photograph, taken from Buckland Mill Road south of its intersection with the Fauquier and Alexandria Turnpike, shows three individuals, an automobile, and a two-story frame structure with its gable ends in a north-south orientation (Figure #46).

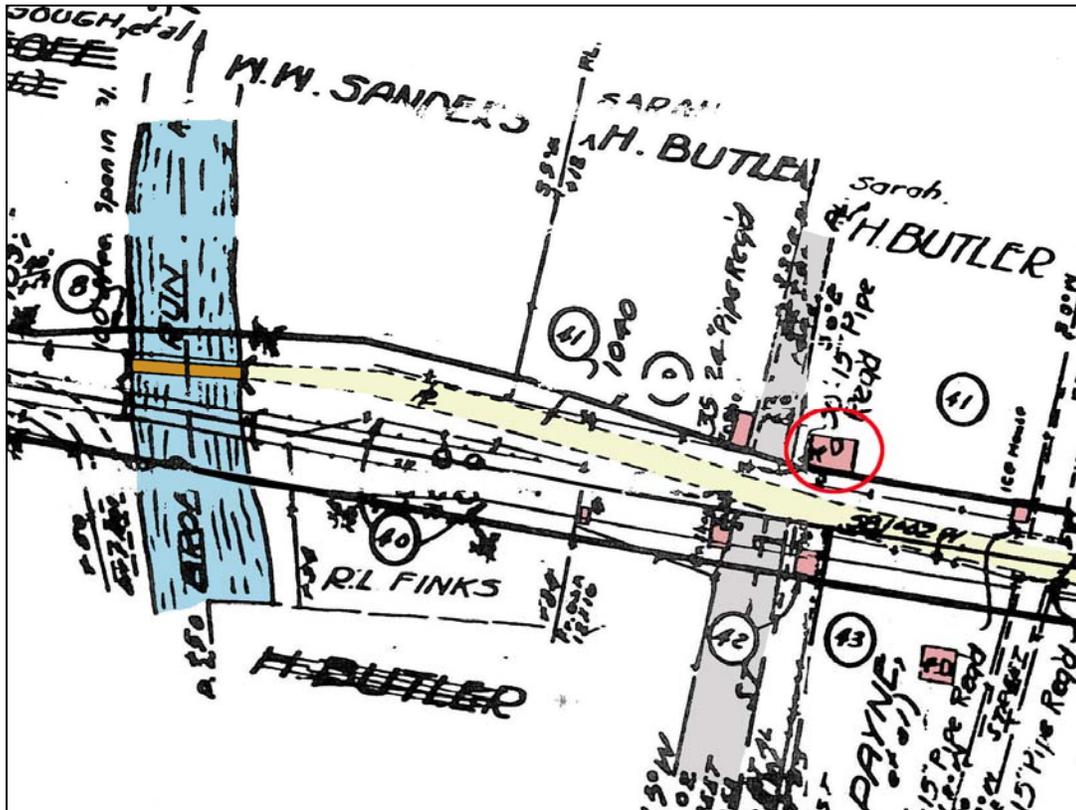
Figure #47: Detail, Plan and Profile of Proposed State Highway, Prince William County, 1.00 MI. E. of Gainesville to Buckland, showing Broad Run, course of turnpike road (shaded in yellow), a frame dwelling located in the northeast corner of the Trone House Lot #6 (circled in red). Plan is color annotated by Rivanna Archaeological Services. North is down in this plan view. State Highway Commission, 1926.

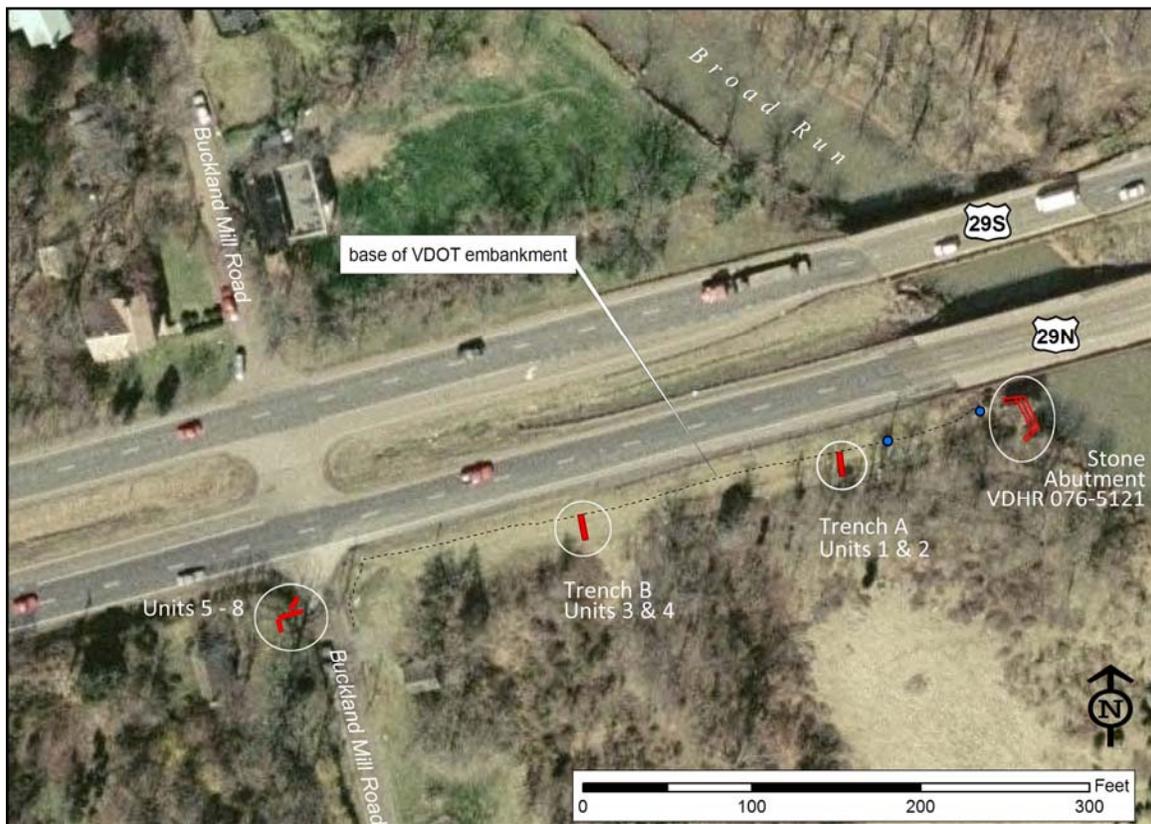
Figure #48: Map of Fauquier and Alexandria Turnpike Road project area showing Rte. 29 / Lee Highway, Buckland Mill Road, Broad Run and trench and unit locations.

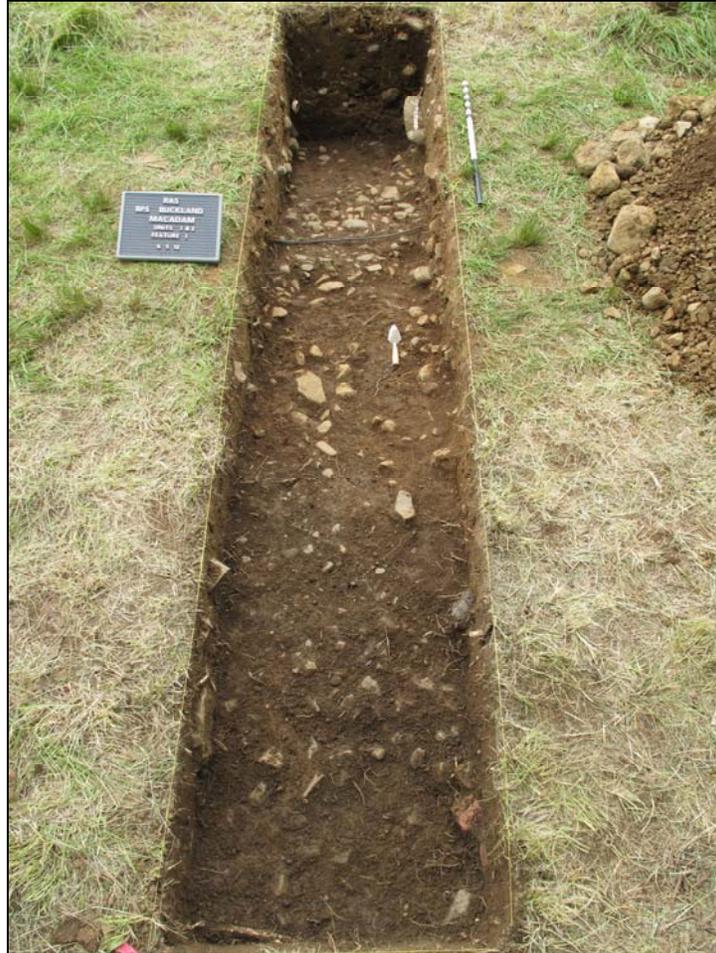
Figure #50: Trench A, Units 1 and 2 looking north, showing feature 1 road surfacing, a convex shaped stratum of stone within a dark brown sandy loam matrix.

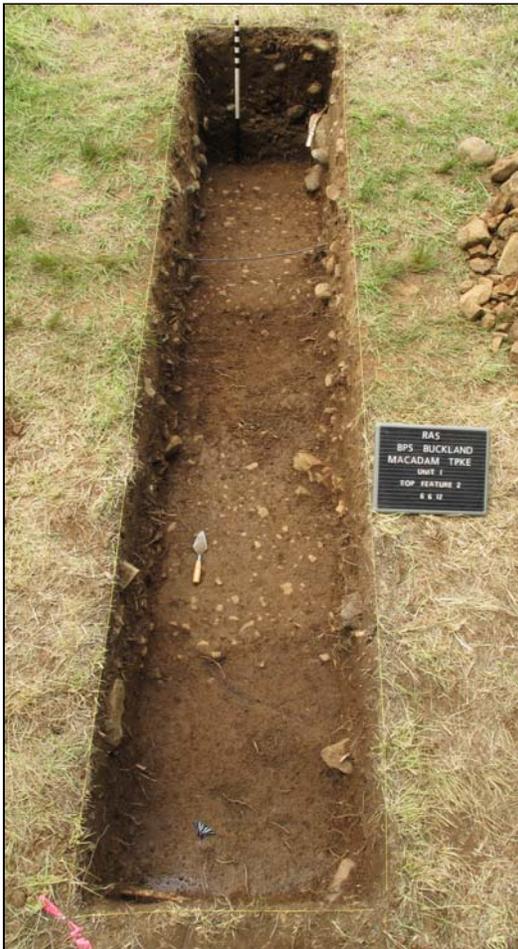
Figure #51: Trench A, units 1 and 2 looking north, showing feature 2 stone surfacing with utility trench running through center.

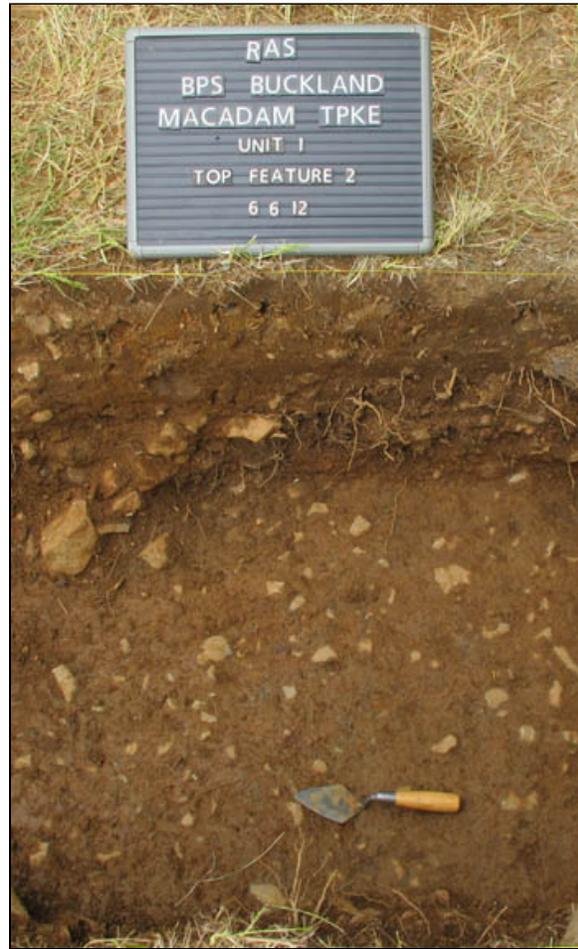
Figure #52: Trench A, unit 2 looking east, showing detail of feature 2 stone surfacing. Note the small size of stone and smooth surface.

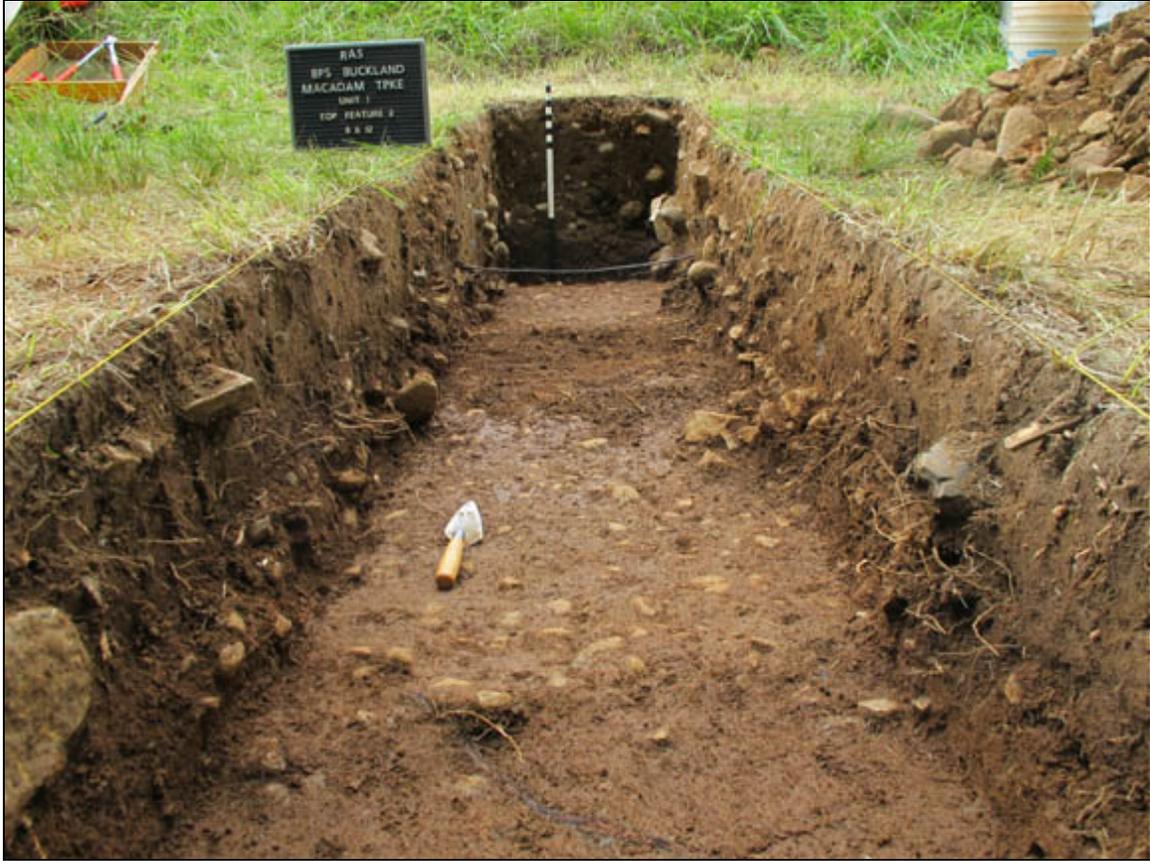
Figure #53: Trench A units 1 and 2, looking north, showing feature 2 stone surfacing.

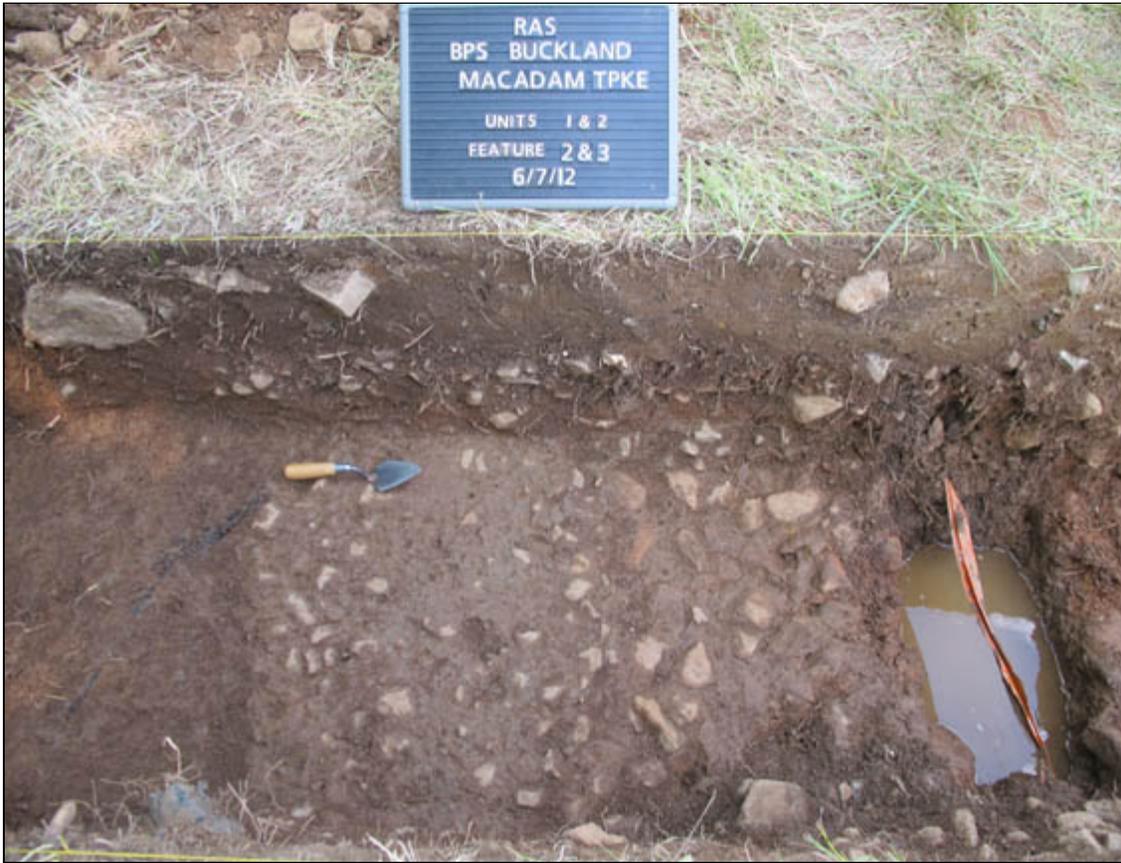
Figure #54: Trench A, units 1 and 2 looking west, showing comparison of feature 2 road surface composed of small stones (at left under trowel), with feature 3 road surfacing composed of larger stones (at right, left of buried utility).

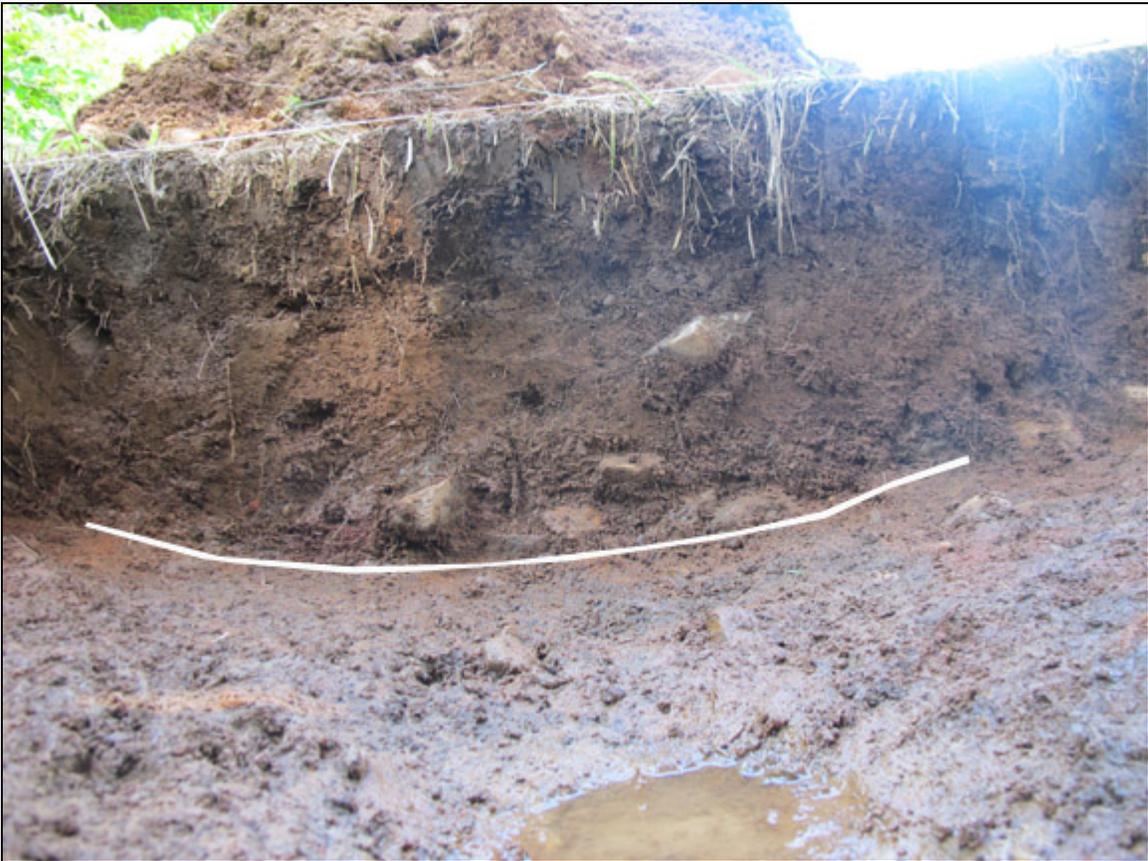
Figure #55: West soil profile at south end of trench B, showing convex profile of swale / drainage trough outlined in white.

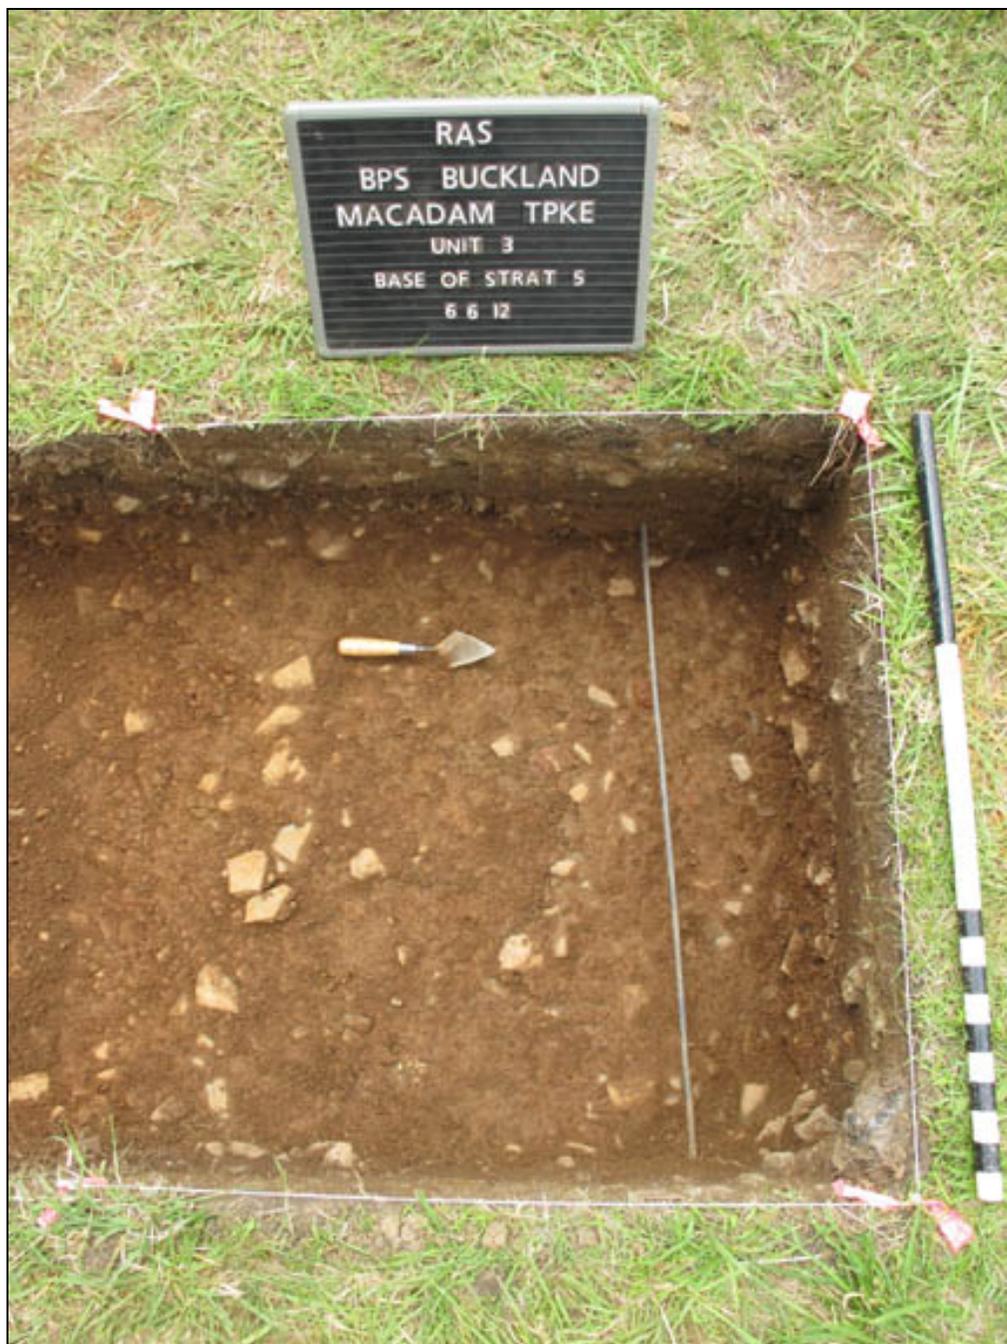
Figure #56: Trench B, unit 3 looking west, showing small isolated areas of angular crushed stone surfacing, and utility 2 east-west oriented black cable at right.

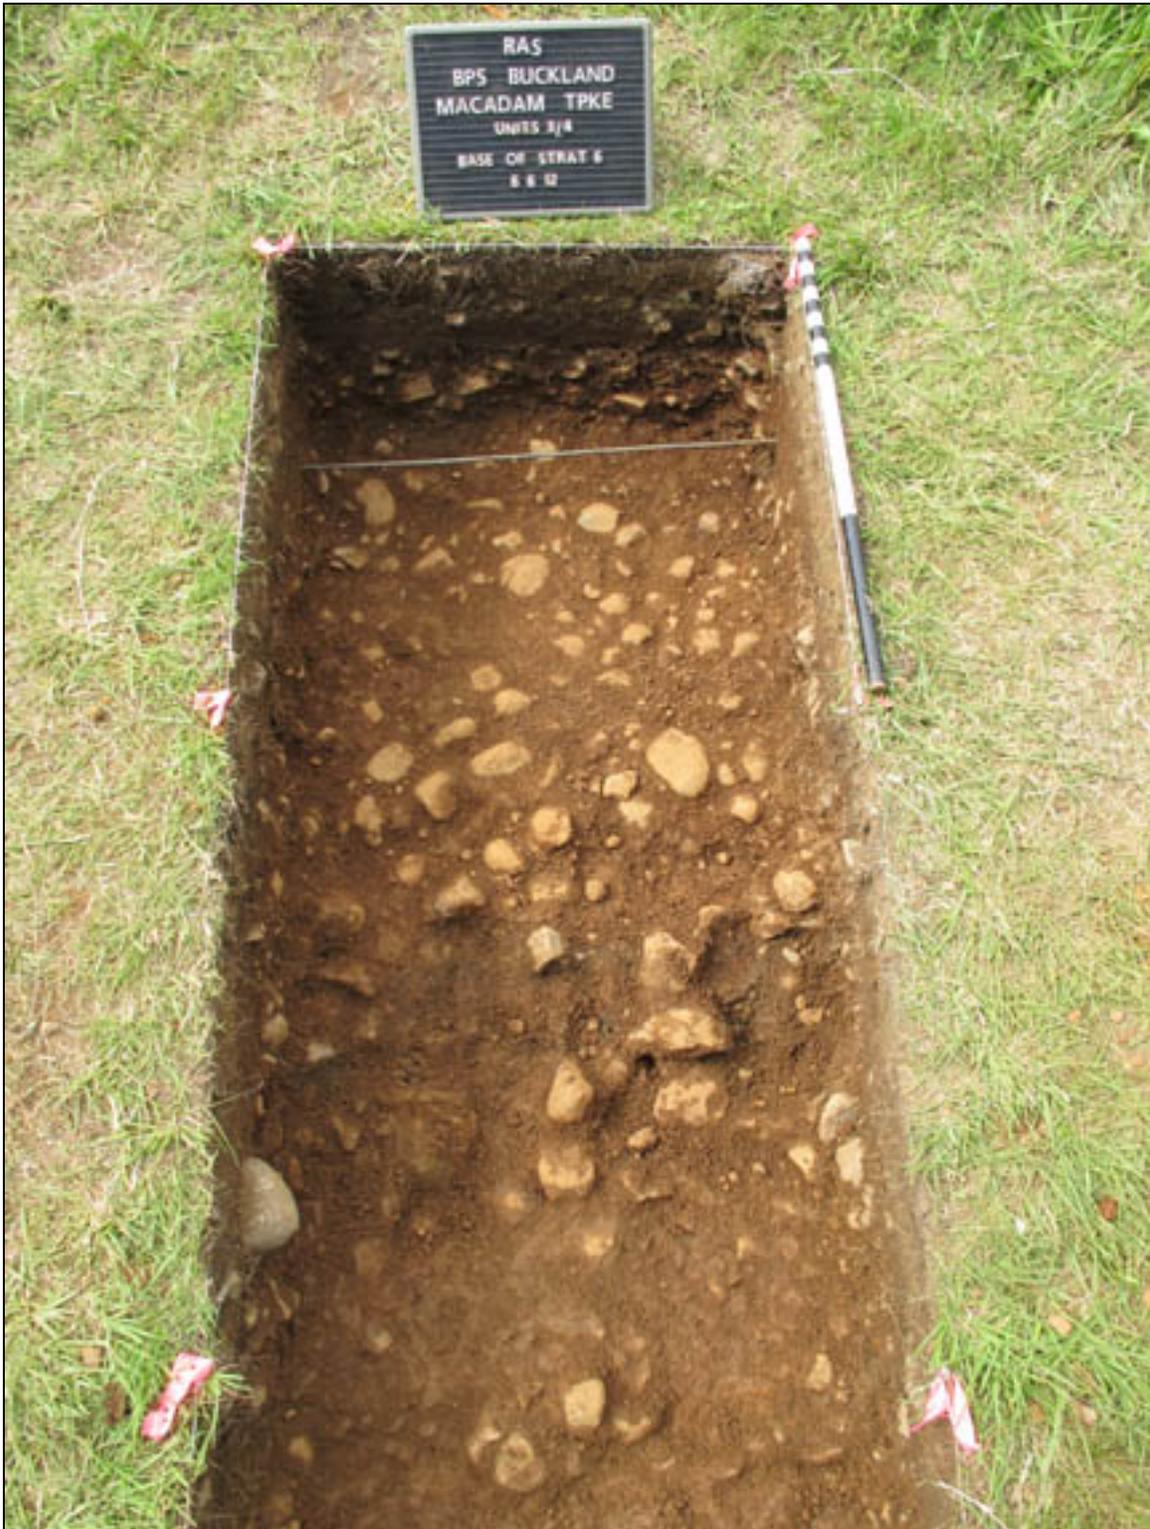
Figure #57: Trench B unit 3, looking north, showing top of stratum 7 and road metal composed of water-worn cobbles approximately 0.5 to 0.85 feet in diameter.

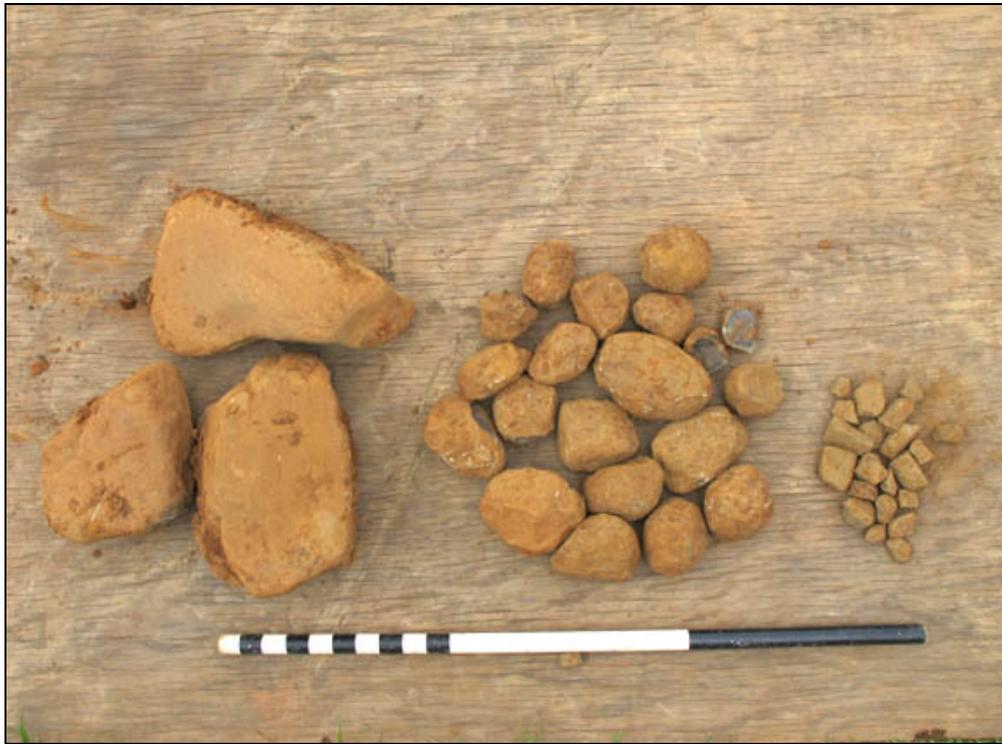
**Figure #58: Road metal samples recovered from trench A unit 3
stratum 6 (right), stratum 7 (center) and stratum 8 (left).**
