Archaeological Investigations

Fauquier and Alexandria Turnpike

44PW1938
Buckland, Virginia

VDHR File No.: 2009-0432
Buckland Historic Transportation Enhancement Project
Project No.: EN06-076-123, P101 UPC 81772

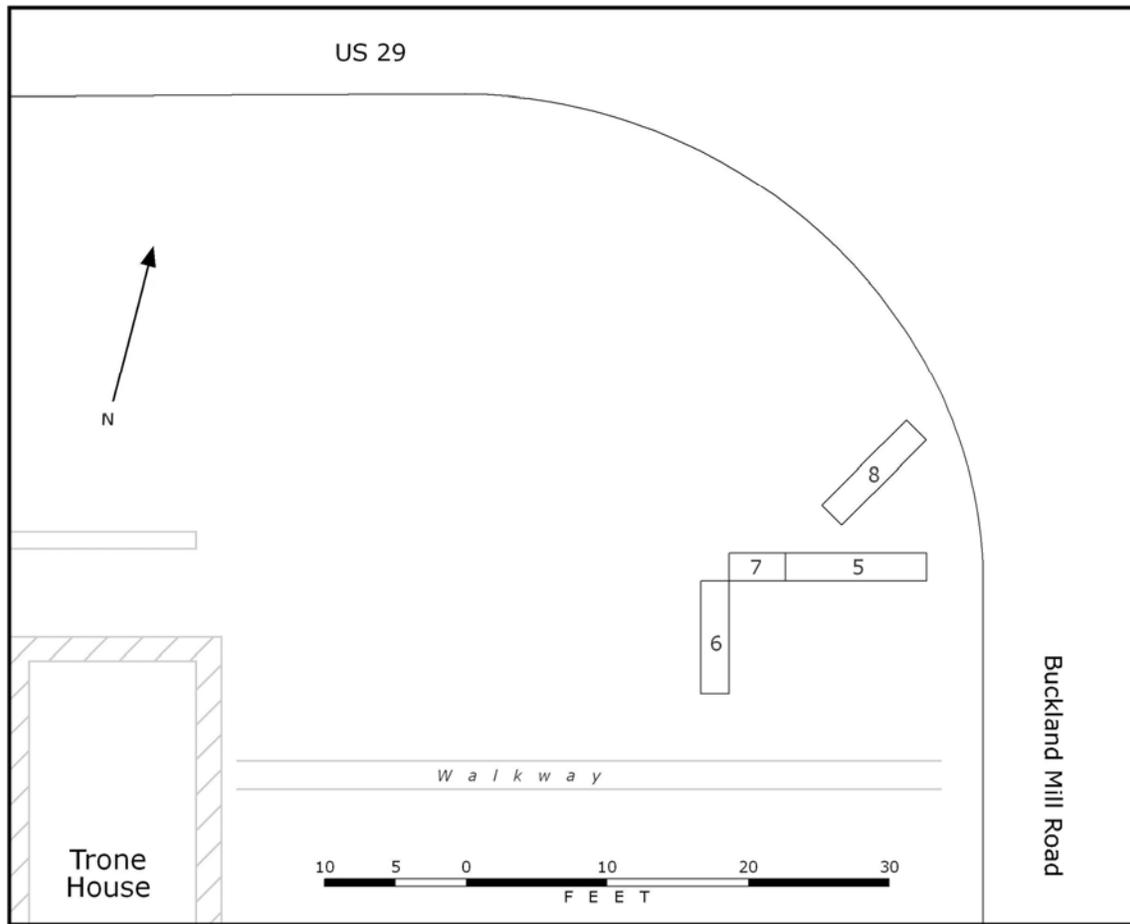
Figure #59: Trone House yard at intersection of Rte. 29 / Lee Highway and Buckland Mill Road showing location of units 5 – 8.

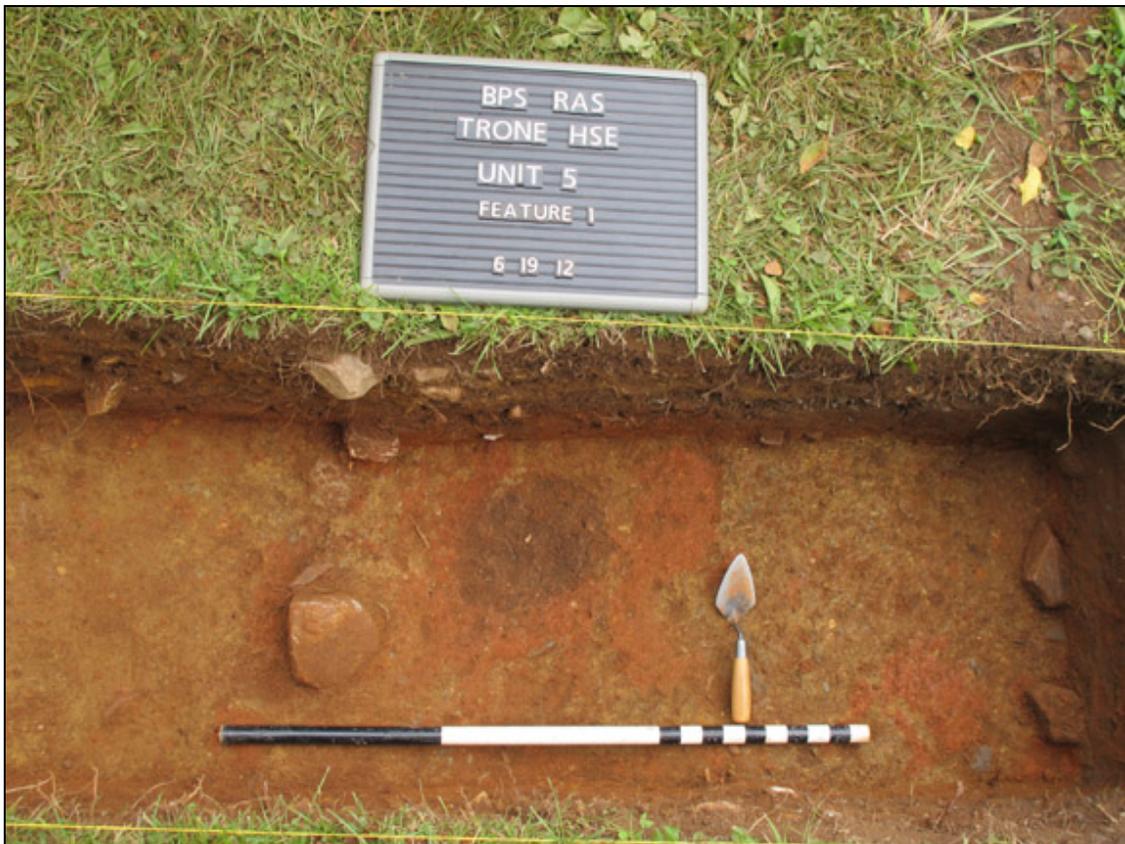
Figure #60: Unit 5, looking north showing feature 1 soil discoloration adjacent to north profile.

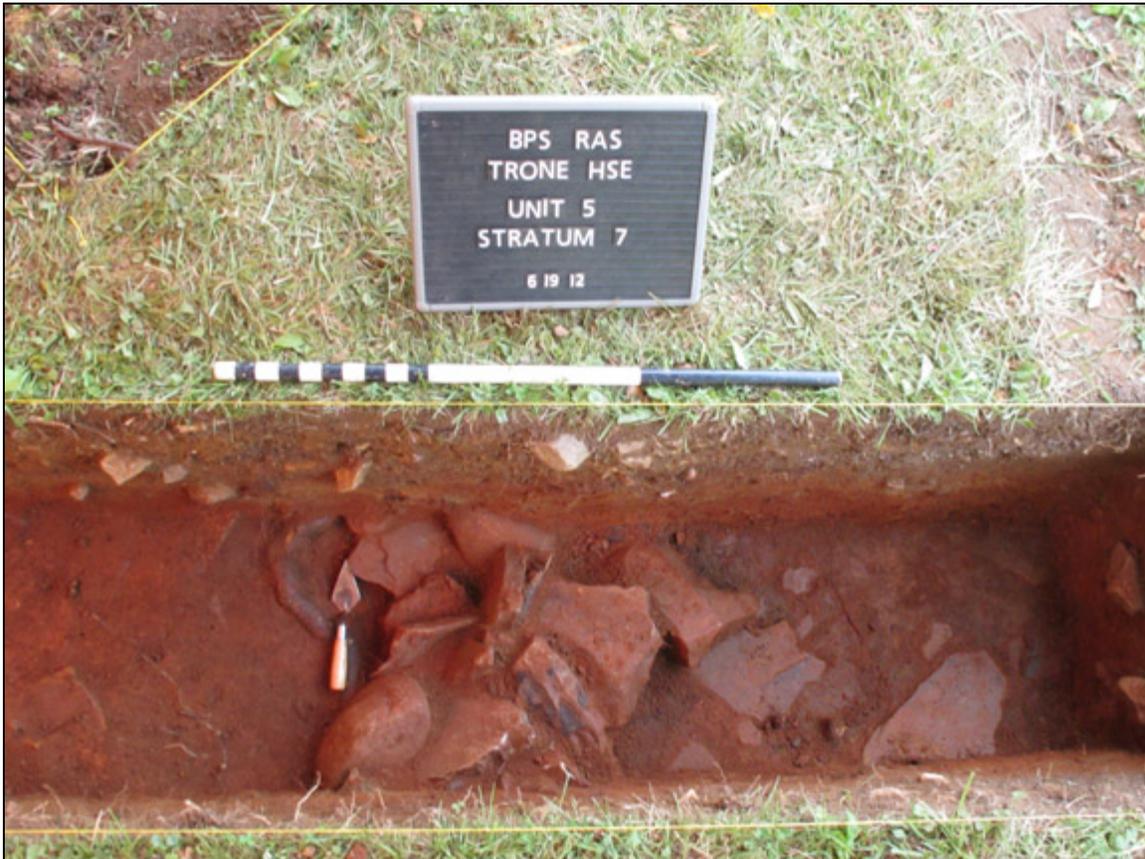
Figure #61: Unit 5 base stratum 7, looking north, showing feature 2 concentration of stone in east end of trench.

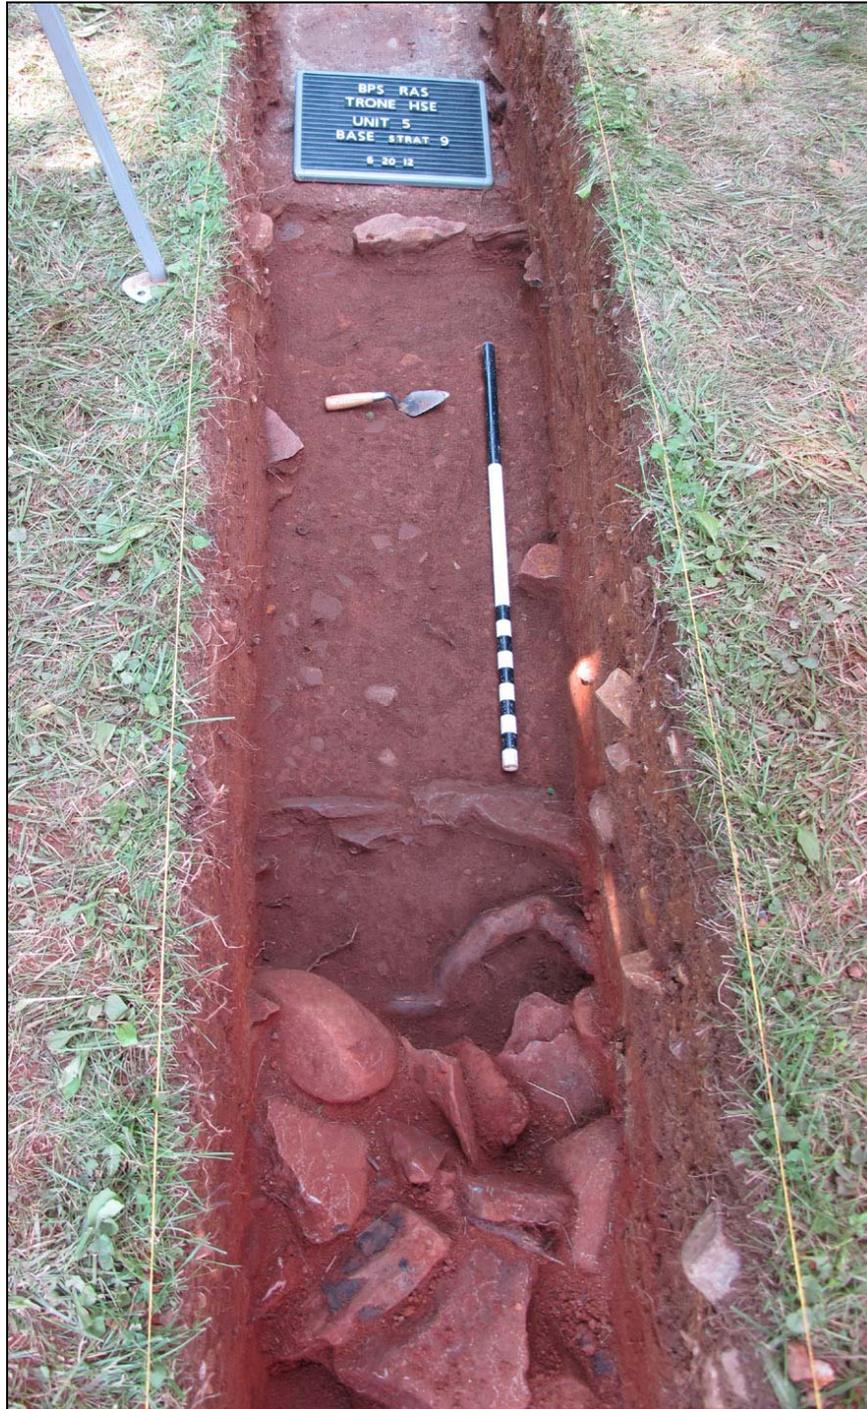
Figure #62: Unit 5 base of stratum 9, looking west, showing feature 2 stone concentration (bottom), features 3 (bottom of scale) and 4 (top of scale) vertically set stone alignments.

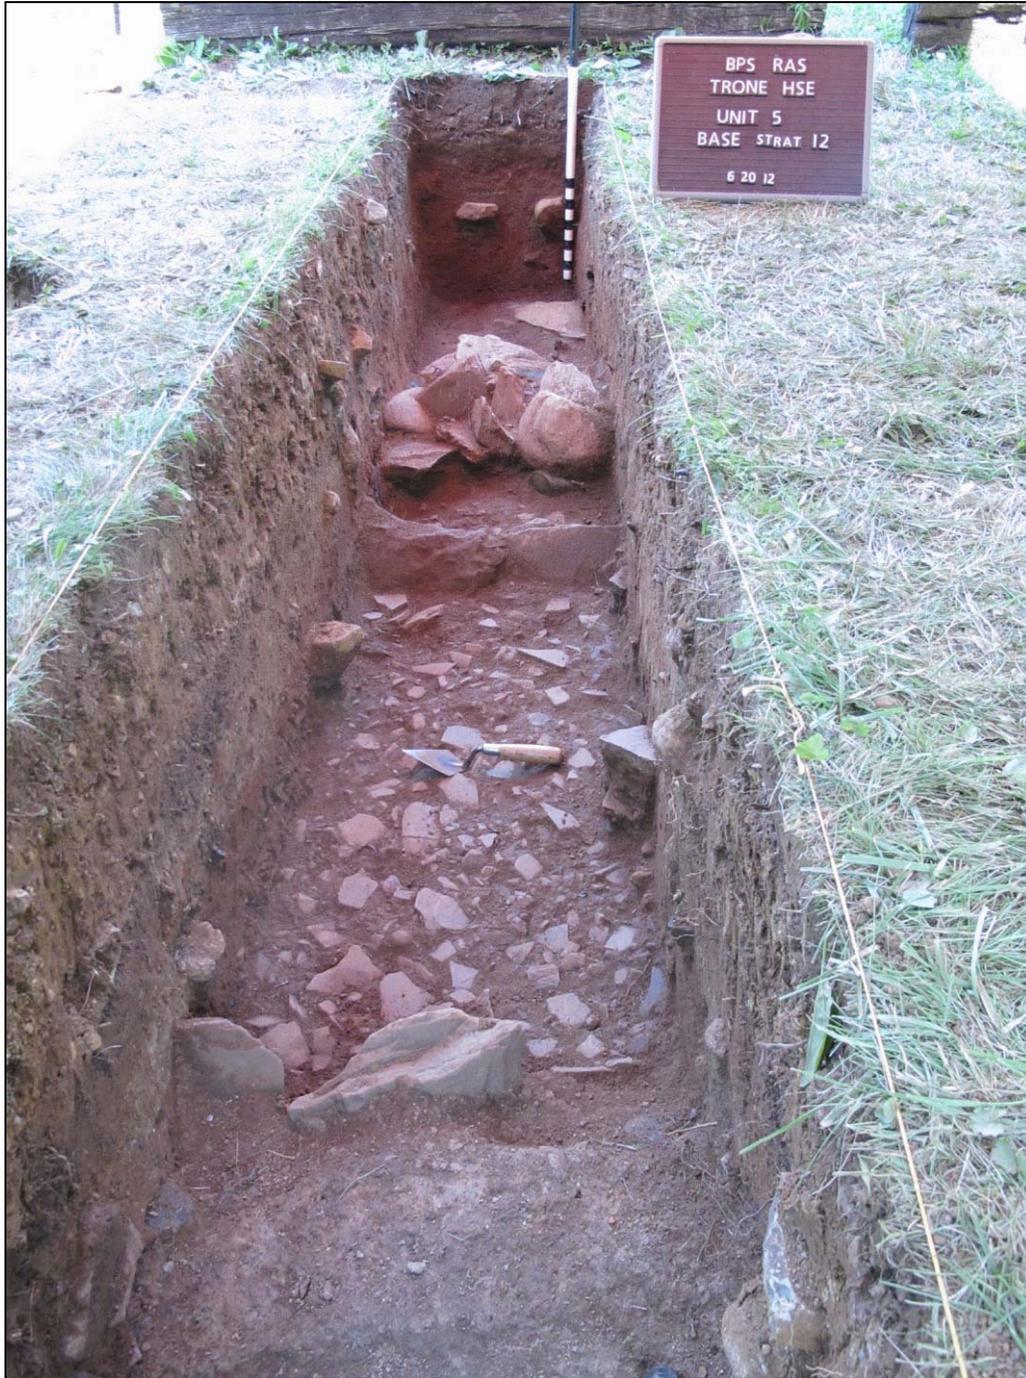
Figure #63: Unit 5 base stratum 12, looking east, showing top of stratum 14 stone surfacing, designated as feature 5, under trowel.

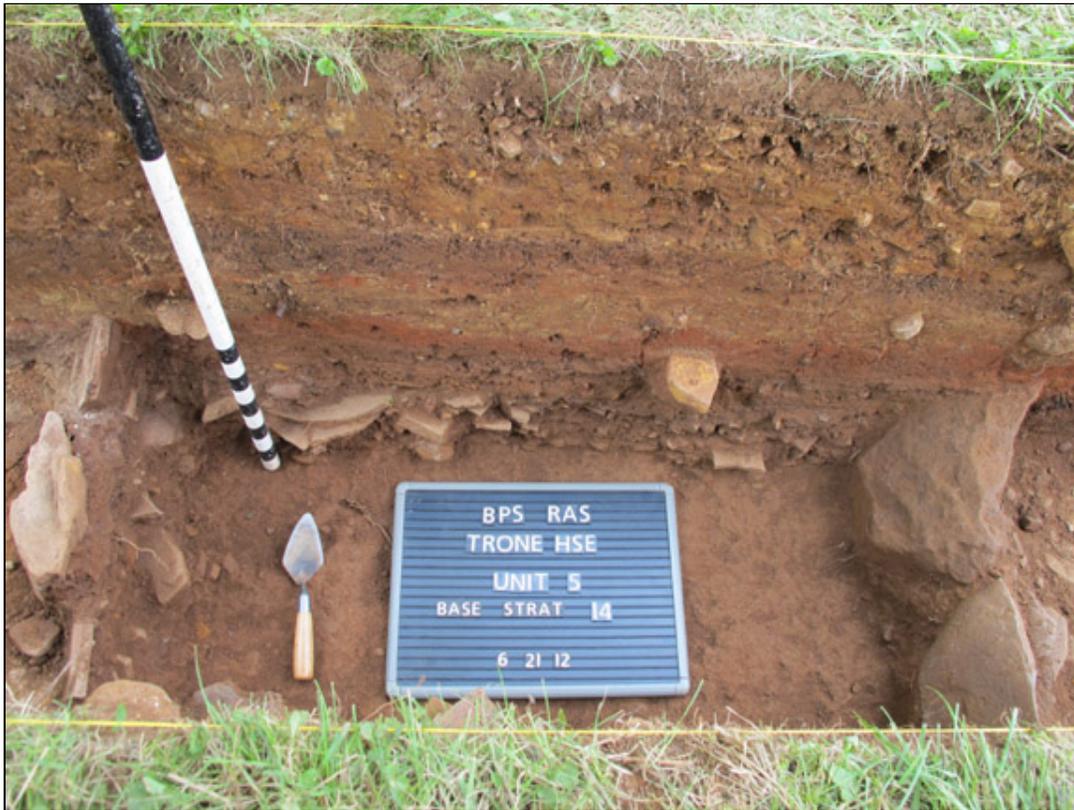
Figure #64: Unit 5 stratum 14 excavated, looking north, showing dense layer of stone paving, feature 5, in profile as well as feature 3 (right) and feature 4 (left) vertical stone alignment.

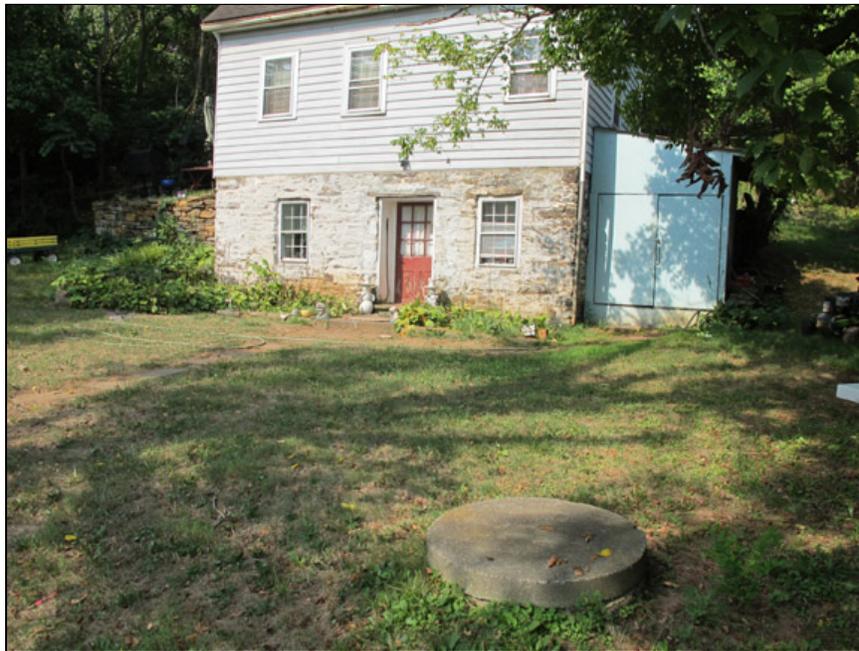
Figure #65: Concrete sanitary feature (lower right) in relationship to John Trone House.

Because the John Trone House possessed an ‘ell’ shaped stone wall attached to its northern façade that architectural historians believed may have once been a hyphen linking the main residence with the Stagecoach Inn to its northeast, a short 2 x 8 foot north-south oriented trench, unit 6, was placed straddling the line of the north façade of the Trone House, approximately 30 – 32 feet east of the historic residence (Figure #55). Unit 6 was also placed approximately 5.5 feet east and down slope from a concrete septic tank feature in the hopes of avoiding the disturbance created during installation of the twentieth century sanitary feature (Figure #65).

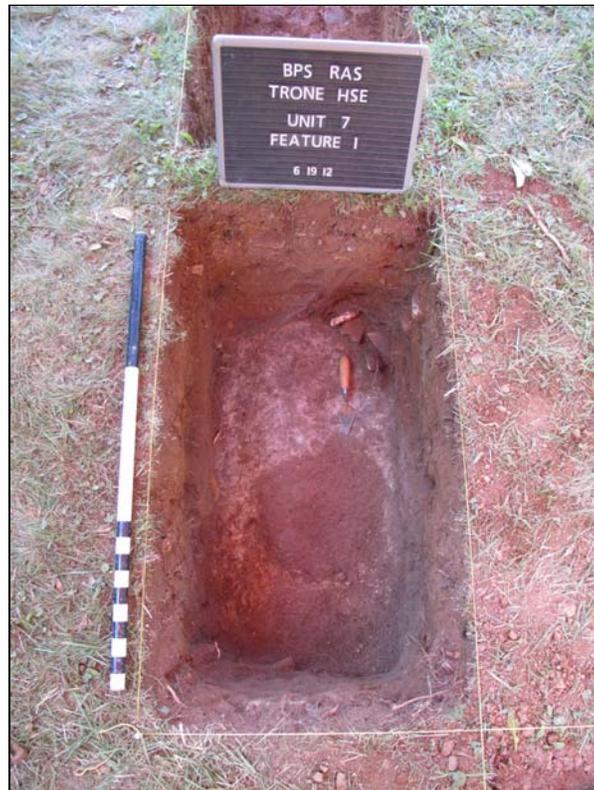
Figure #66: Unit 7, looking east, showing top of white-gray ashy deposit, stratum 2, and feature 1 circular discoloration.

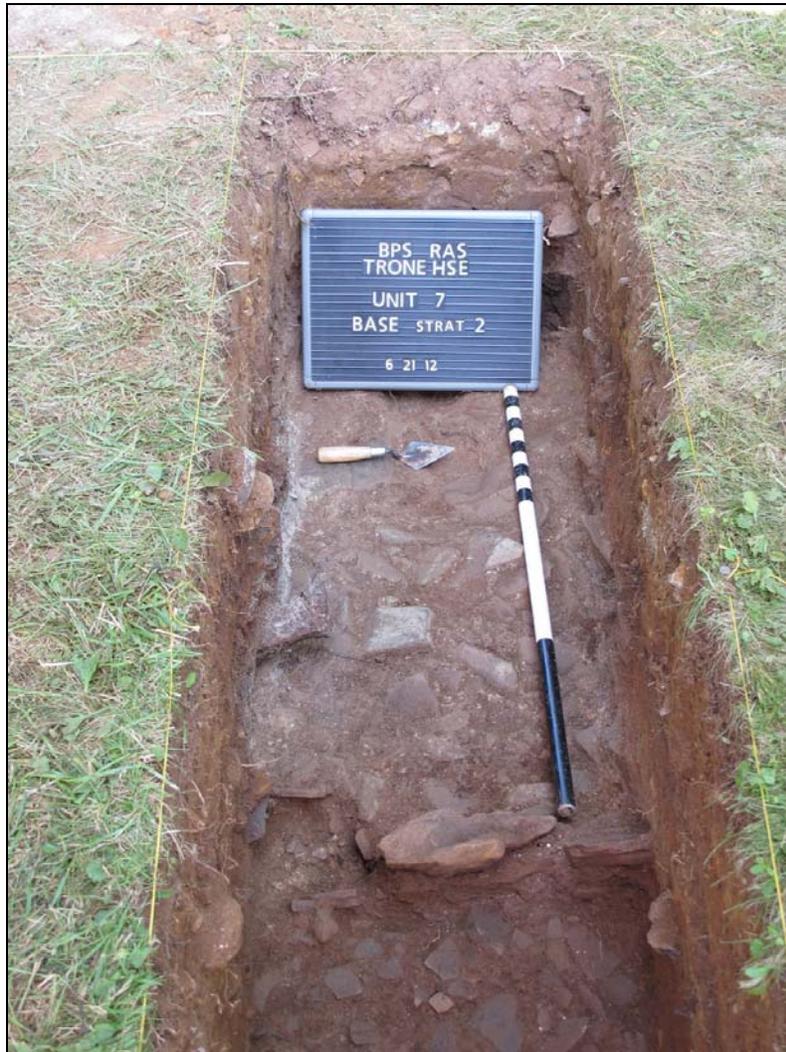
Figure #67: Unit 7, looking west, showing stratum 3 deposit of dense small angular rock surfacing.

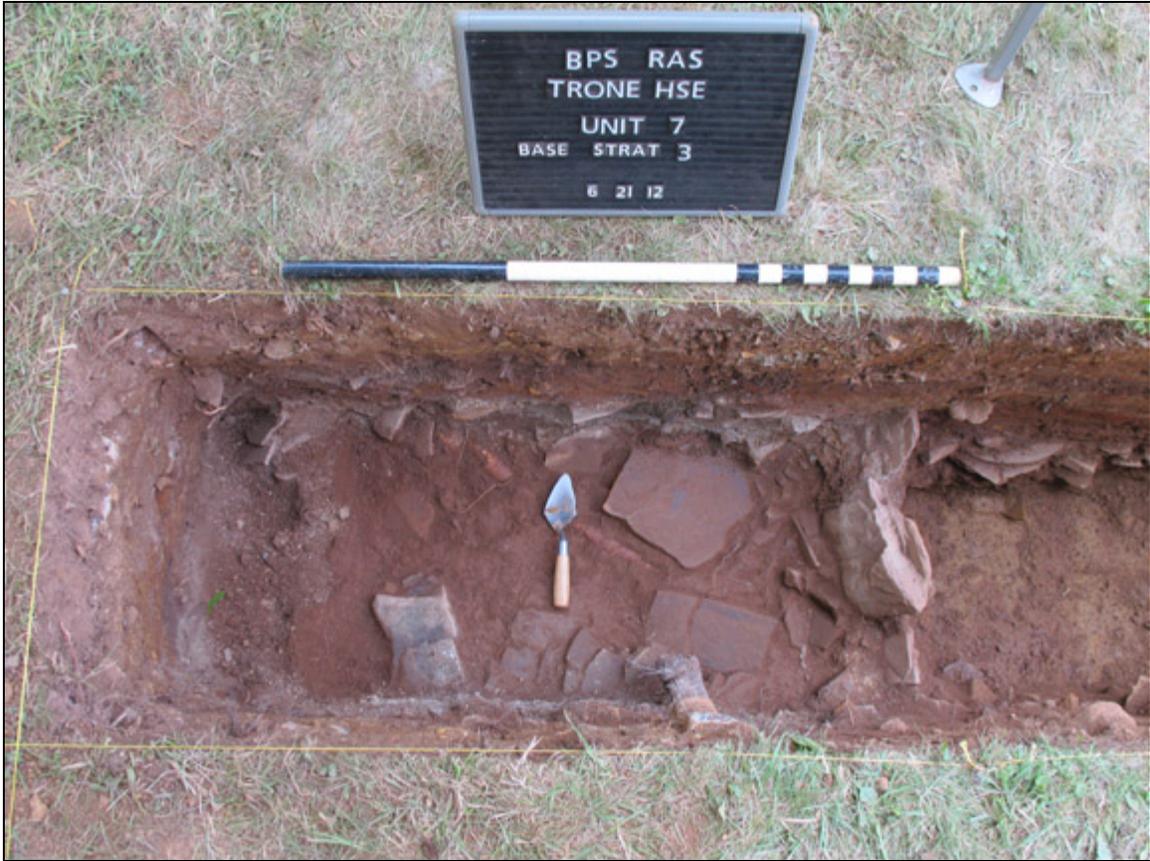
Figure #68: Unit 7, looking north, showing surface of large tabular rocks, stratum 4.

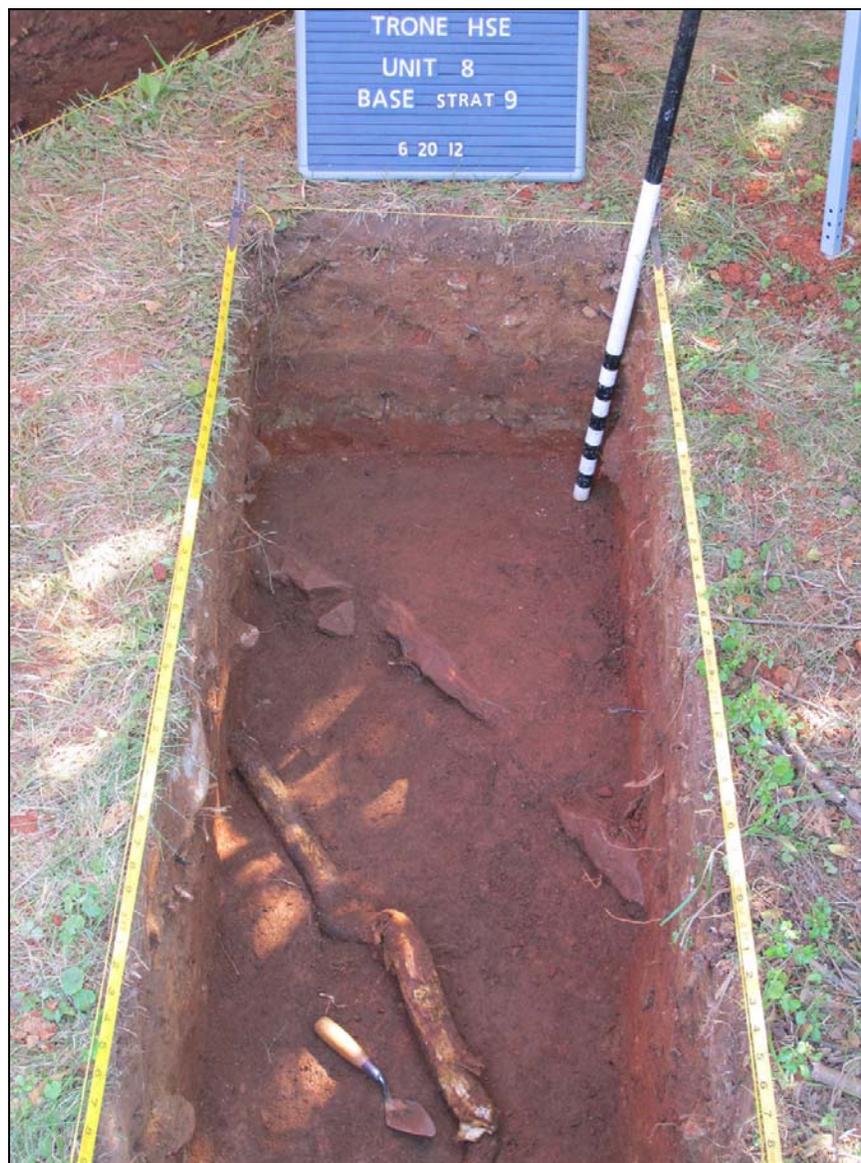
Figure #69: Unit 8, looking southwest, showing north-south oriented alignment of vertically set stone, feature 2.

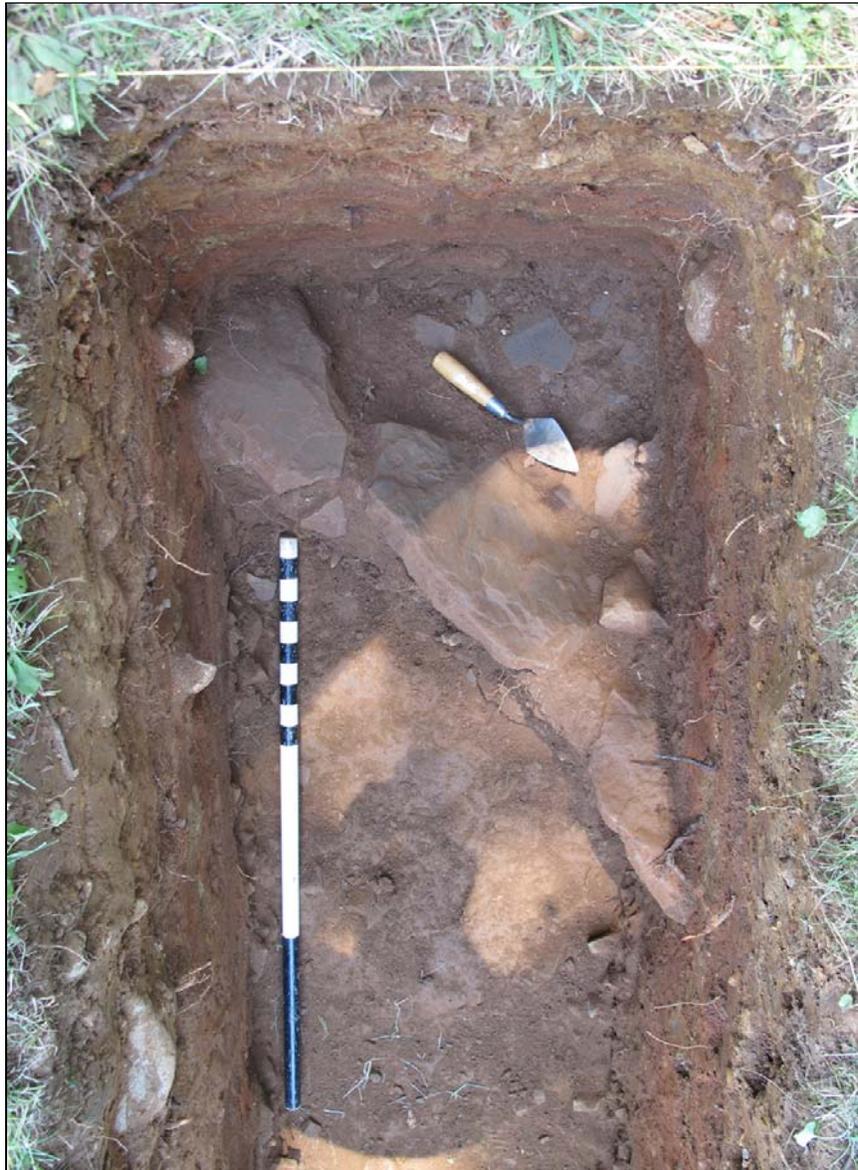
Figure #70: Unit 8 looking west and showing feature 4 angular stone surfacing (under trowel), west of feature 2 vertical stone alignment.

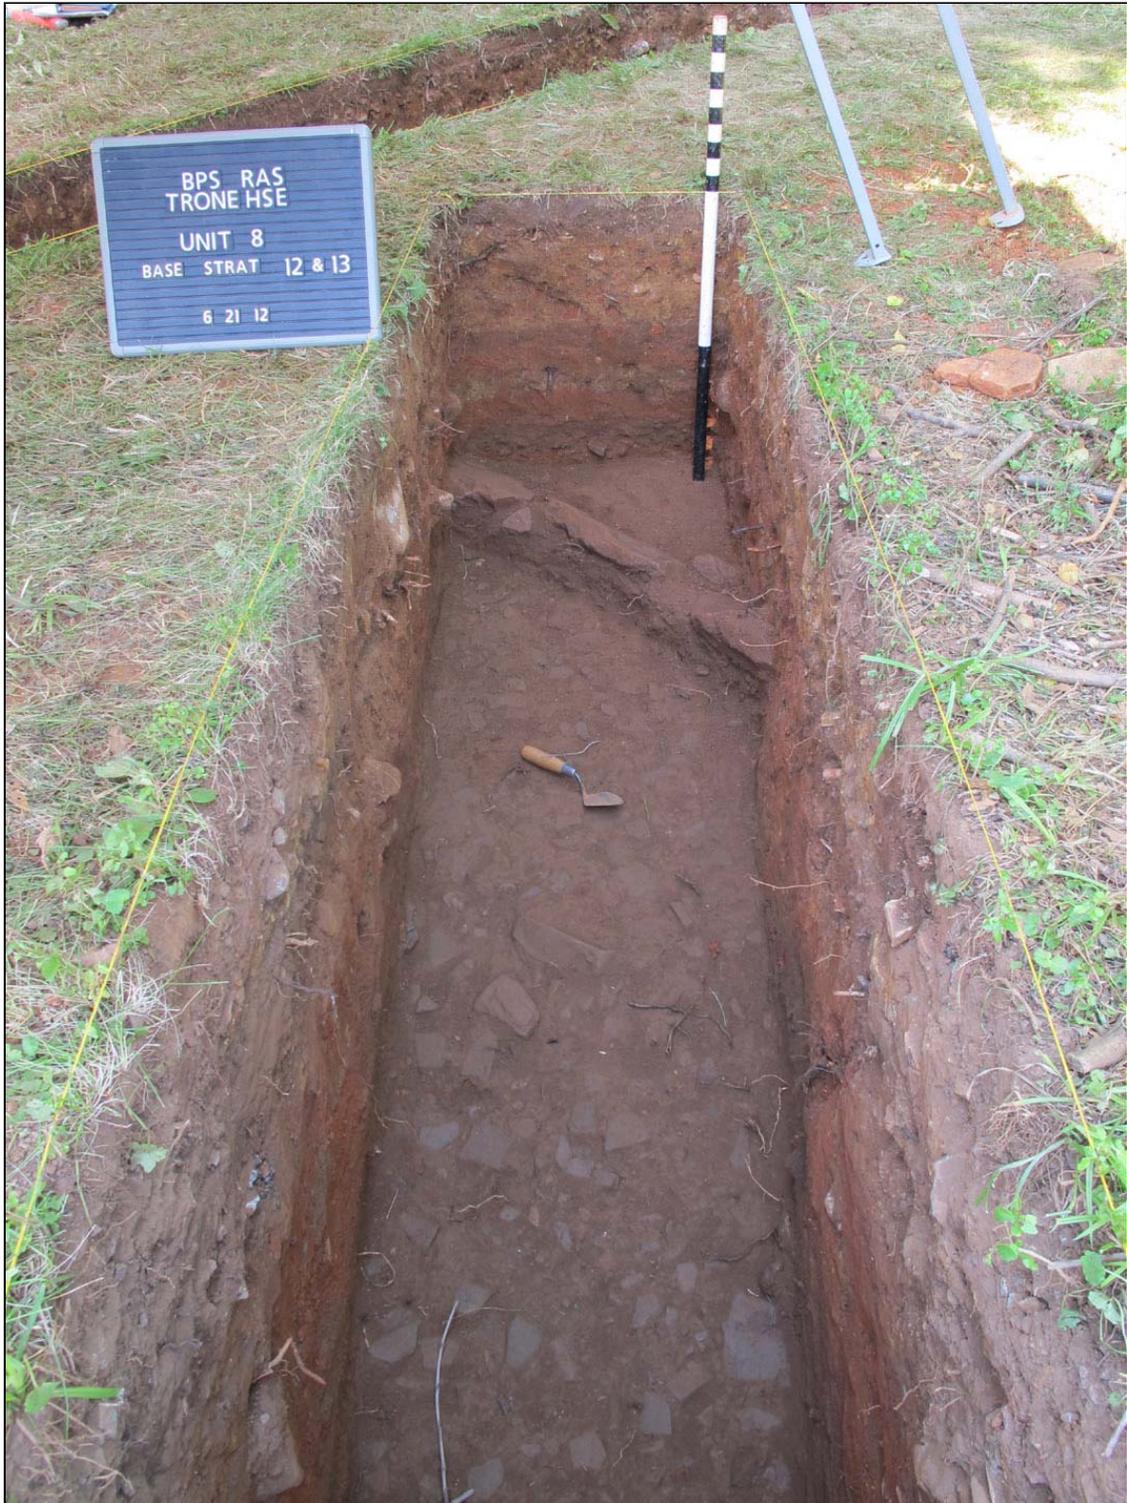
Figure #71: Unit 8, looking southwest, showing top of stratum 15, a dense deposit of hard, angular flat stone designated feature 3.

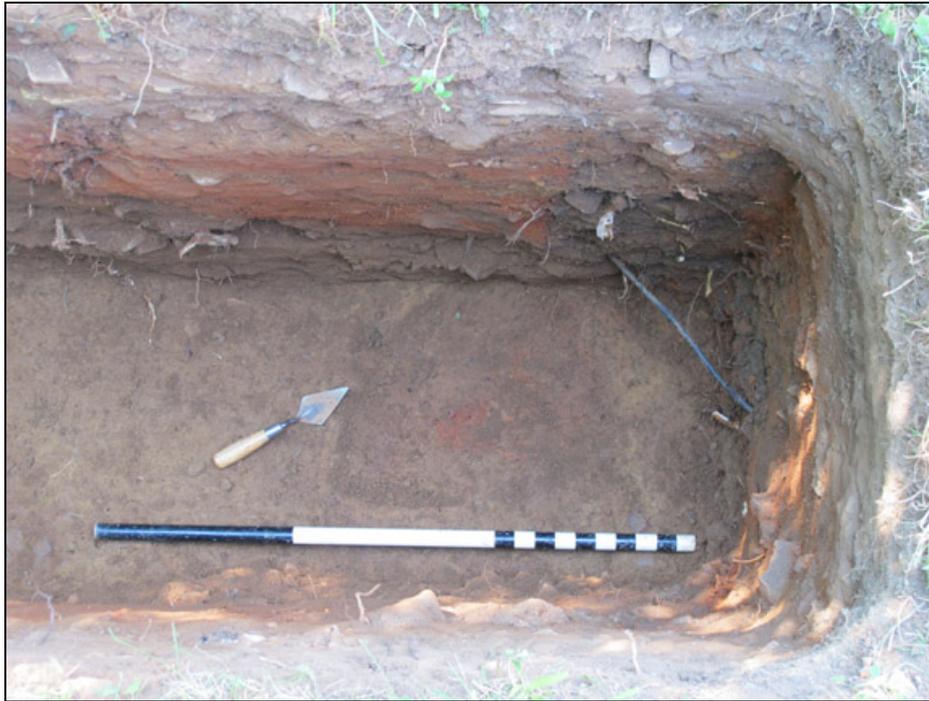
Figure #72: Unit 8, looking northwest, showing top of feature 5 soil discoloration.

Underlying stratum 17 was a dense yellow brown silty clay with naturally occurring iron? nodule inclusions, most likely the underlying local subsoil. Cutting subsoil was an approximately 1.2 foot diameter circular soil discoloration, feature 5. At its surface, feature 5 contained a brick bat and brick and mortar inclusions (Figure #72). Although feature 5 exhibited characteristics of a possible post-hole, due to time restrictions it was not excavated.

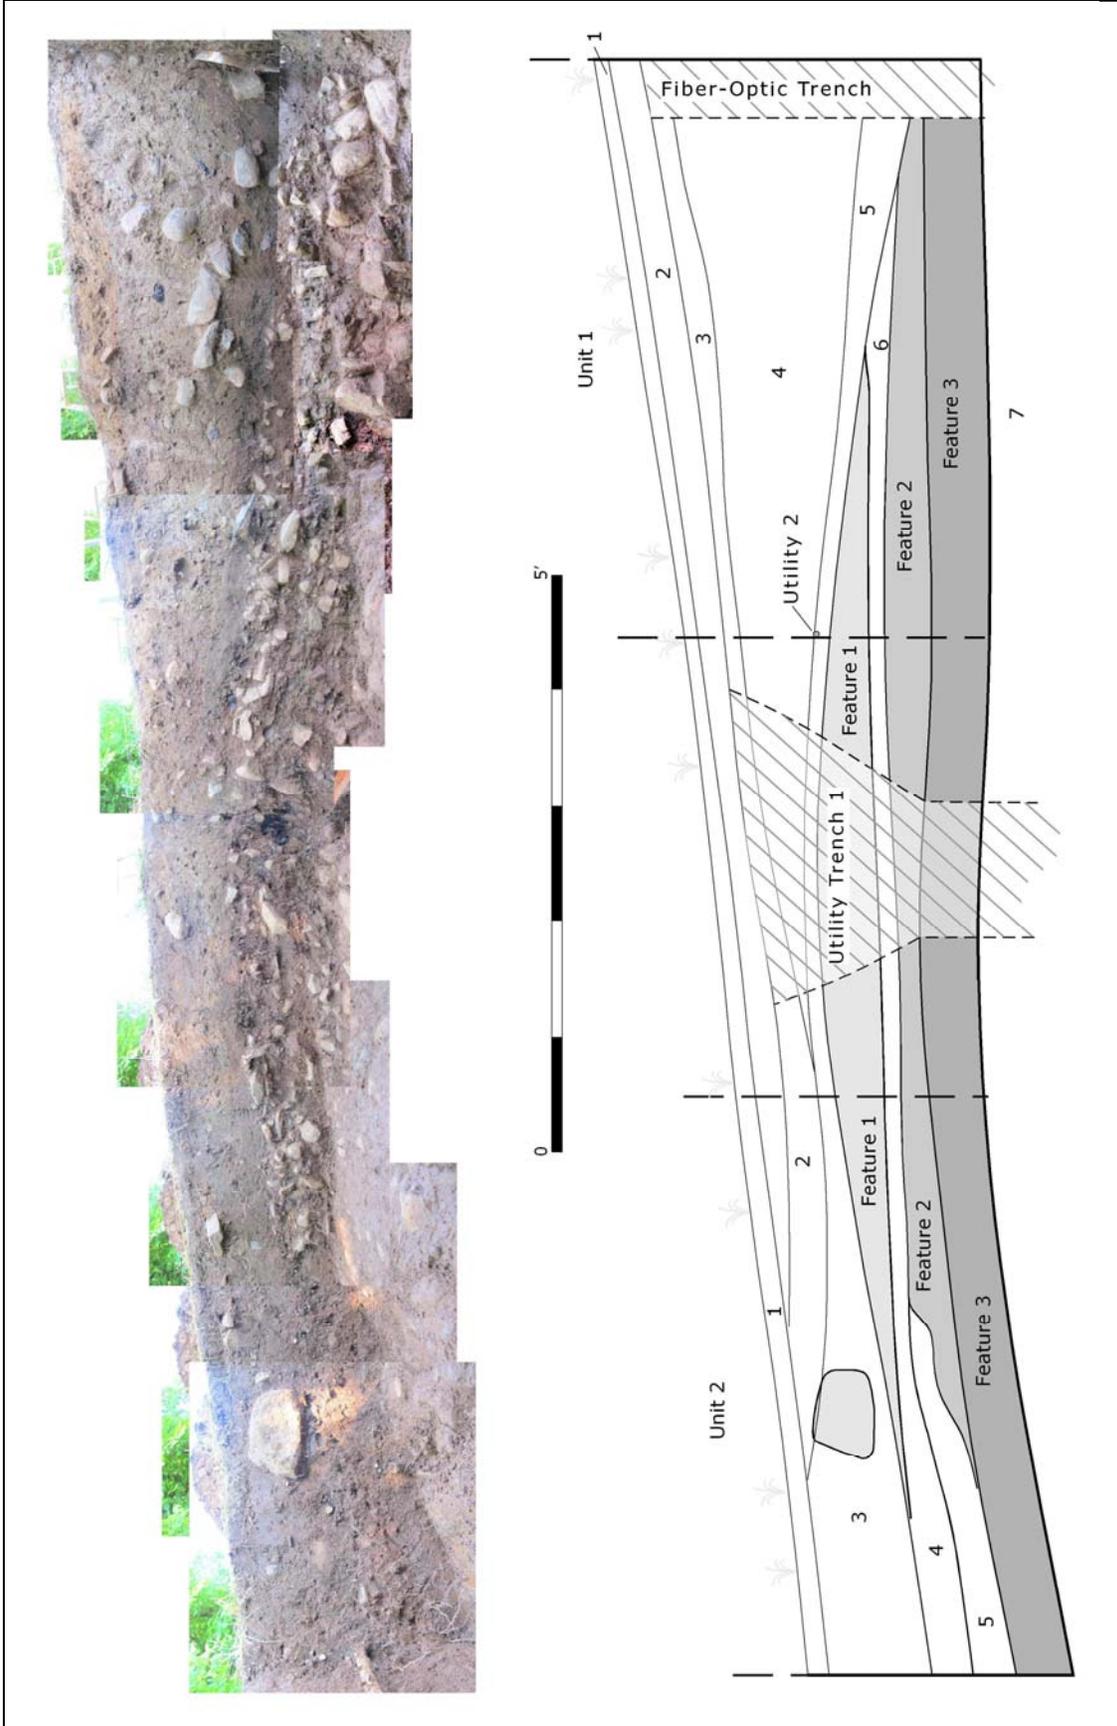
Figure #76: West soil profile, trench A (units 1 and 2), showing road surface 1 (feature 1), road surface 2 (feature 2), and road surface 3 (feature 3).

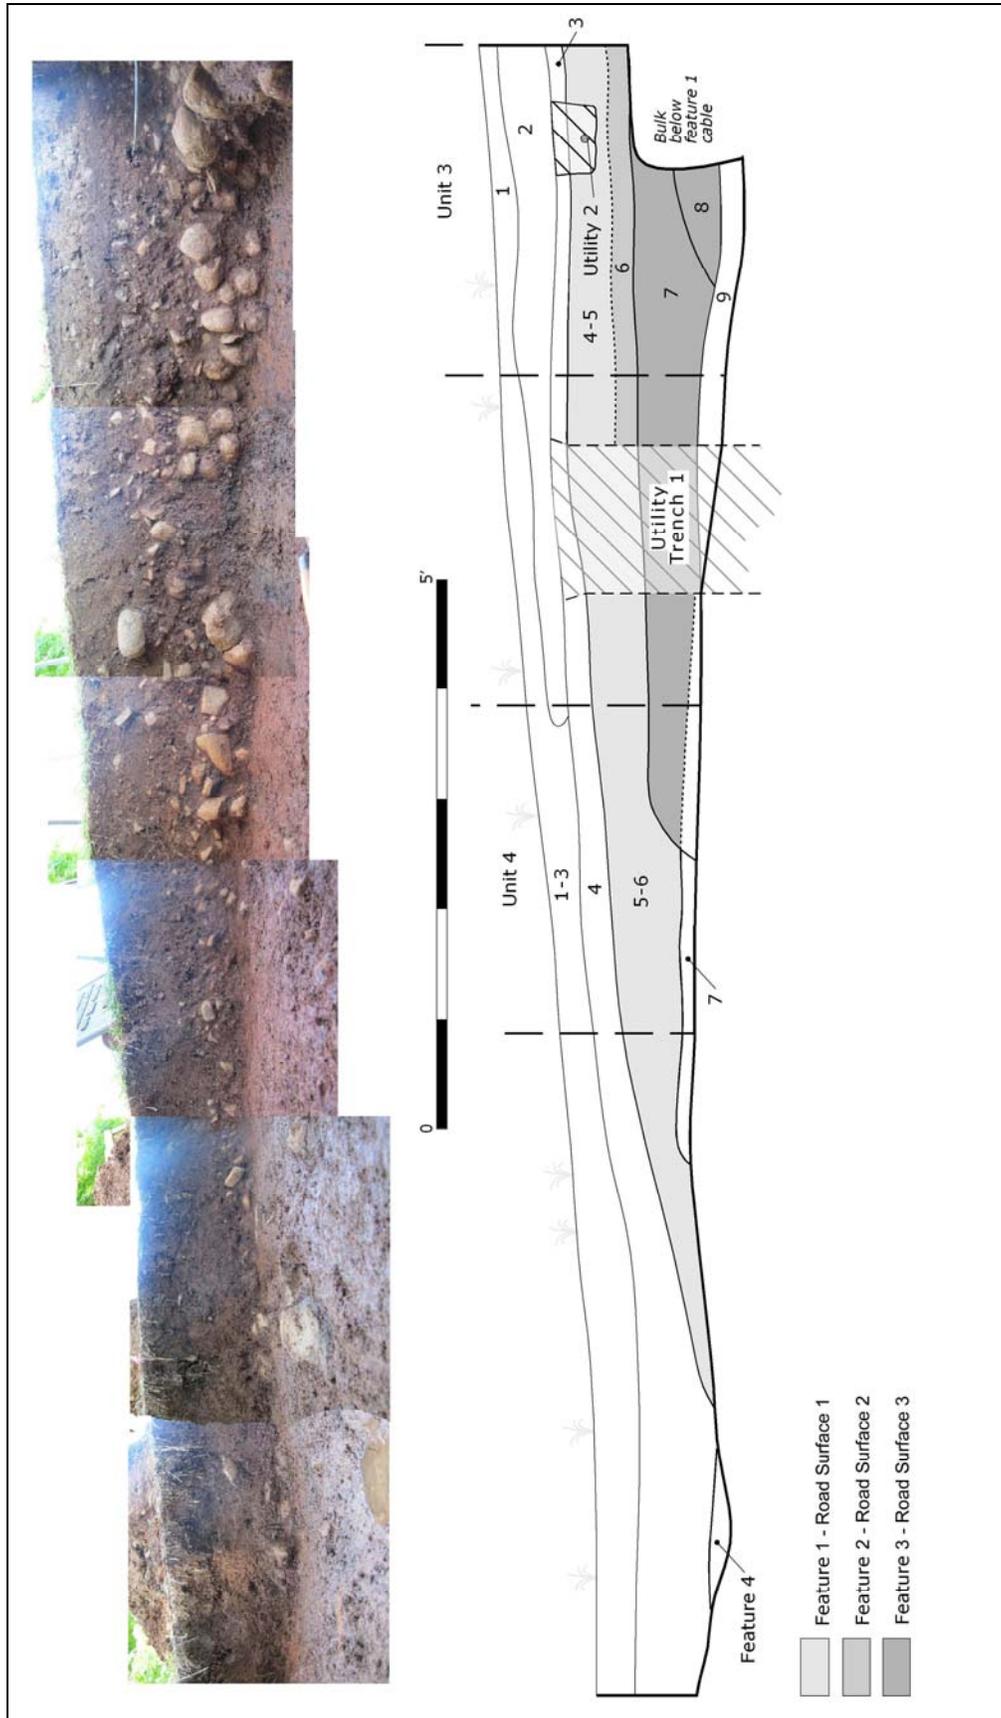
Figure #77: West soil profile, trench B (units 3 and 4), showing road surface 1 (strata 4-5), road surface 2 (stratum 6) , and road surface 3 (strata 7-8), and feature 4 swale.

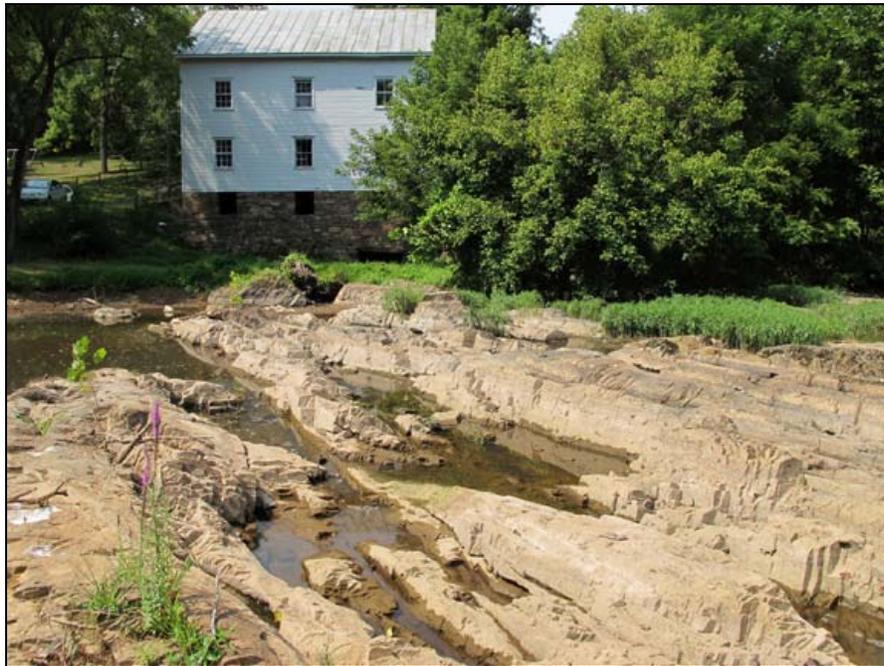
Figure #79: Vertical sheets of diabase bedrock crossing Broad Run at Buckland Mill.

An examination of the historic Buckland quarry and the bedrock underlying the former Buckland Mill dam in Broad Run has identified this outcropping as diabase. The shape of the diabase bedrock in the Buckland vicinity appears to be vertically set sheets of varying thicknesses (Figures #79 and #80).

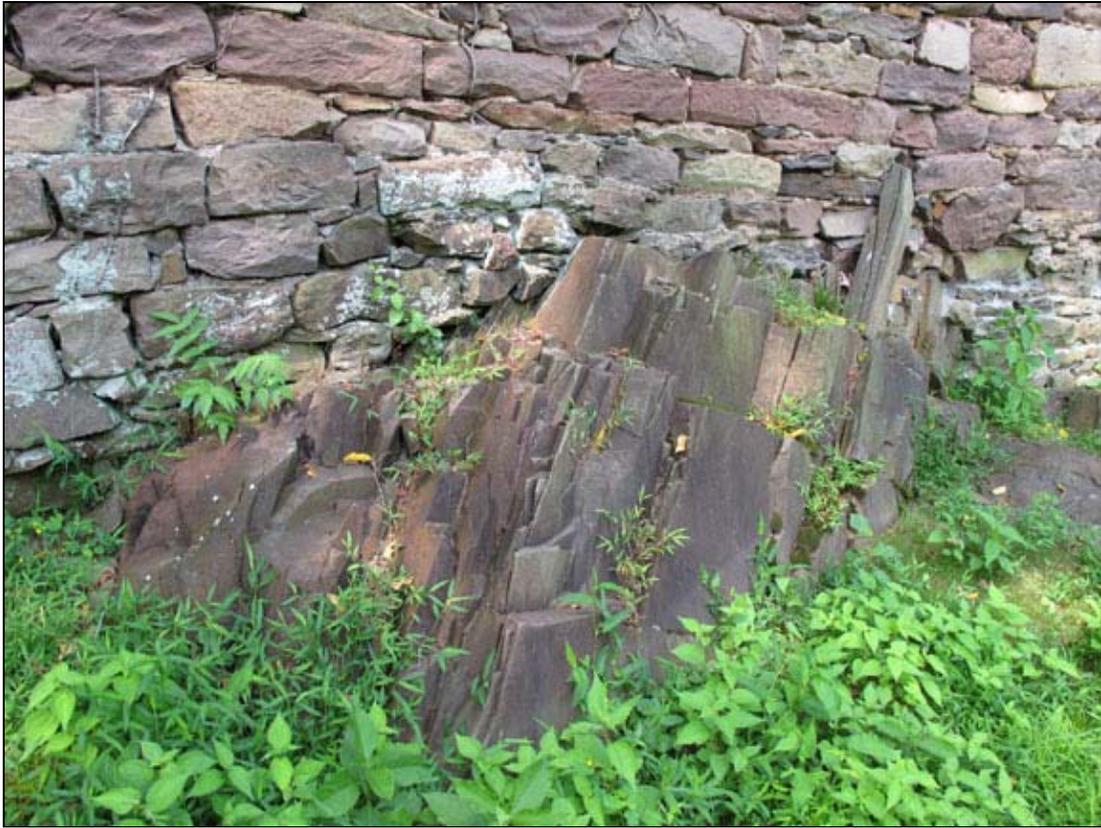
Figure #80: Vertical sheets of diabase bedrock underlying Buckland Mill foundation.

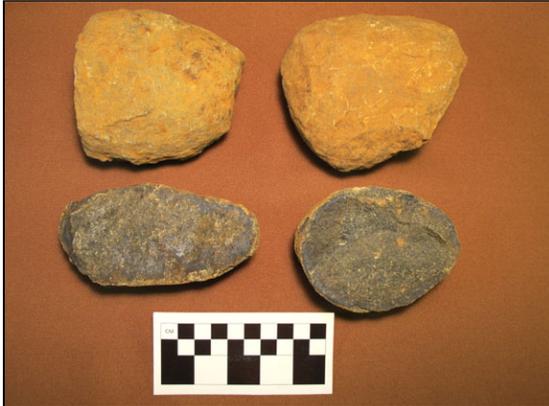
Figure #81: Weathered diabase cobbles showing dark gray interior.

Road surface 3 in trench B (feature 3 in units 3 and 4) was composed of two separate strata distinguished only in the size of their road metal. Stratum 7 was composed exclusively of weather worn diabase cobbles ranging in size between 2 ½ to 6.5 inches in diameter (Figure #81). Stratum 8 was composed exclusively of very large weather worn quartz boulders ranging in size between 9 – 12 inches in diameter. Very little of the metal in *road surface 3* contained angular faces or surfaces (Table #10).

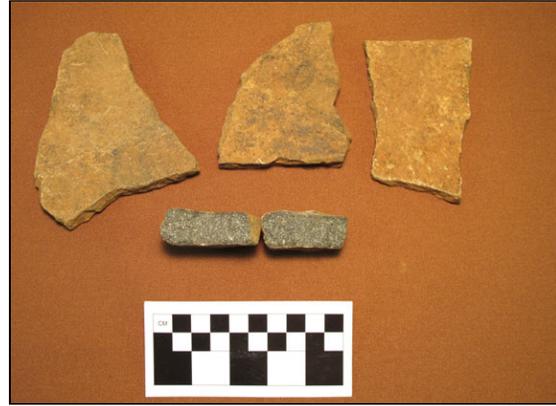
Figure #82: Flat sheets of diabase showing dark gray interior.

Road surface 2 in both trenches A (feature 2 in units 1 and 2) and B (units 3 and 4) was composed exclusively of diabase stone. The diabase was broken into small pieces of stone ranging in size between 0.75 to 3.0 inches in diameter and weighing between 0.8 to 6.1 ounces. Although broken quite small, the diabase metal in *road surface 2* was of similar thickness and possessed mostly flat angular surfaces due to its origin as flat sheets (Figures #82 and #83) (Table #10).

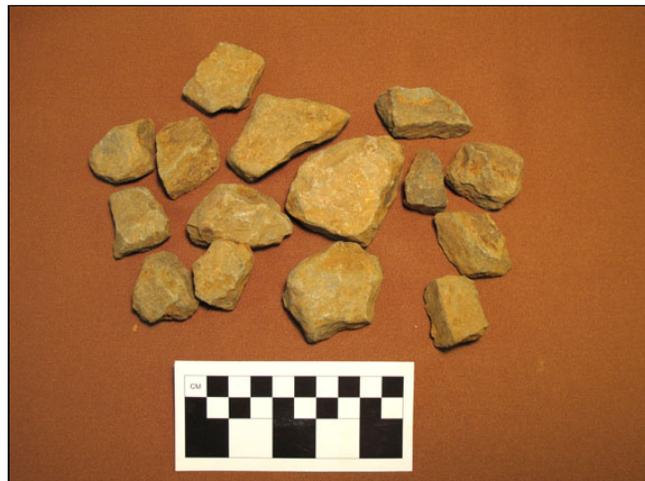
Figure #83: Sheet diabase broken into small sized stone used for road surfacing.

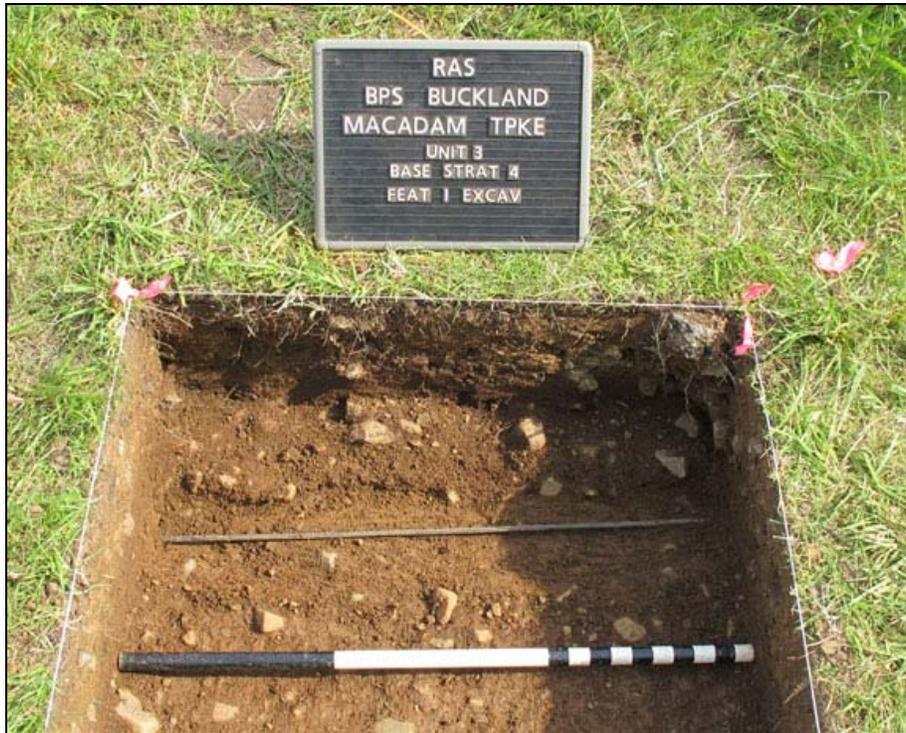
Figure #84: Trench B unit 3 showing narrow diameter cable, utility 2, cutting top of Fauquier and Alexandria Turnpike Road.

Archaeological investigations at 44PW1938 have documented a relatively intact and well-preserved remnant section of the Fauquier and Alexandria Turnpike Road corridor. Only two unmarked and unidentified utilities were documented as disturbing the remnant road corridor during archaeological excavation. A shallowly buried east-west oriented 0.05 foot diameter black cable (utility 2) was identified in the northern ends of both trench A and B. In trench A (units 1 and 2) the cable and its associated trench cut only fill associated with the construction of the 1950s bridge. However in trench B (units 3 and 4) the cable and its associated trench cut into the top portion of *road surface 3* approximately 0.2 to 0.25 feet (Figure #84). A second unidentified buried utility line was found to impact the Fauquier and Alexandria Turnpike Road corridor in both trench

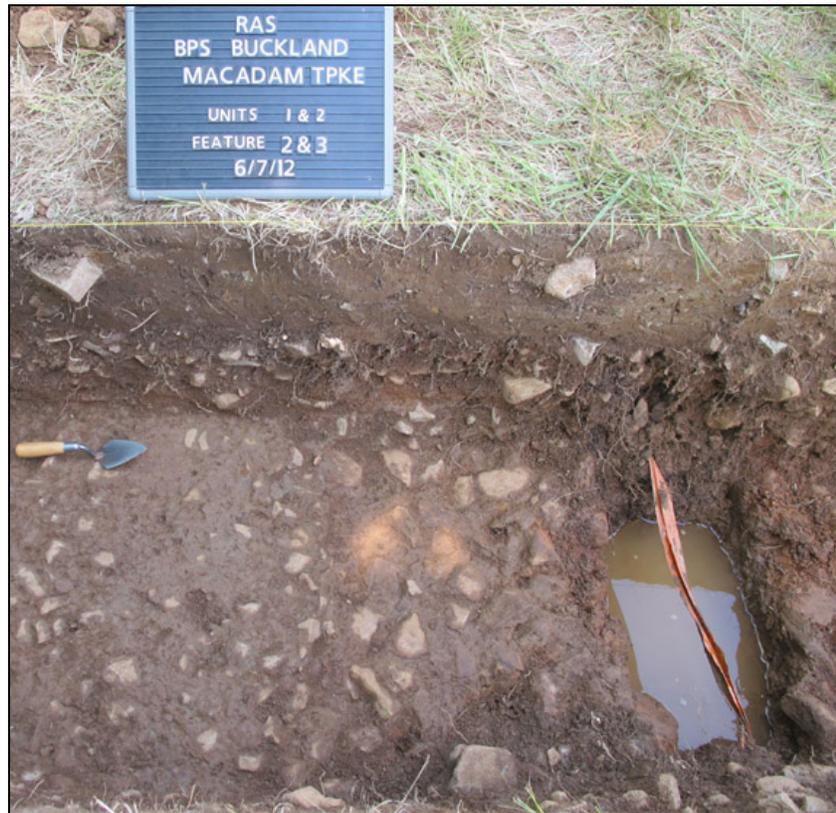
Figure #85: Trench A units 1 and 2, looking west, showing impact of water-filled trench, utility 1 (at right).

locations. An approximately 1.5 foot wide east-west oriented utility trench, utility 1, was documented cutting and extending below the historic road to an unidentified depth (Figure #85). Both utilities are believed to date to the late twentieth century.
