Archaeological Investigations

Fauquier and Alexandria Turnpike

44PW1938
Buckland, Virginia

VDHR File No.: 2009-0432
Buckland Historic Transportation Enhancement Project
Project No.: EN06-076-123, P101 UPC 81772

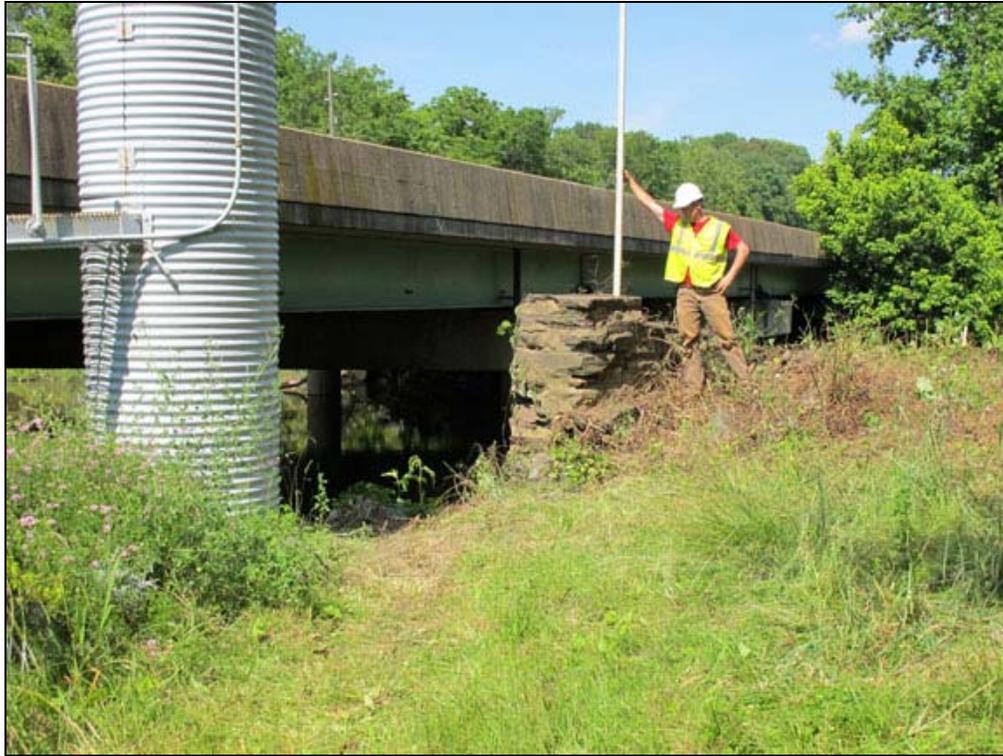
Figure #86: Cylindrical river gauging station located between the northbound Route 29 corridor (at left) and the western stone bridge abutment (DHR 976-0252) over Broad Run (at right).

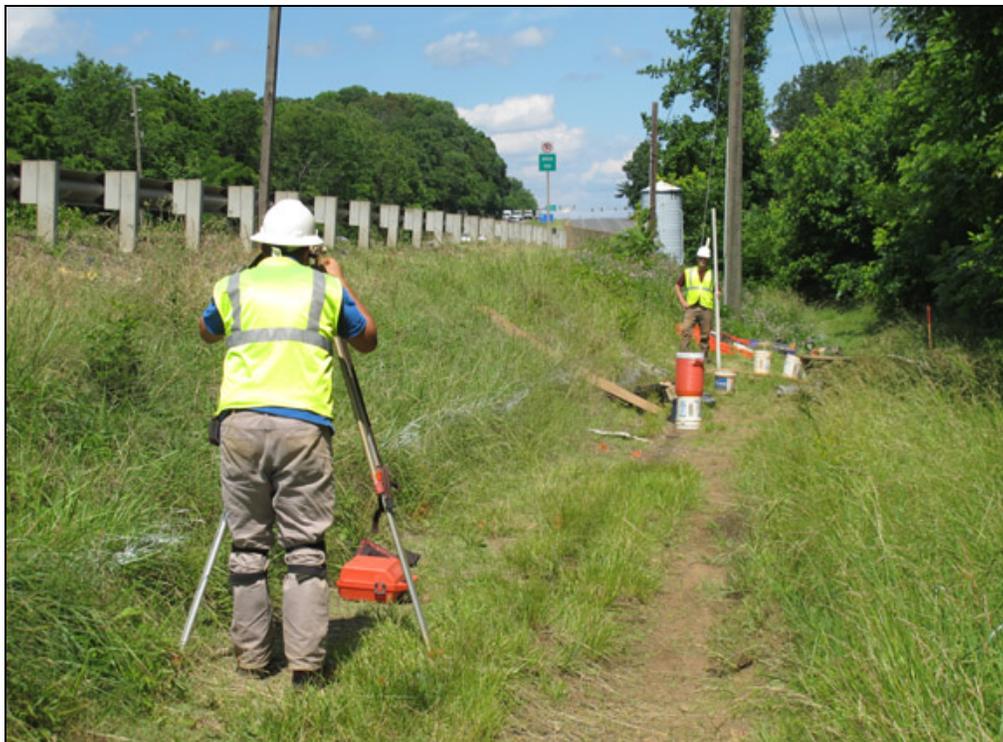
Figure #87: Taking elevations within the historic Fauquier and Alexandria Turnpike road corridor. Note the telephone pole in background and the existing northbound Route 29 lanes at upper left.

Although the extent of their impact has not yet been determined, three other structures that intersect or lie adjacent to the historic Fauquier and Alexandria Turnpike Road corridor have the potential to impact this resource. A single wooden electrical pole stands within the historic Fauquier and Alexandria Turnpike Road corridor approximately 90 feet west of the western stone abutment (DHR 076-5121). In addition, sometime after 1927, the Virginia Department of Conservation and Development, Division of Water Resources installed a river gauging station at the downstream intersection of Broad Run and Rte. 29 / Lee Highway. The cylindrical housing of the gauging station is located adjacent to and south of the northbound lane of Rte. 29 / Lee Highway. Lastly, the existing northbound lanes of Route 29 intersect the central and western portions of the linear remnant Fauquier and Alexandria Turnpike Road corridor at some unknown point. It is not yet known how or if the current Rte. 29 / Lee Highway corridor has impacted the historic road resource (Figures #86 and #87).

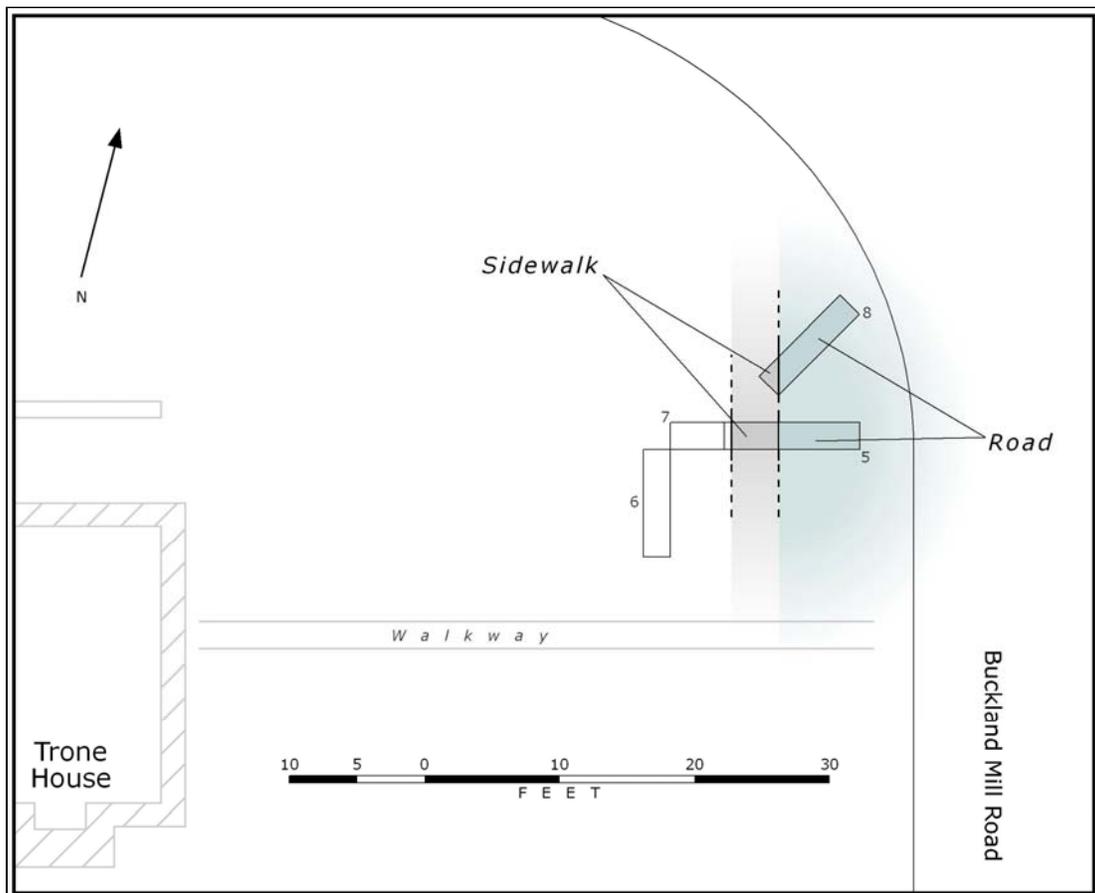
Figure #88: Plan showing location of Mill Street (green shading) and associated sidewalk feature (gray shading) as identified in units 5 and 8.

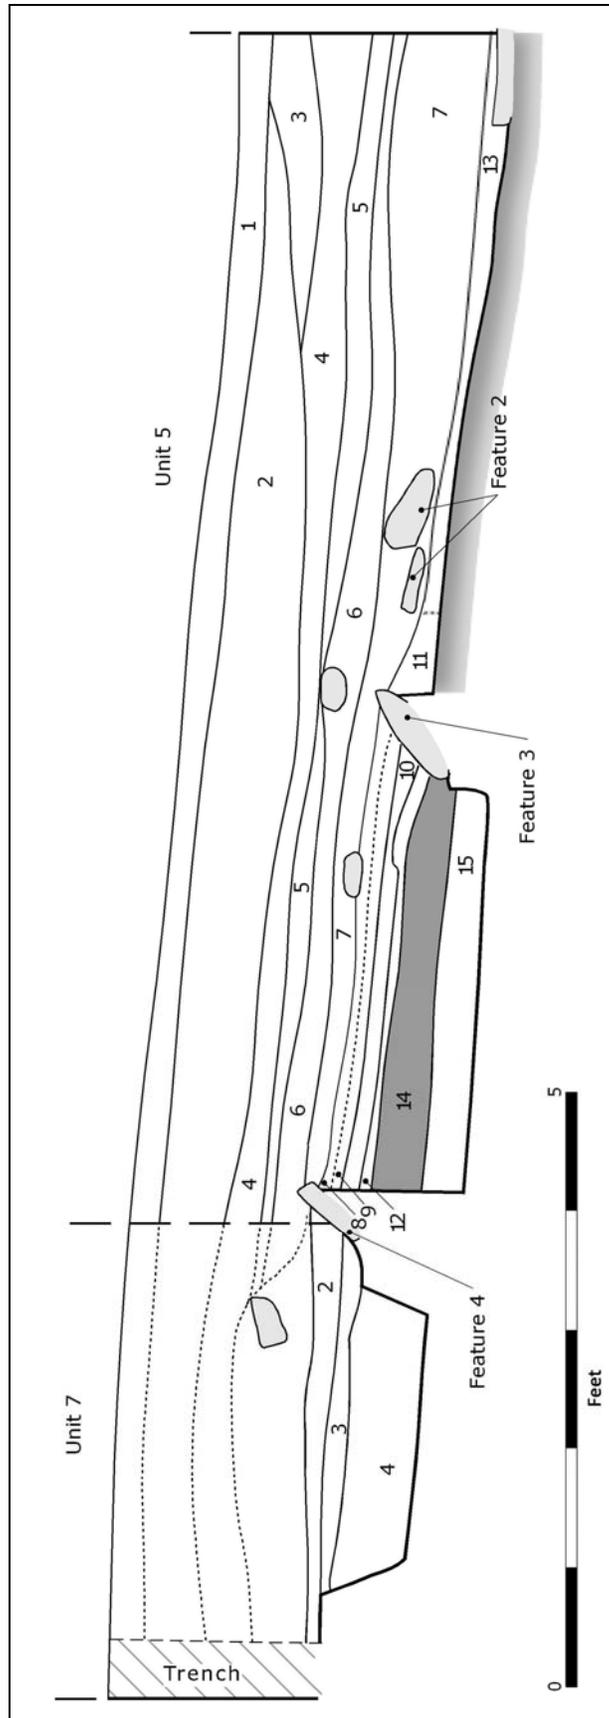
Figure #89 North soil profile, units 5 and 7, showing features 3 and 4 stone curb alignments, stratum 14 - feature 5 sidewalk stone surfacing, and feature 6 Mill street stone surfacing underlying stratum 13.

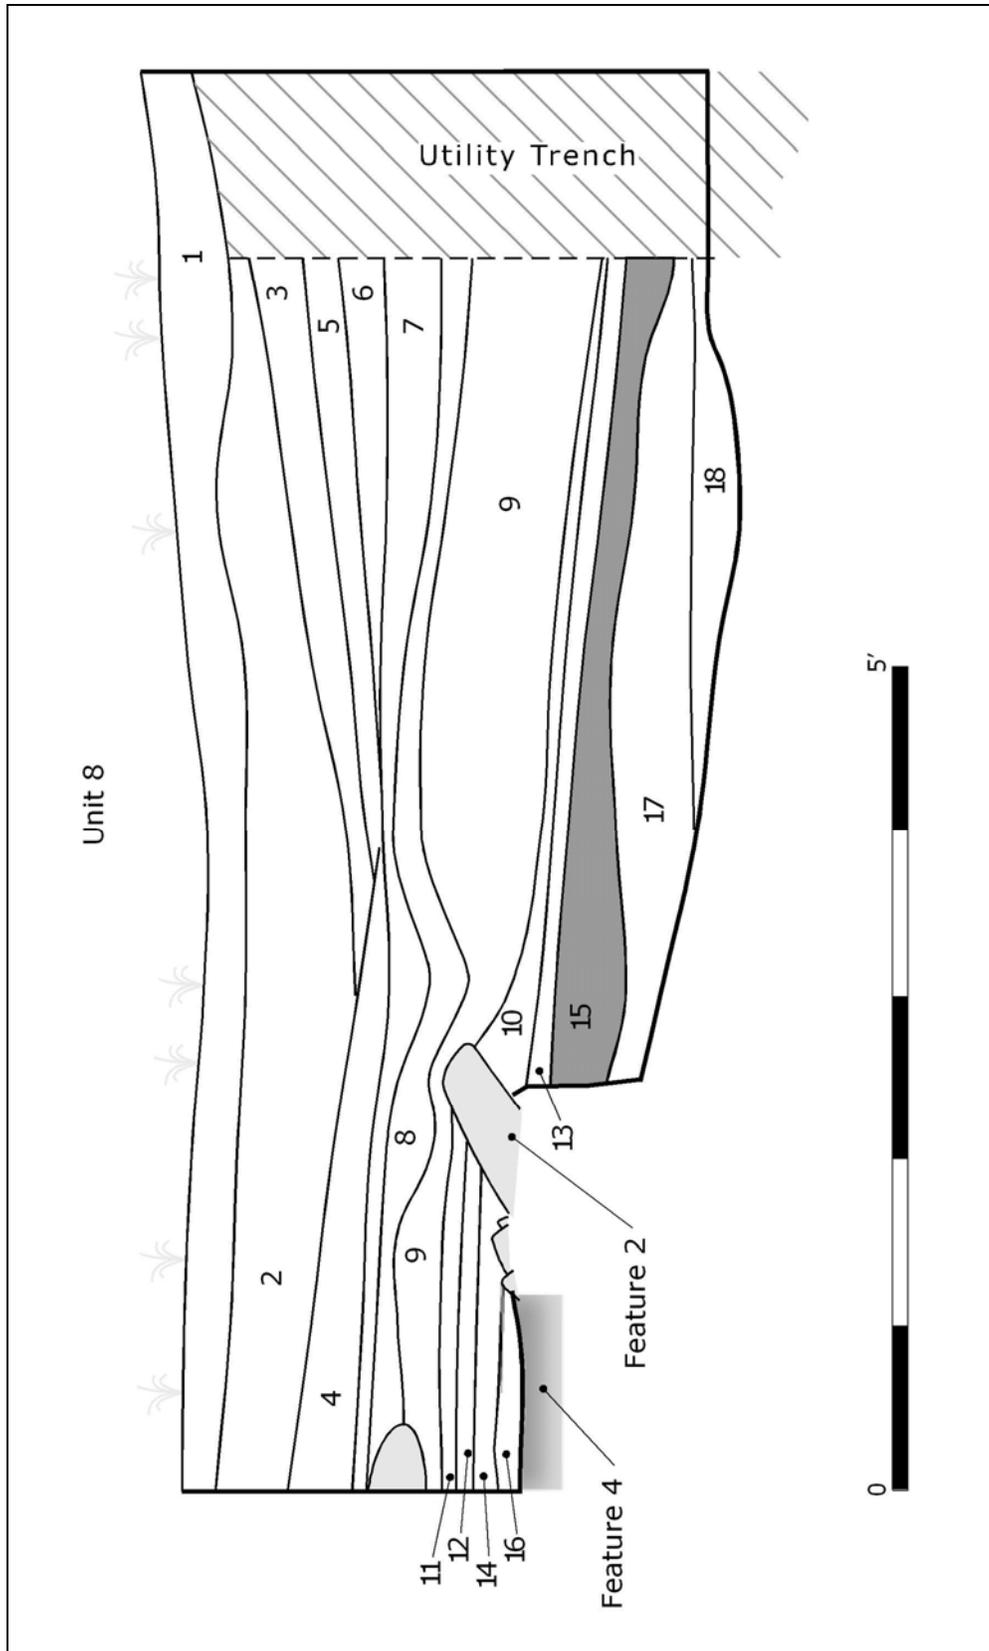
Figure #90: Northwest soil profile, Unit 8, showing feature 4 sidewalls stone surfacing, feature 2 stone curb alignment, and stratum 15 – feature 3 stone surfacing in Mill Street.

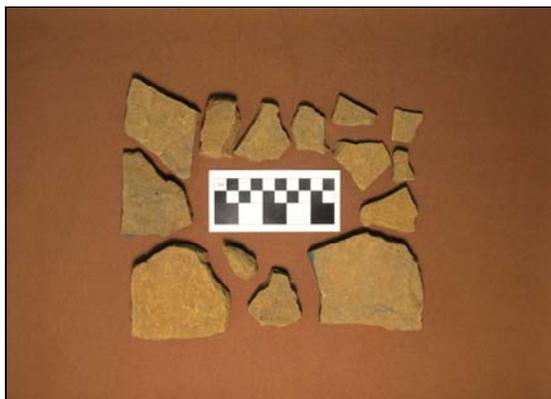
Figure #91: Broken sheet diabase from unit 8, stratum 15 / feature 3 historic Mill Street stone surfacing.

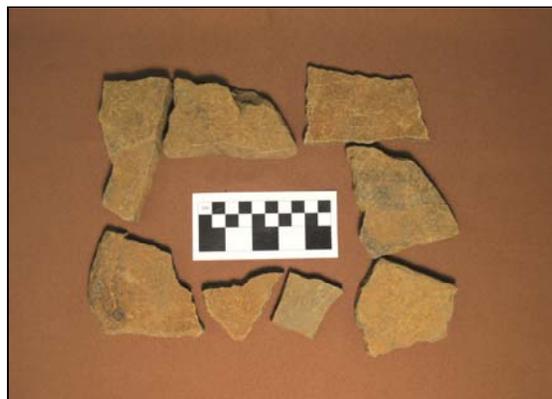
Figure #92: Broken sheet diabase from unit 5, stratum 14 / feature 6 historic sidewalk stone surfacing.

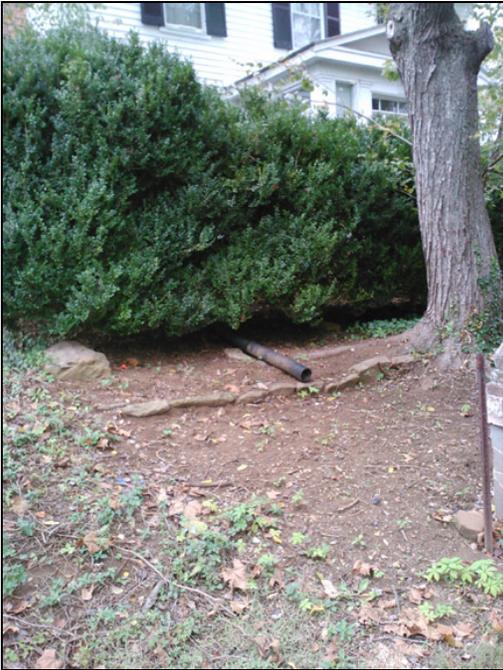
Figure #93: Vertically set stone parallel to Buckland Mill Road, in foreground, with Moss House (076-0120) in background.

A recent non-scientific reconnaissance level survey of front yards of several properties north of Route 29 / Lee Highway along Buckland Mill Road has identified an unusual line of vertically set stone possibly related to the historic road and sidewalk features identified at the Trone House property. In particular in front of the Moss House / Brooks Tavern (076-0120) in Lot 2, at least eight consecutive vertically set tabular stones, possibly the remains of an historic curb and/or sidewalk feature, were identified above current grade and parallel with Buckland Mill Road (Figures #93 and #94).

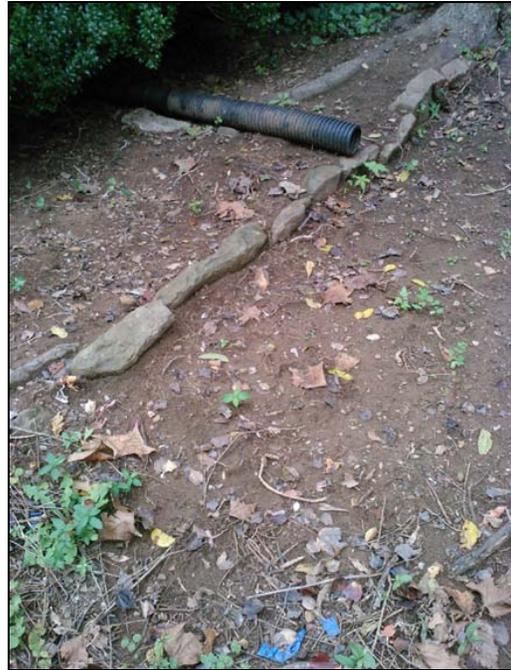
Figure #94: Stone alignment, at Moss House (076-0120), showing individual stones set vertically in ground.

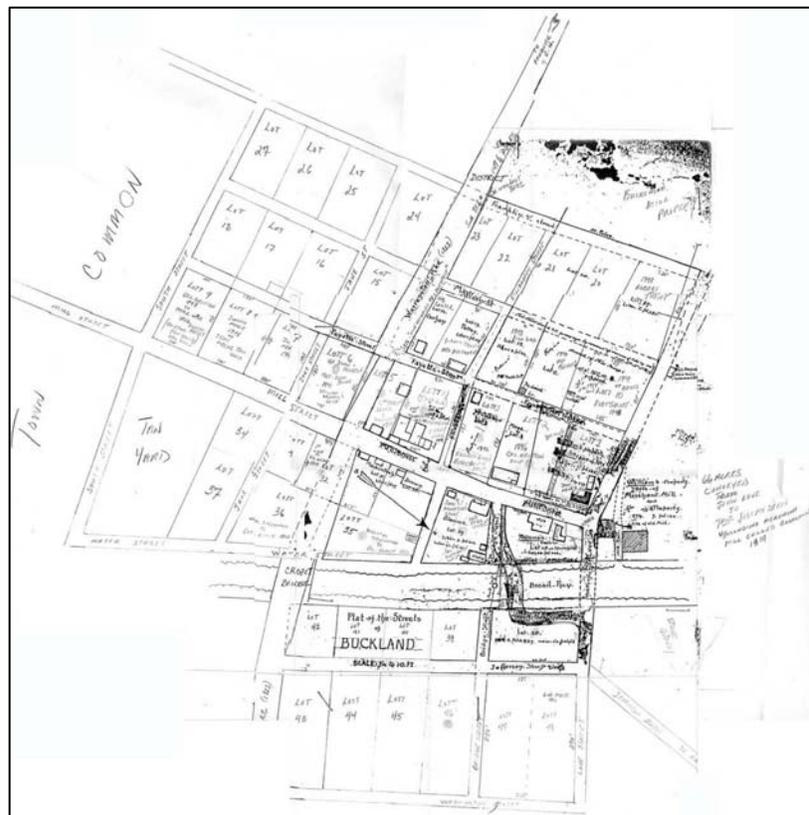
Figure 96: David Blake's late 20th-century extension and annotation of the Plat of the Streets of Buckland. The additional lot numbers and street names are based upon extensive deed research.

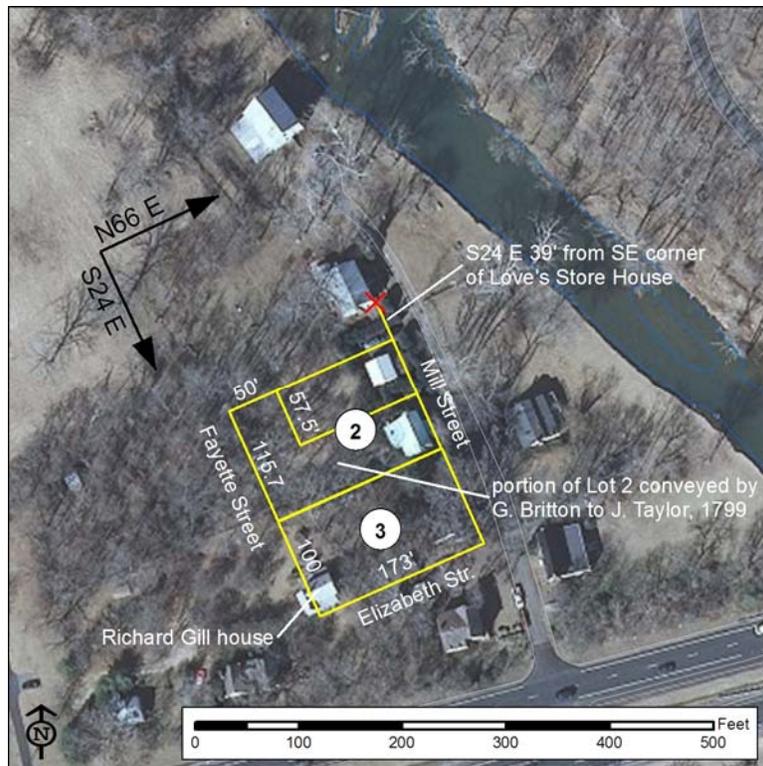
Figure 100: GIS map showing corrected 1796 – 1799 metes and bounds for Lots 2 and 3 overlaid on recent aerial photography. .

Lot 3: Lot 3 also was built on prior to the establishment of Buckland, and a 1796 deed recording the sale of the lot by John Love to Richard Gill describes the property as being located immediately south of Lot 2, and thus also fronting on Mill Street. Orientations for the sides of Lot 3 are identical to (and presented in the same order as) those for Lot 2. While Lot 3 also measures 173 ft in depth (east-west), this lot measures only 100 ft wide (north-south). With the northeastern corner of Lot 3 congruent with the southeastern corner of Lot 2 and correcting the bearings as in Lot 2 to result in a rectangular lot, platting of Lot 3 reveals that the late eighteenth-century portion of the Richard Gill house occupies the extreme southwestern corner of the lot (Figure 100).²⁵³

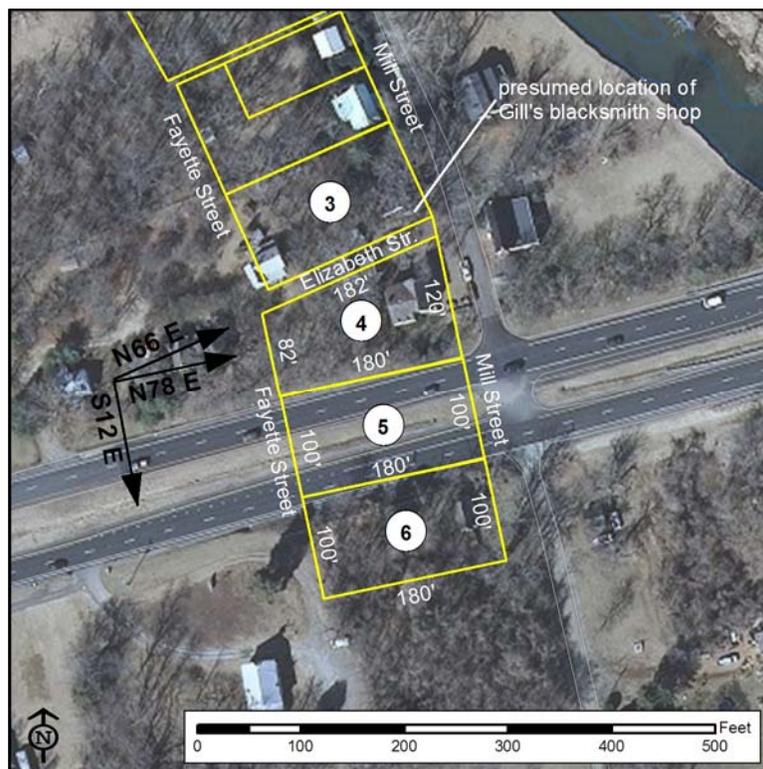
Figure 102: GIS map showing the boundaries of Lots 4, 5, and 6 as platted from historic metes and bounds descriptions and overlaid on recent aerial photography. Note the rotation of this group of lots 12° east of the lots north of Elizabeth Street.

Lot 5: Prior to the establishment of Buckland, Robert Thrift had constructed a store and multiple dwelling houses on Lot 5. The 1797 deed recording John Love's conveyance of property to Thrift describe the 180 ft by 100 ft Lot 5 as bounded by Mill Street and Fayette Street to the east and west, respectively. The northeastern corner of Lot 5 is given as 140 ft southeast of the southeastern corner of Gill's blacksmith shop in Lot 3 along a line running S24° East thus, as mentioned, implying a 120-ft eastern width for Lot 4. Orientations provided in the 1797 deed for the eastern (S24°E), southern (S78°W), western (N12°W), and northern (N78°E) sides indicate that the lot was rectangular and likewise that its bounding streets formed right angles with one another (Figure 102).²⁵⁶

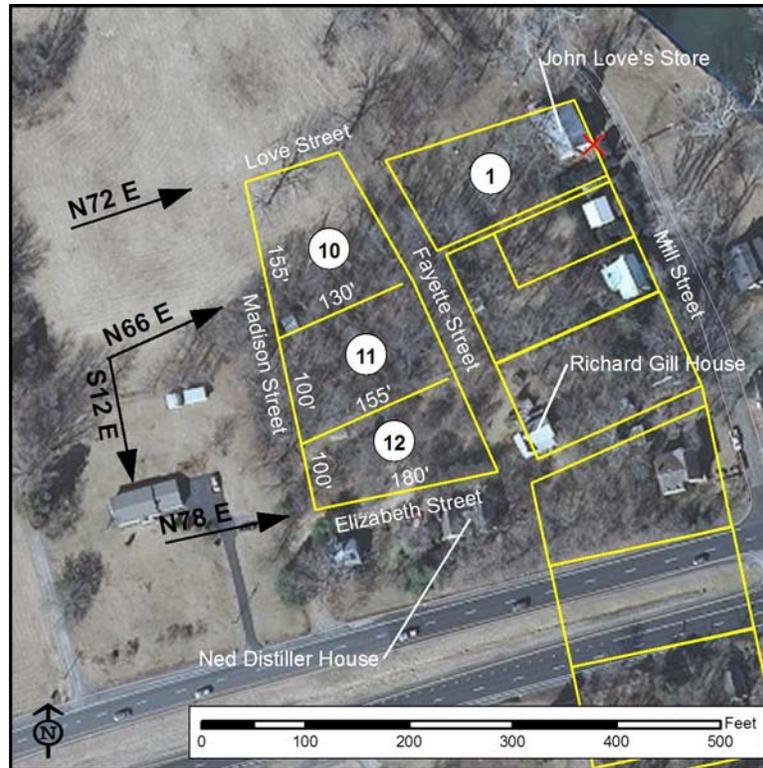
Figure 104: GIS map showing the boundaries of Lots 10, 11, and 12 as reconstructed from historic metes and bounds descriptions and overlaid on recent aerial photography.

Further complicating the accurate platting of Lots 10, 11, and 12 is the fact that nowhere in the deed record are the intended widths of the streets provided with the exception of Elizabeth Street which appears to have been 20 ft. Following the example of Elizabeth Street, the other east-west cross streets within Buckland are assigned widths of 20 ft. The north-south oriented Fayette and Madison Streets are assigned widths of 30 ft. As here reconstructed and illustrated in Figure 100, the shared boundary between Lots 10 and 11 is roughly 11 ft longer than described in the deed, while the shared boundary between Lots 11 and 12 is 7-12 ft longer than the values provided.

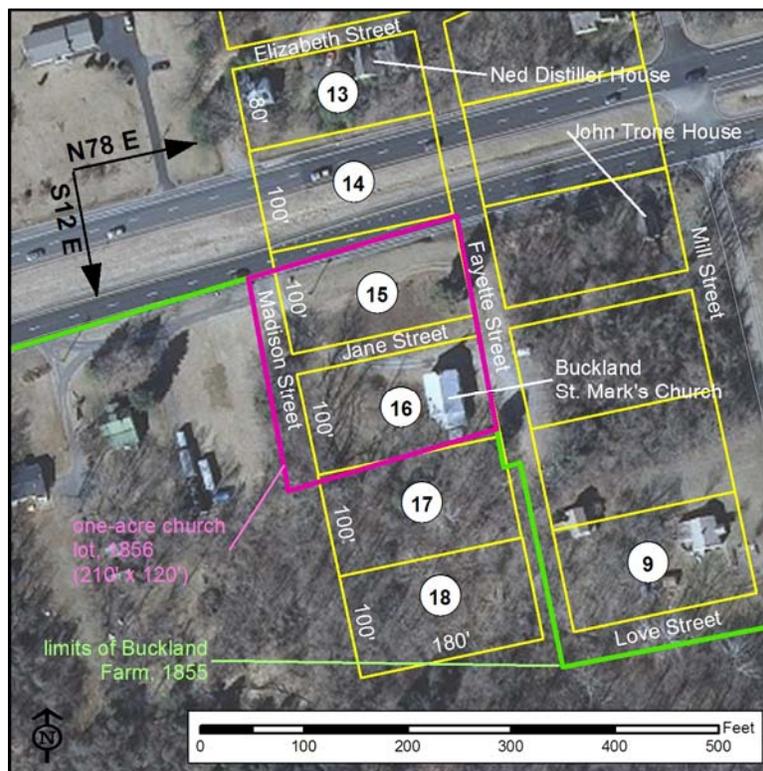
Figure 105: GIS map showing the boundaries of Lots 13 – 18 as reconstructed from historic metes and bounds descriptions and overlaid on recent aerial photography.

of Lot 13 share the same orientations as the rectangular lots east of Fayette Street and south of Elizabeth Street (Figure 105).²⁶¹

the one-acre tract sold by Buckland Farm's owner Hugh Hite in 1856 and that now houses the Buckland St. Mark's Methodist Church (Figure 105).²⁶³

Lots 16, 17, and 18: These three lots were all purchased by John Love and apparently were never resold, and thus effectively remained part of Love's Buckland Farm through at least the middle of the nineteenth century. Metes and bounds descriptions for these three lots have not been discovered. The reconstruction presented here in Figure 105 assumes that in shape, size, and orientation these three lots are identical to those east of Mill Street. According to this reconstruction, Lot 16 made up roughly half of the one-acre tract sold by Hugh Hite in 1856 to the trustees of Buckland's St. Mark's Church.²⁶⁴

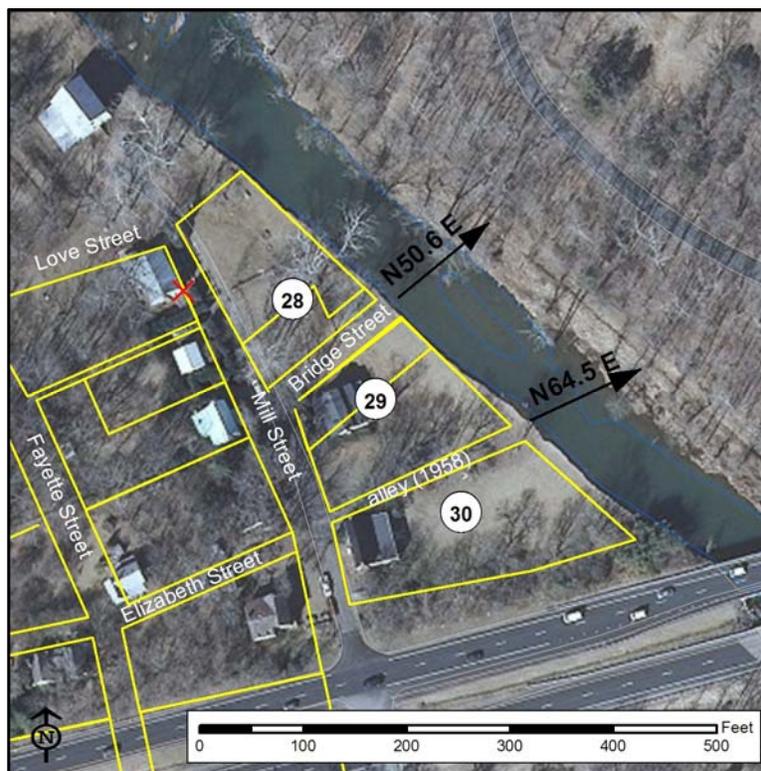
Figure 108: GIS map showing the proposed boundaries of Lots 28 – 30 as platted from late 19th- mid-20th-century metes and bounds and overlaid on recent aerial photography.

but does reference Taylor’s stable on the property. In 1801, county tax records indicate that Taylor operated a still on the property. Taylor appears to have sold this northern portion of Lot 29 between 1806 and 1810. By November 1811, ownership of the property had passed to Samuel Hudson who conveyed the partial lot, further described as the site of John Hampton’s store, to William Brooks. Ridout et al. date the extant building on Lot 29, Deerlick Cottage, to this period. Several months later in February 1812, Brooks acquired the remainder of Lot 29, described in the deed as “where the old still house stood,” from John Love.²⁶⁸ Unfortunately, the deed conveying this southern portion of Lot 29 to Brooks in 1812 contains no metes and bounds description of the property. No further deeds in the chain of title of Lot 29 are known until an 1870 deed in which the property, described as containing “one half acre more or less” and bounded by “Main Street” on the west and by an unnamed street running along Broad Run on the east and by unnamed streets on the north and south, was conveyed by Miranda Chappell to Orlando J. Glasscock. Two decades later in 1891, Lassie Glasscock paid delinquent taxes owned on the property and the deed recording this payment and transfer of ownership contains a full metes and bounds description of the half-acre property. These late nineteenth-century boundaries of Lot 29 are mapped (with the appropriate 3.77o westward (counterclockwise) rotation to account for historic variation in magnetic declination) in Figure 108.²⁶⁹

Close consideration of the late nineteenth to early twentieth-century boundaries of Lots 28 and 29 as mapped in Figure 108 above suggests that by this date the orientation of Bridge Street may well have changed since the late eighteenth-century establishment of Buckland. The late-nineteenth to turn-of-the-twentieth-century map of Buckland (Figure 95, above) suggests as much, showing both a northward-trending street that crosses Broad Run at a ford as well as the apparently earlier limits of Bridge Street oriented more nearly perpendicular to the north façade of Deerlick Cottage. In point of fact, assuming that the late nineteenth-century boundaries of Lot 29 as mapped in Figure 108 correspond closely to the lot's limits in the original late 18th-century plan runs up against the problem that the 38-ft-wide portion of the lot along the south side of Bridge Street that was parceled out in 1799 seems barely sufficient to contain Deerlick Cottage. An alternate reconstruction, and the one preferred here, reorients Bridge Street such that it runs (N66°E) parallel to the north façade of Deerlick Cottage and intersects Mill Street at a right angle (Figure 106). In Figure 110, Bridge Street is depicted with a width of 30 feet, Mill Street has been widened to 60 feet, and the “alley” referenced in the 1958 deed running between Lots 29 and 30 has been reconfigured slightly so that it more clearly represents a continuation of 20-ft-wide Elizabeth Street.

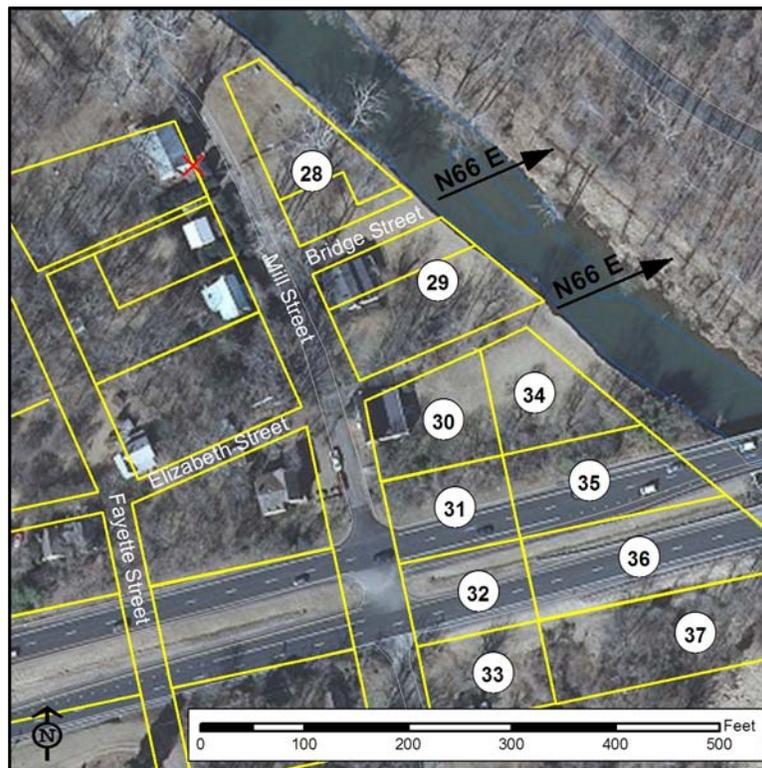
Figure 110: GIS map showing a preferred reconstruction of the original boundaries of Lots 28 – 37 overlaid on recent aerial photography. Note reorientation of Bridge Street and the continuation of Elizabeth Street between Lots 29 and 30/34.

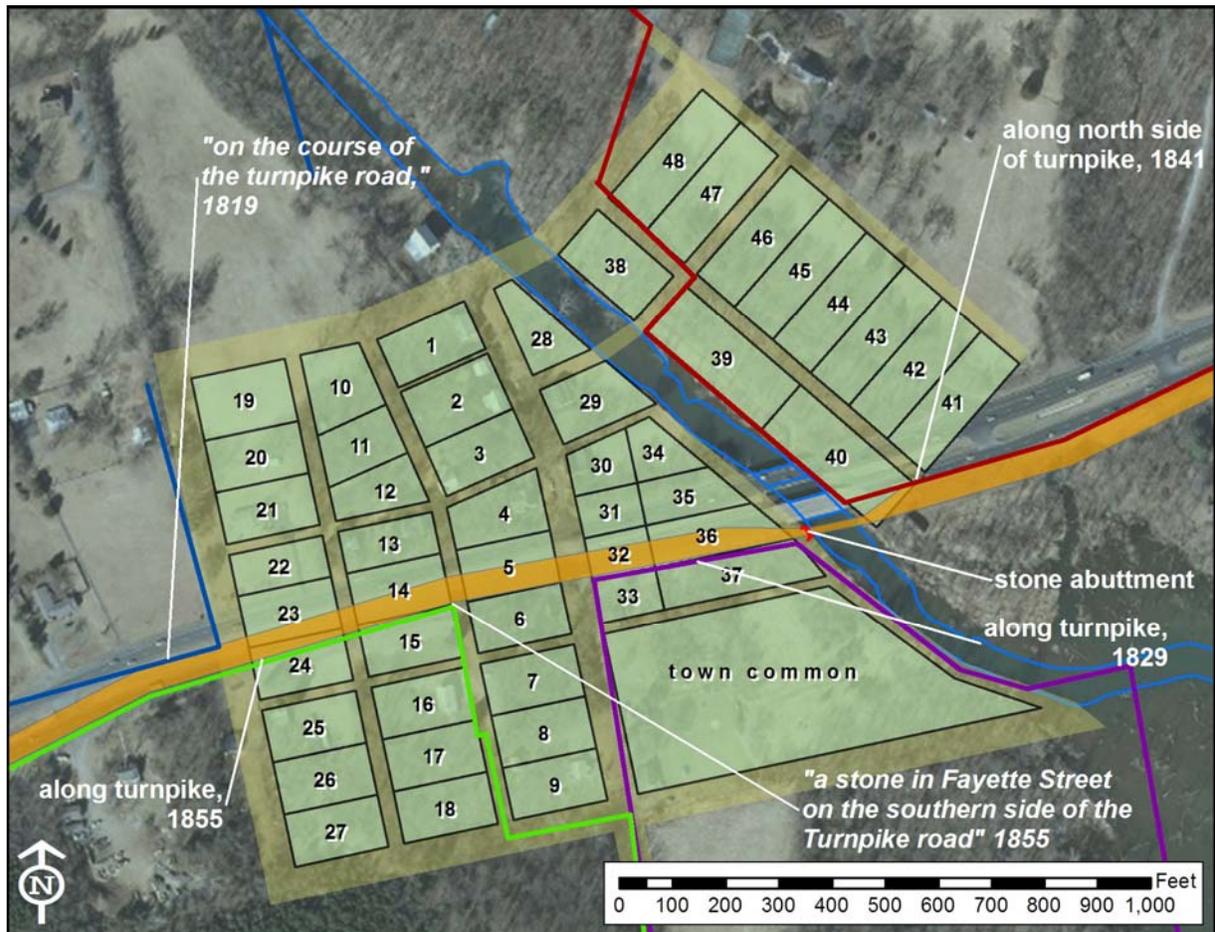
Figure 113: GIS map showing the reconstructed Buckland town plan and the route of the Fauquier and Alexandria Turnpike as determined from historic metes and bounds surveys and the extant western bridge abutment at Broad Run overlaid on recent aerial photography.
