THE ENTREPRENEURIAL LANDSCAPE
OF A TURNPIKE TOWN:
AN ARCHITECTURAL SURVEY OF
BUCKLAND, VIRGINIA

ORLANDO RIDOUT V, ALFREDO MAUL, AND WILLIE GRAHAM
BUCKLAND, VIRGINIA
2005

A Project of the Buckland Preservation Society

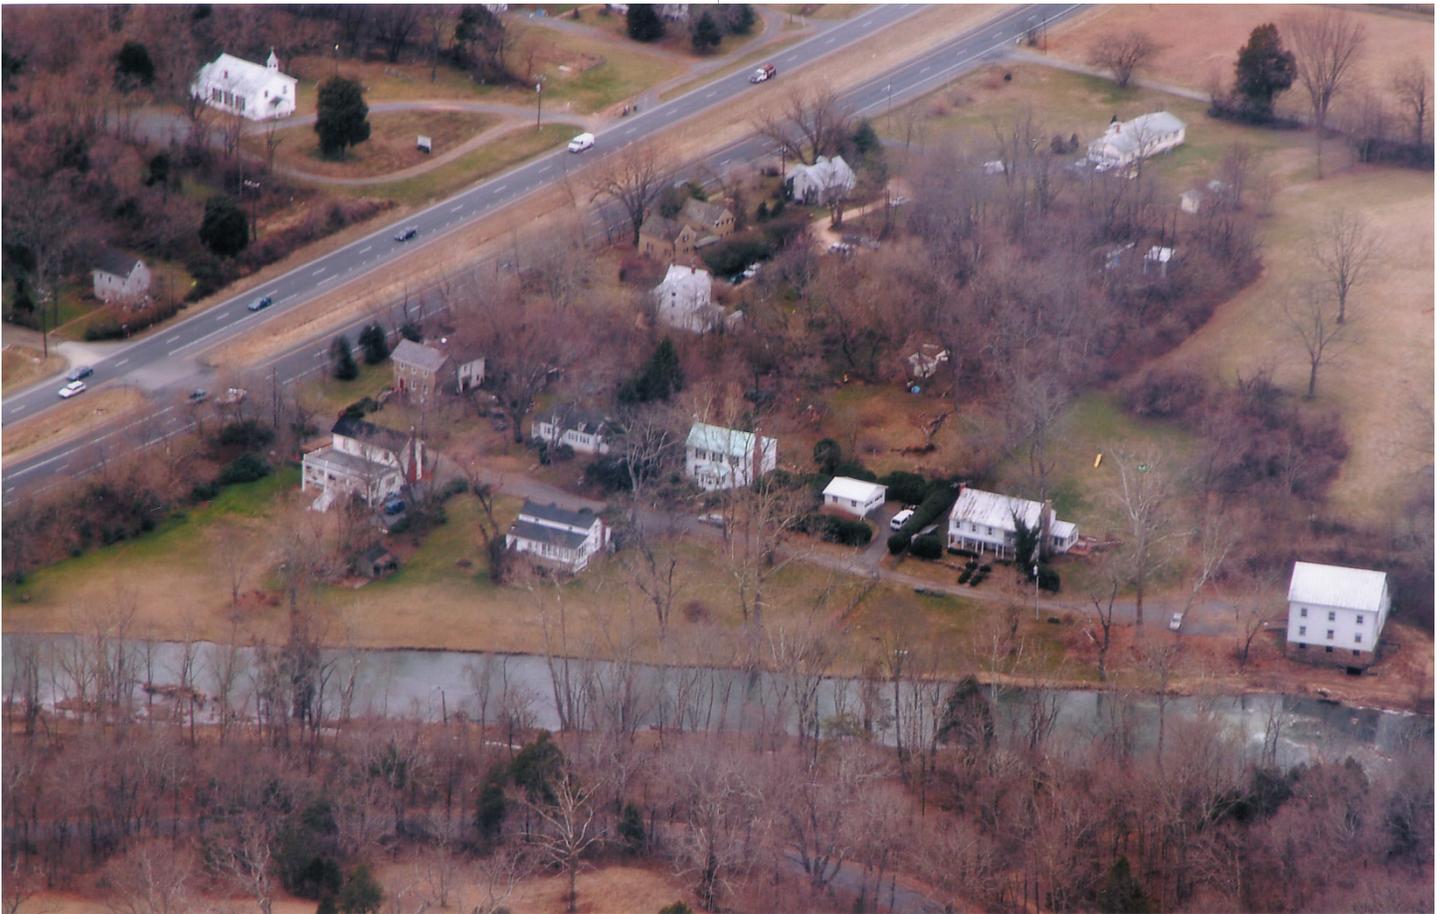
FIGURE 10. *Aerial photograph of the town of Buckland, facing west from above Cerro Gordo. The mill is at the lower right in this image, serving as the northern terminus of Buckland Mill Road. The church is at upper left, on the south side of Lee Highway. Buckland Preservation Society, 2004.*

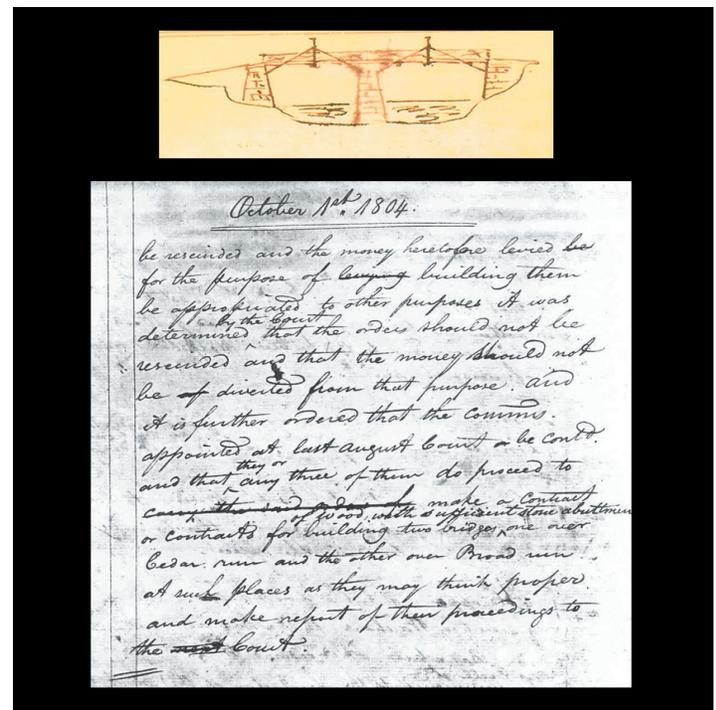
FIGURE 11. Elevation drawing for the timber bridge built at Cedar Run ca. 1805-1808. This neatly executed drawing included in the turnpike field notes provides good evidence for the original bridge at Broad Run, as the two bridges were authorized by the same orders in 1804 and 1805. Library of Virginia Archives.

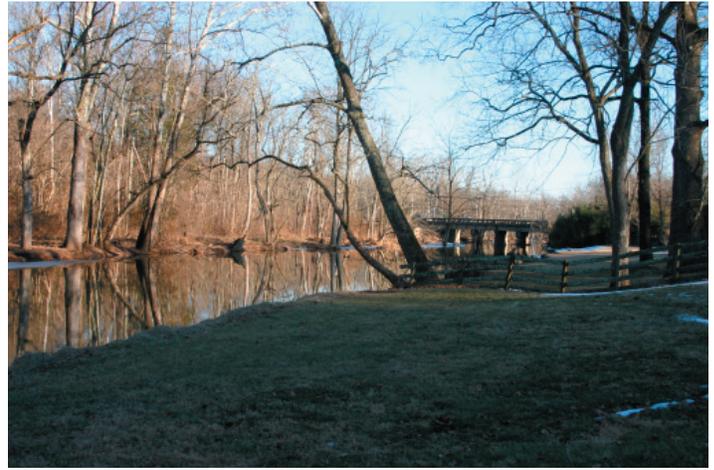
FIGURE 13. *The 1953 bridge at Buckland. This bridge was constructed to carry the new, southbound lanes of Route 29 when the highway was expanded from two lanes to four in 1953. Alfredo Maul for Buckland Preservation Society, 2005.*

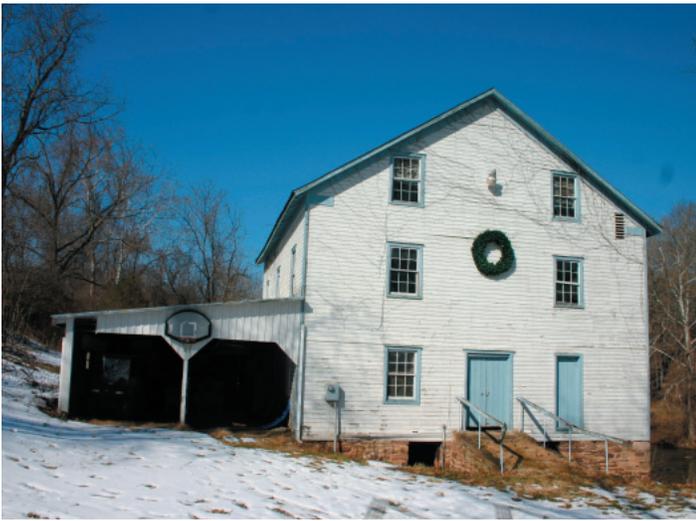
FIGURE 1-1. *South Elevation. Broad Run is visible to the right of the building, and the mill race followed the tree line behind the lean-to shed, bringing water from a dam that was located about one-quarter mile upstream. When the light strikes the building at a raking angle, it is possible to make out promotional advertising stenciled onto the siding between the second-story windows, now covered by white paint.*

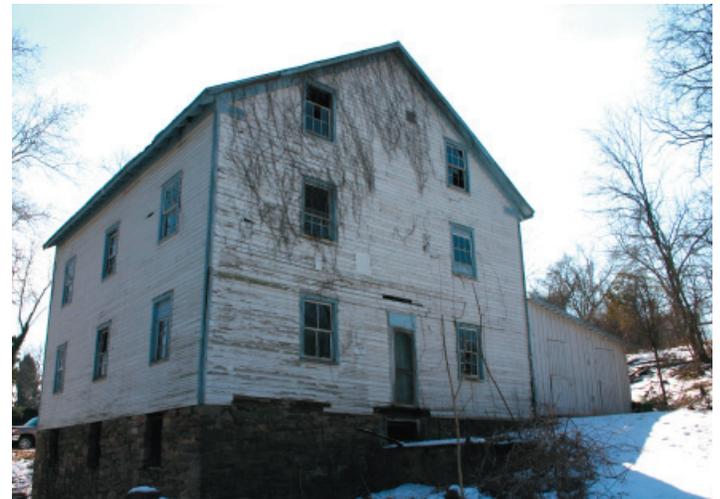
FIGURE 1-2. *View from Northeast. The mill race arrived at the mill at the right margin of this photograph and was carried by a flume to the portal directly below the door in the center of the north gable elevation.*

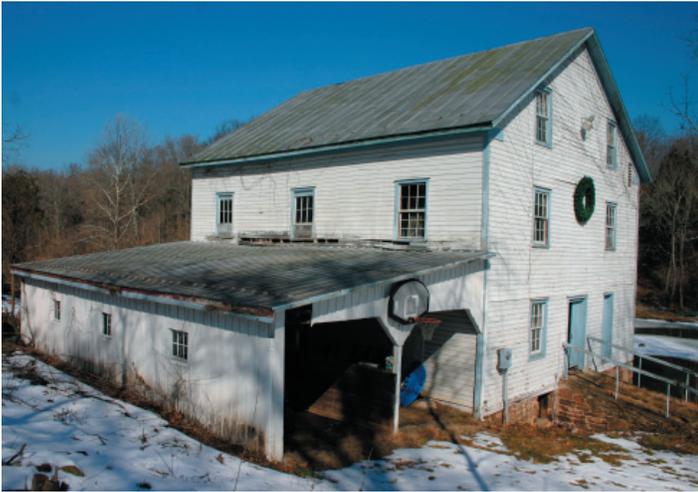
FIGURE 1-3. *View from Southwest. The lean-to shed post-dates the building's use as a mill.*

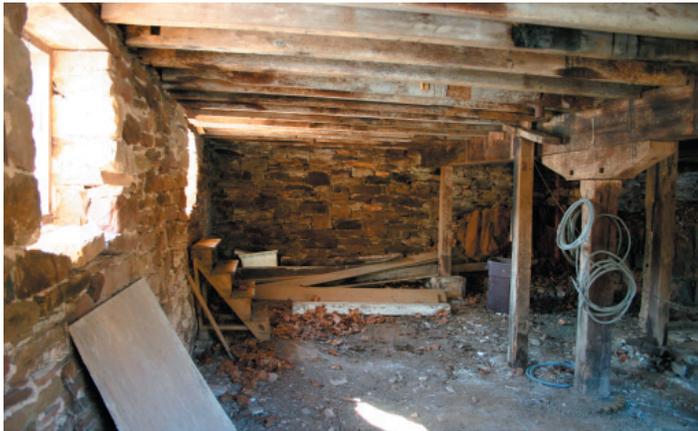
FIGURE 1-7. *View of the south bay of the cellar, facing west. The chamfered post and massive bearing plate to the right are recycled from the earliest of three construction periods that can be identified in the mill.*

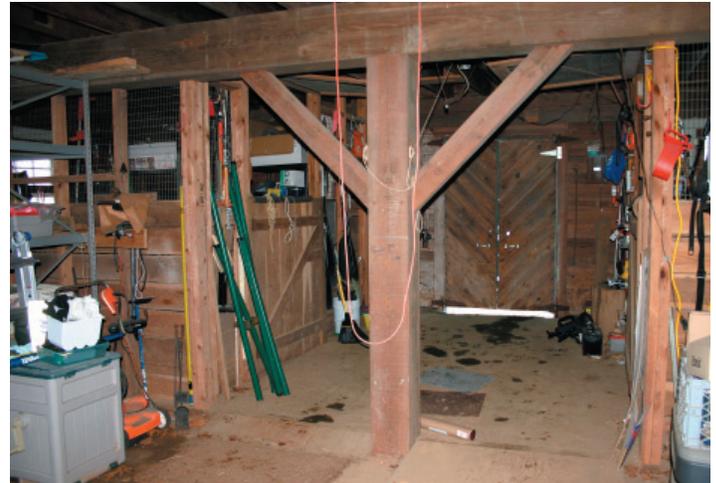
FIGURE 1-8. *View from the center bay of the first floor, facing south to the double doors. The quadrants on either side of the entrance aisle were enclosed with horizontal planks and turkey wire sometime prior to 1973 for use as horse stables. Note the diagonal double-planked doors, tightly laid sheathing on the exterior walls, and the finely crafted timber framing.*

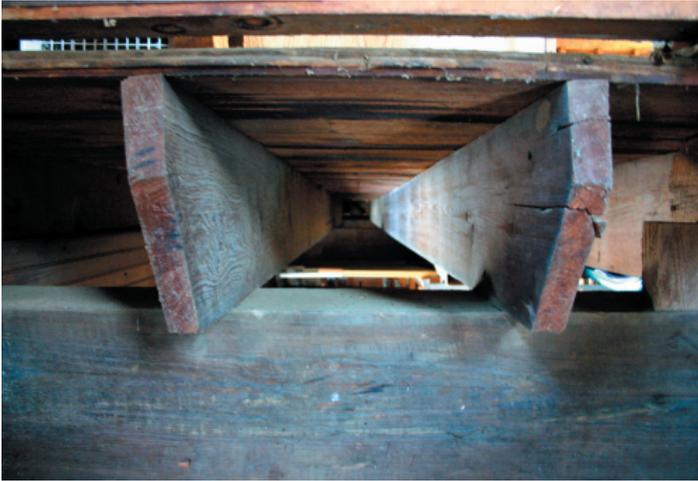
FIGURE 1-9. Floor joists for the second floor run continuously the full 40-foot length of the building from north to south. Note the tongue-and-groove flooring of the second floor and the complete absence of diagonal bridging to provide lateral stability to the joists, a feature that comes into practice in the mid nineteenth century for even the most routine domestic construction.

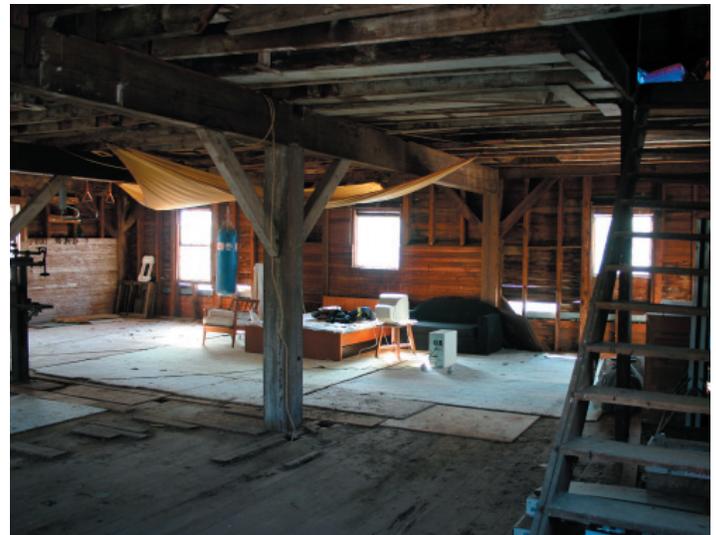
FIGURE 1-10. The second story viewed from the top of the stairs, facing southwest. The whitewashed ceiling joists and attic flooring are a mix of two periods, both recycled in the period III building. The exterior walls were sheathed on the inside with horizontal boards in the western portion of the second story; framing in the eastern half was left exposed.

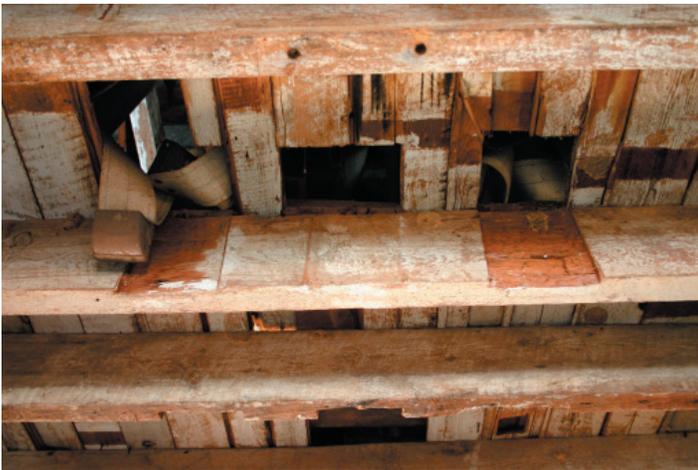
FIGURE 1-11. *The second-story ceiling is framed with joists recycled from an earlier structure and overlaid with recycled flooring as indicated by the ghosting of a different joist system captured by the whitewash. Boxed, square-section chutes delivered the grain from sifters and graders on the third story to machinery and storage bins on the first and second stories. The broad, shallow notches in the side of a joist in the middle of this view are evidence of the boxed elevator conveyors that carried freshly-ground grain to the top of the building to begin the gravity-fed procession through sifters and graders.*

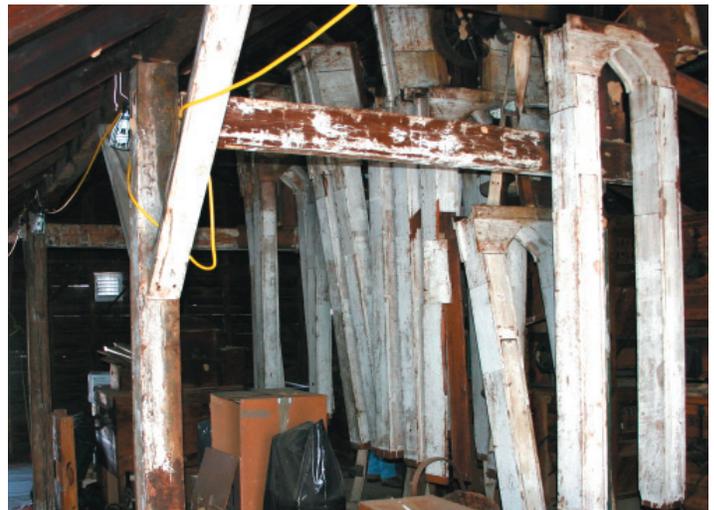
FIGURE 1-12. *View of the third story, facing northeast. Wooden housings, painted white, served as a protective casing for the canvas conveyor belts that brought freshly-ground grain to the top of the mill. Originally, these would have extended all the way down to the cellar.*

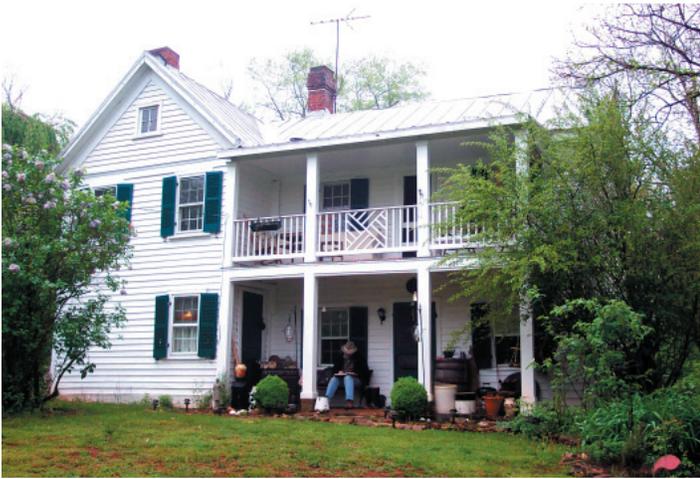
FIGURE 4-1. *South elevation. The core of this house is a one-story log structure constructed by blacksmith Richard Gill by 1796. Gill’s house forms the first story of the right-hand section in this view. The house was raised to two stories shortly after the Civil War and expanded by the two-story frame addition to the left around 1900.*

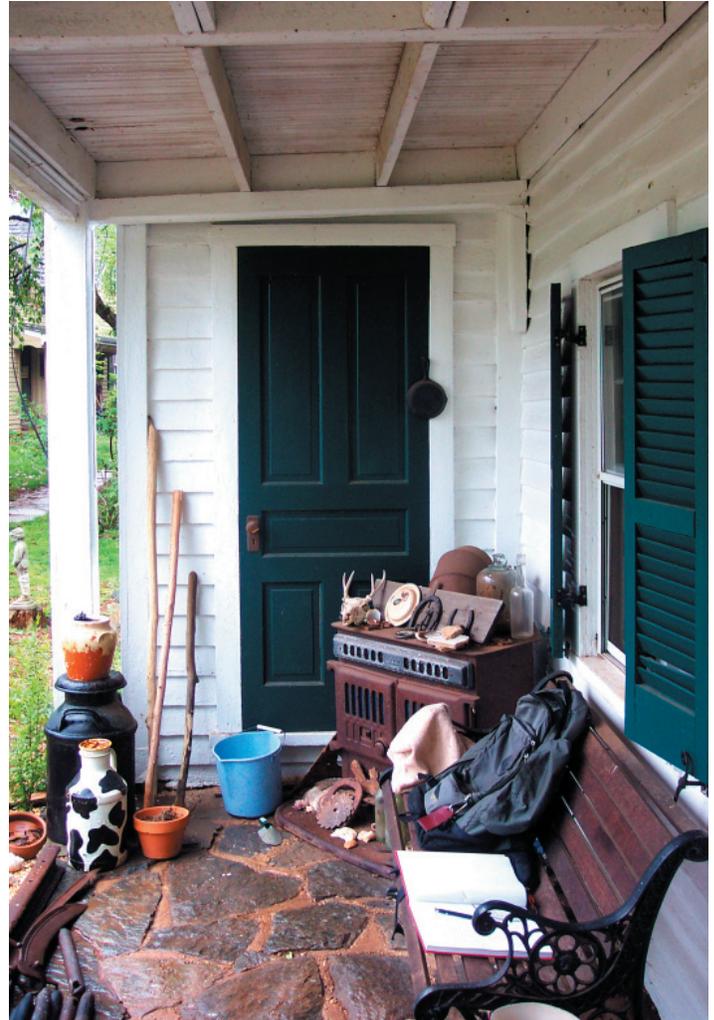
FIGURE 4-2. A door at the west end of the porch provided direct access to the turn-of-the-twentieth-century west wing. The flagstone paving dates to 1974.

The porch required extensive repairs by Tom Ashe, but retains exposed, scrolled rafter ends resting on a chamfered horizontal plate (probably salvaged from another location), supported by boxed posts. The flagstone paving at ground level includes an inscription scratched into the mortar: “VW 74.”

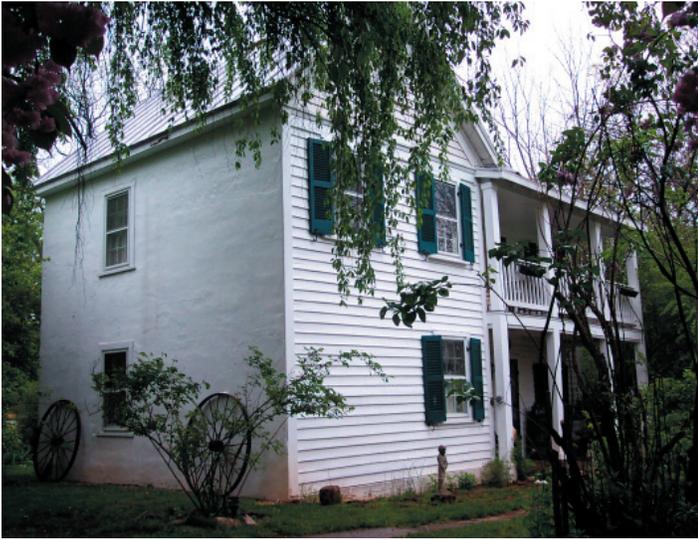
FIGURE 4-3. View from southwest. The west wing in the foreground was added around 1900 by “Bun” Graham, using a late form of hewn pole construction widely used in Buckland from the 1850s to about 1900. The stucco was added in the latter part of the twentieth century.

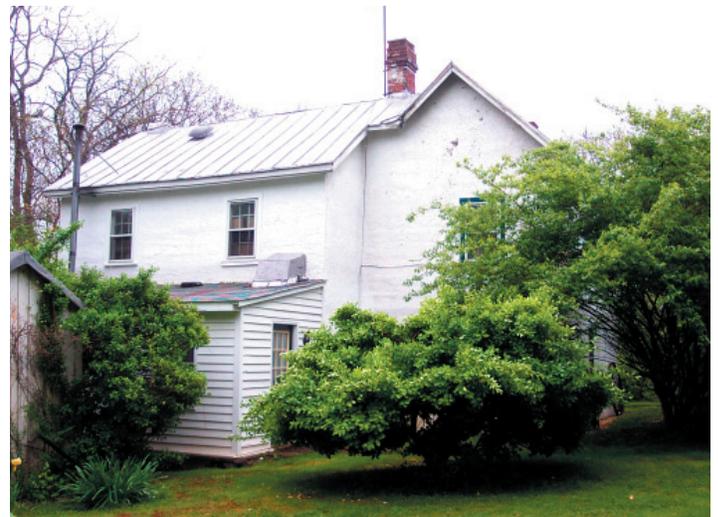
FIGURE 4-4. North elevation from the northwest. The original one-story log house is at left, concealed behind a 1970s lean-to addition. The outbuilding in the left foreground is a board-and-batten structure of about 1900 constructed over a root cellar or ice-house pit.

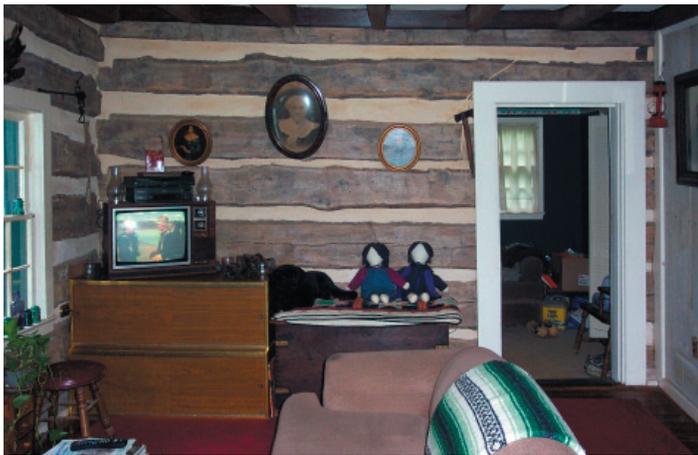
FIGURE 4-5. West parlor in the original house, facing north. The log construction is exposed on the north and west walls of the west room, as are hewn and pit-sawn ceiling joists. The partition to the right is constructed of beaded vertical boards, some early and others added as part of a late twentieth-century renovation.

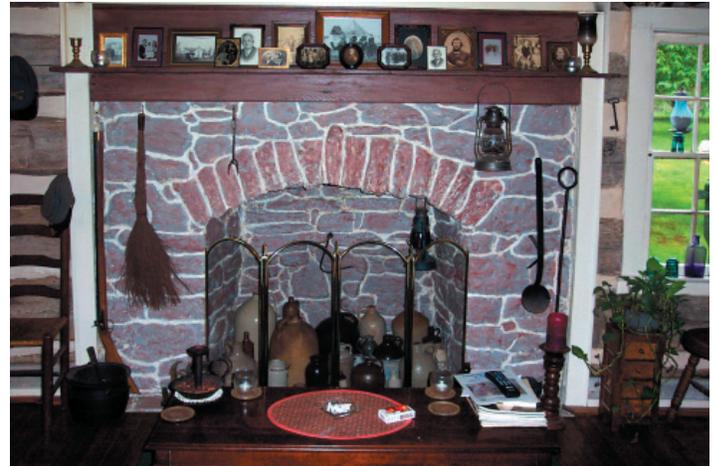
FIGURE 4-6. Fireplace on west wall of original house. The size of the fireplace opening indicates it was intended to heat this, the best room, but was not intended for cooking.

The stone fireplace is centered on the west gable wall, served by a massive stone chimney heavily coated with whitewash. This chimney measures 7'-4" north to south and is approximately 3'-7" deep; it projects from the west gable wall and was incorporated into the later two-story west wing. The firebox measures 3'-10" wide by 1'-7" deep and 2'-9" high at the center of the arched opening, proportions that suggest it was intended for heat but not for cooking.

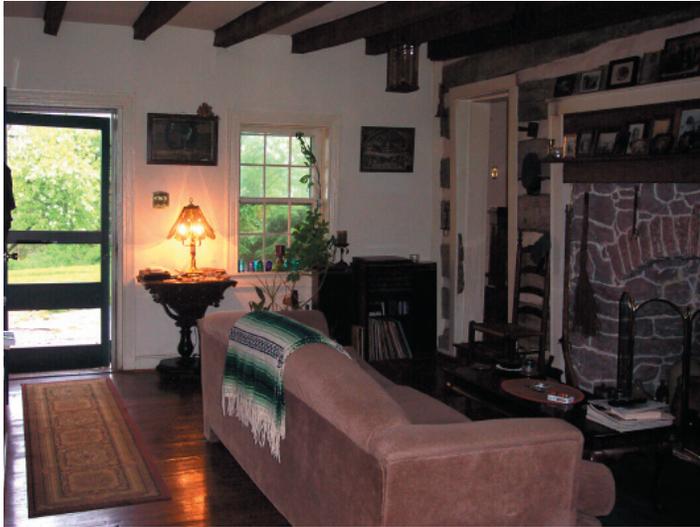
FIGURE 4-7. West room of original house, facing south. The log construction of the south wall is concealed behind modern plaster or drywall. A door to the left of the fireplace now opens into the west wing, but originally may have provided access to the kitchen, located either in a smaller, earlier wing, or as a separate structure.

The south exterior wall is finished with plaster or drywall but the original log construction is exposed on the north and west walls. The logs range from 8” to 12” in height and have been chinked with mortar that dates to the late twentieth-century restoration. The logs are oak (or possibly chestnut) and are joined at the corners with V-notch joints. The ceiling joists are exposed and beaded, 3½” wide and of uncertain depth, set on 24” centers. Flooring in this room is 2½” wide with a tongue-and-groove edge and laid from east to west. This modern flooring may explain why the fireplace hearth projects just 5” into the room, most likely an alteration made when the new flooring was installed.

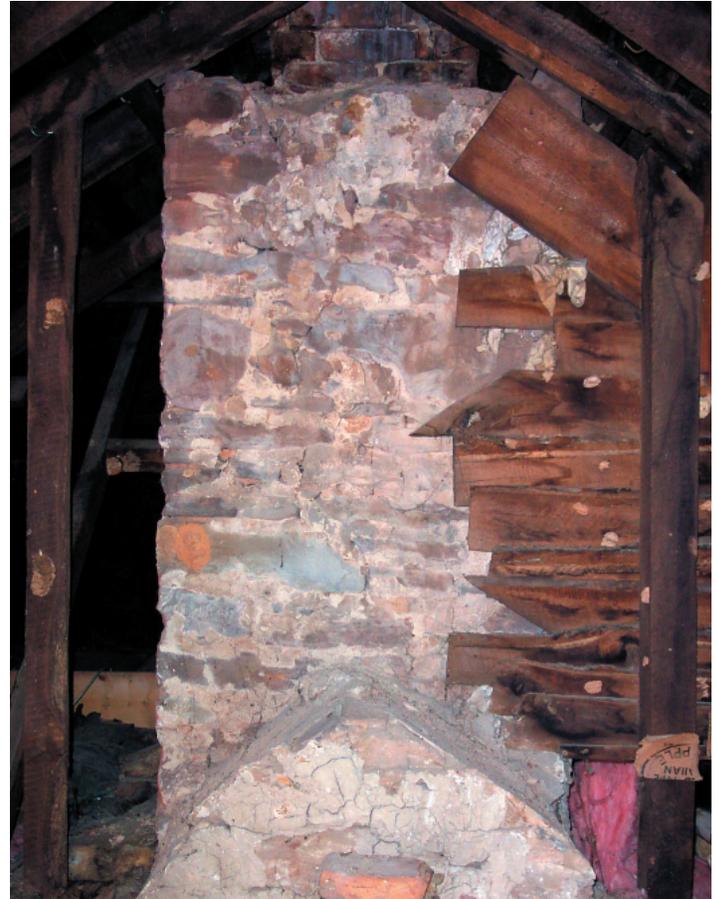
FIGURE 4-8. Original chimney viewed from the attic, facing west. The stone chimney with red limewash finish retains a clear outline of the pitched roof of the original 1½-story house, now encapsulated within the attic of the raised, two-story house. The shaft was extended in height with brick construction when the roof was raised, and the chimney received additional protection when the two-story west wing was added around 1900. Gable framing and siding from the period II west gable is evident to either side of the chimney. The attic beyond the chimney serves the west wing.

Originally, the period I house was one-and-a-half stories, but the roof was removed and a full second story was added. The outline of the original roof peak survives, visible from the present attic as a ghost in the original chimney shaft. The pitch of the original roof was 40 degrees, and the peak of the roof was approximately 9’-1” above the original loft floor. One piece of early trim was also found, reused as a nailer in the later roof. This element has a beaded edge and

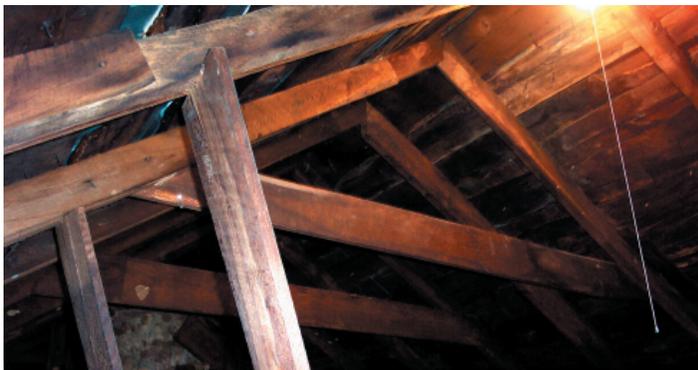
FIGURE 4-9. Roof framing in period II attic, facing west. The 1½-story log house was raised to two stories shortly after the Civil War. The new roof was framed with circular-sawn common rafters, mitered at the ridge and nailed with mature machine-made nails. Circular-sawn collar pieces were scabbed on at a later date using wire nails, which came into use in the 1880s.

The period II roof is constructed of common-rafter pairs joined at the ridge with mitered and nailed joints, and mitered and nailed at the base to flat false plates supported by the second-story ceiling joists. The rafters range in size from 2” by 4” to 2” by 5½” and are circular-sawn; nails are mature, machine-made nails of a type commonly used from the 1830s to the 1880s. Four rafter pairs have been reinforced at a later date with light collar pieces, circular-sawn and scabbed on with wire nails. The ceiling joists also are circular-sawn and measure 2” by 7½”. The west gable end of this roof survives intact where it was encapsulated at a later date by the construction of the west wing. The exterior

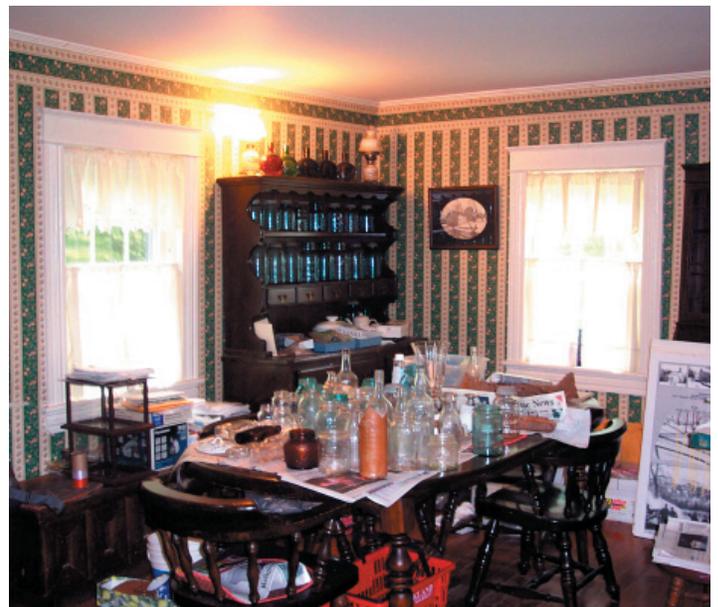
FIGURE 4-10. First-floor dining room, west wing. This wing was added by “Bun Graham” around 1900 and the first-floor room now serves as the dining room.

Local tradition has suggested that the west wing was a separate house that was moved to this location and joined to the earlier Gill House. However, there are no nail holes in the top face of the period III rafters where they are protected at the juncture with the main house, so this portion of the roof was never covered with shingles—a pretty clear indication that the west wing was built in place and was not moved.

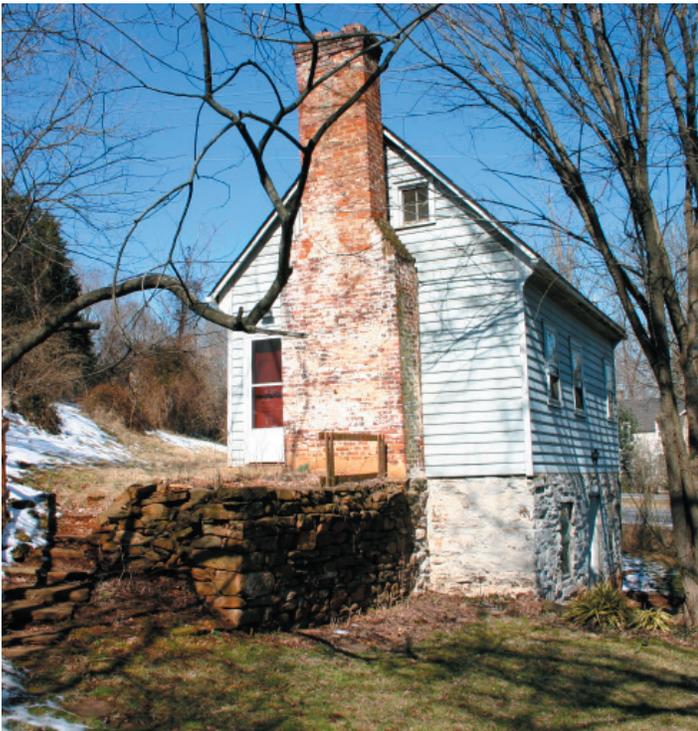
FIGURE 7-3. View from southeast. The stone and brick chimney serves fireplaces on the cellar and first floor. The door to the left of the chimney is probably not original, as it would have eliminated a key structural brace. Lee Highway and the Buckland Tavern are visible in the background.

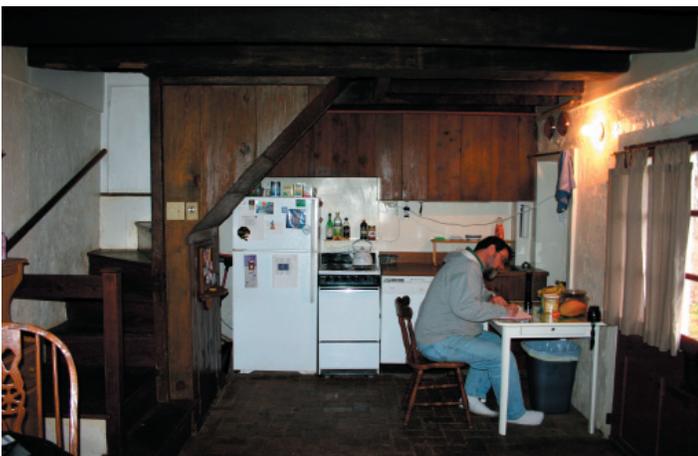
FIGURE 7-6. The cellar and stair, facing north. Originally, this space was probably partitioned into two rooms. The lower run of the cellar stair has been reversed to create enough room for utilities and a kitchen across the north end of the enlarged space.

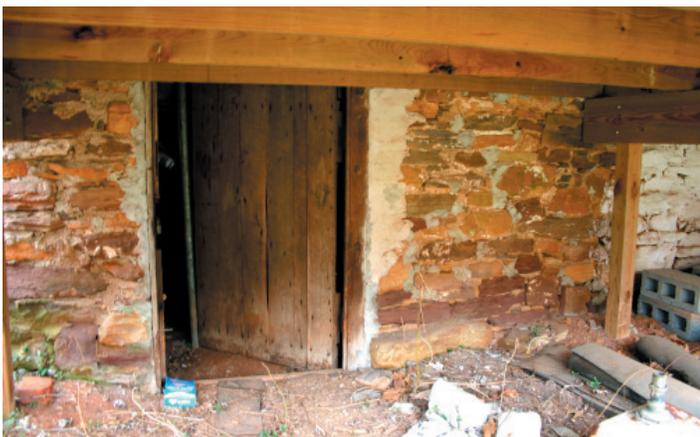
FIGURE 8-5. *Cellar entry. Located at the west end of the south elevation, this doorway opens into a shallow, unheated cellar. Note the contrast between the exposed stone foundation at the west end of the foundation and the whitewashed stonework to the east, suggesting the size and location of an earlier and smaller porch predating the post Civil War addition.*

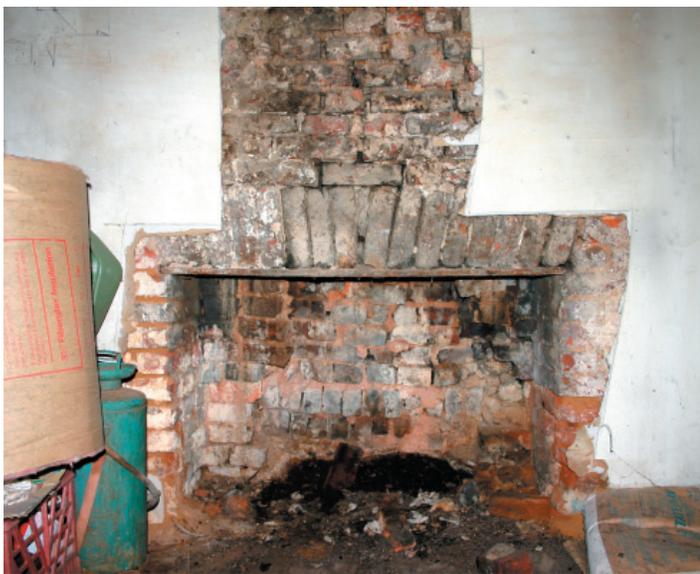
FIGURE 8-6. *Fireplace, first floor of period I. The fireplace is smaller than would be expected for a chimney of this size, but the exposed portion of the chimney shows no evidence of alterations.*

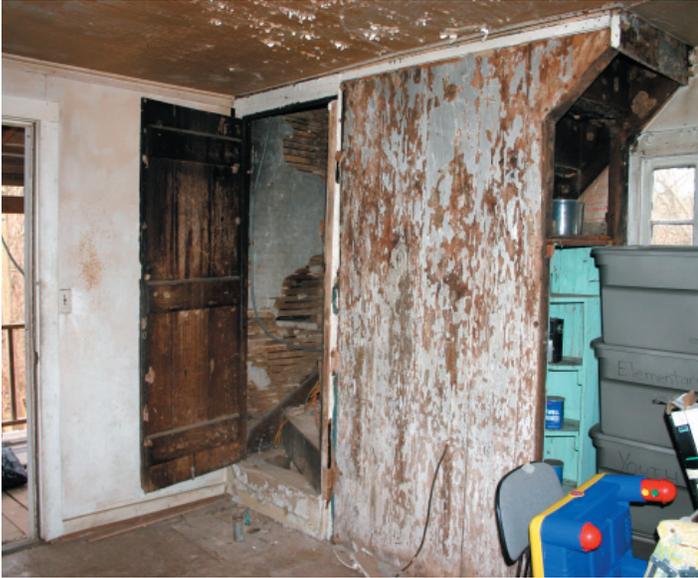
FIGURE 8-7. *Stair in southwest corner of period I house. A tightly proportioned winder stair provides access to the garret of the original house. The plaster within the stair enclosure is applied to circular-sawn lathing, an indication of improvements made after 1850, most likely when the east addition was constructed ca. 1870.*

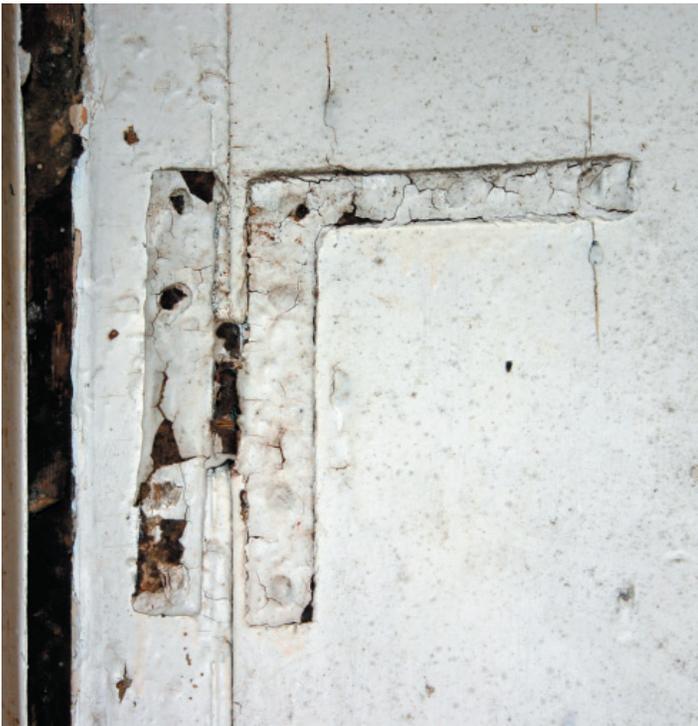
FIGURE 8-8. *Door to winder stair. The beaded batten door is hung on 7" hand-forged HL hinges secured with hand-wrought nails.*

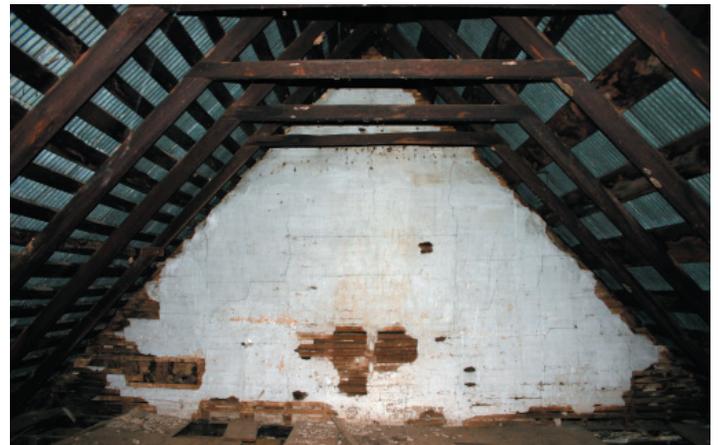
FIGURE 8-9. *View of garret, facing east from the top of the stairs. The loft was floored but otherwise unfinished initially. Sometime after 1850, the gable ends were plastered all the way to the peak of the roof using circular-sawn lathing applied with mature cut nails. Even with this improvement, the roof frame was not upgraded with either whitewash or plaster. The sash-sawn, common-rafter pairs are set at 48 degrees, half-lapped at the ridge and nailed with hand-forged nails. Each pair is reinforced with an original collar tie, half-lapped and nailed to the rafters with hand-forged nails. Original nailers for a wood shingle covering survive on the north (left) plane of the roof but have been replaced to the south.*

The garret originally was unfinished except for a floor; later, the gable ends were plastered. The floor is

laid with random-width planks 8" to 12½" wide by 1" thick with tongue-and-groove edges, face-nailed with hand-forged T-head nails. The roof is constructed of common rafter pairs set at a 48-degree pitch and joined at the ridge with half-lap joints secured with two hand-forged nails and reinforced with collars that are half-lapped and nailed with a single wrought nail. The rafters are 2½" wide and 3" deep, with no taper; the collars are 1½" to 2" wide and 2¾" to 3" deep. Where saw marks are visible, both collars and rafters are sash-sawn. The rafter pairs are supported on 1" by 9" false plates, which in turn are nailed to the floor joists, which measure 2½" to 2¾" wide and 6¼" to 6¾" deep. Original nailers survive on the north side of the roof; these are 1" by 2¾", with approximately 3" gaps between them, indicating the original roof was wood shingle. Fragments of early shingles were recovered from this attic recently, as well as a hand-forged shingle nail. Hand-forged, spade-point nails are still evident, protruding through the nailers. On the south face of the roof, most of the early nailers have been replaced with circular-sawn, random-width planks, presumably dating to the present corrugated metal sheeting. The attic space was never whitewashed, and initially lacked any plaster as well. However, when the house was enlarged after the Civil War, the gable ends of the garret were plastered all the way up to the peak of the roof, using circular-sawn lathing secured with machine-made nails.

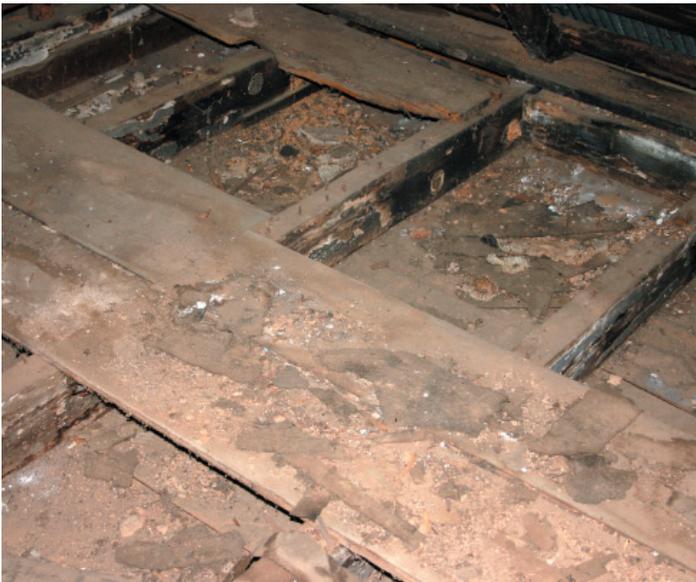
FIGURE 8-10. *Garret flooring and framing. Random-width, tongue-and-groove flooring survives across part of the garret, secured with hand-forged T-head nails. Traces of whitewash and fireplace soot are evident on the first floor ceiling joists, which were exposed until the post Civil War period or later. The present ceiling is gypsum board, post-dating World War II.*

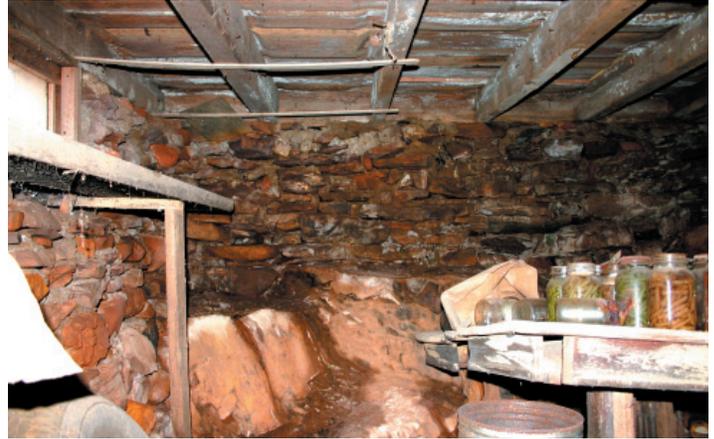
The cellar under the period I house is quite low, with just 4'-10" of headroom between the dirt floor and the ceiling joists, and was used only for storage. There is no fireplace at this level, and the floor is interrupted on the north side by a ragged outcrop of bedrock. The ceiling joists run north-south and are sash-sawn; they measure 2¾" to 3¾" wide and 6½" to 7" deep.

FIGURE 8-11. *View of cellar, period I. The cellar provides just 4'-10" of clearance, and was never heated, indicating it was used for food storage rather than as domestic space. The flooring overhead varies considerably in thickness and has been gauged with a drawknife and undercut by as much as 1½" at the joists.*

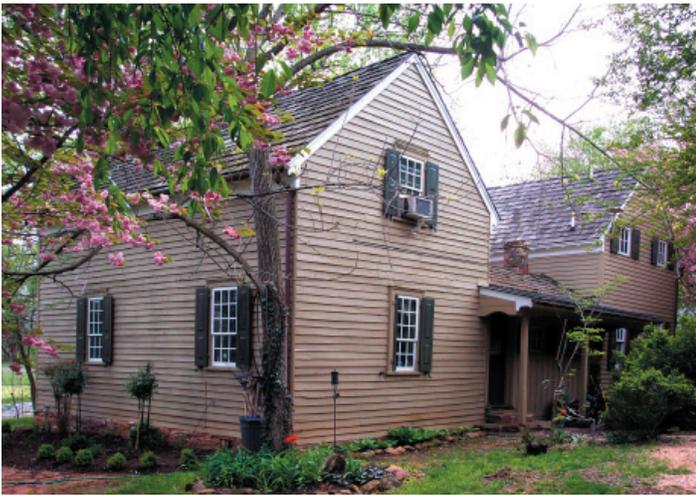
FIGURE 9-1. *View from northeast. The early house is a “true” story-and-a-half, in which the wall framing extends up into the garret story, providing more space and eliminating the need for kneewalls. A rebuilt one-story wing now serves as a hyphen to the 1980s addition in the back-*

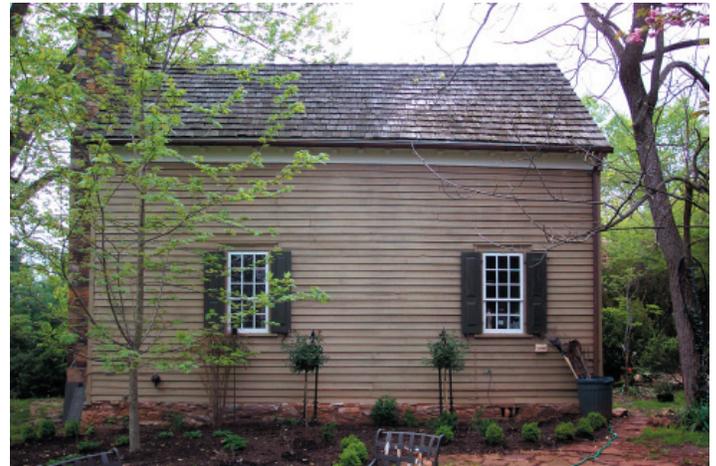
FIGURE 9-2. *East elevation. Framing evidence indicates the north (right) window marks the location of the original front entrance, which opened into a generously proportioned stair passage to the north with adjoining parlor to the south. The restored nine-over-six windows are based on sash found in the south bay of the west elevation.*

The house has a two-room plan, with a large heated room to the south and a smaller, unheated room to the north. The latter room serves as the stair passage, but is of sufficient size to also provide useful living space. Typically, this arrangement would include a door at both ends of the passage, so that the east elevation should have a door in the north bay and a window or windows to the south. While the present fenestration consists of two nine-over-six windows in the east elevation, one lighting each first floor room, the Hazels found evidence to indicate that the northerly window replaces an original door.

The house rests on a continuous stone foundation that was repointed in 1988 using a buff-colored mortar and plain joints. The siding and trim also date to the restoration. An original beaded weatherboard was discovered during the restoration, but the current material is plain, with a lap joint and 4½” to 4¾” exposure. It is weathered and has paint build-up, but is applied with wire nails. Filled, vacant nail holes indicate the siding has been taken off and reapplied, and variant spacing of those nail holes indicates that much of the siding was

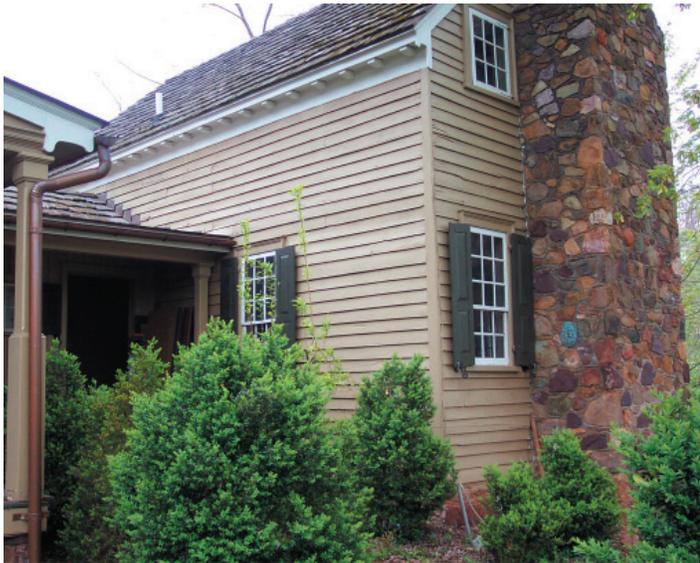
FIGURE 9-3. South gable and west elevation, viewed from the southwest.

Prior to 1988, photographs indicate an interior chimney was centered on the south gable, with a four-panel door in the east bay and a window with mismatched salvage sash in the west bay; two small two-over-two windows flanked the chimney in the upper gable. Mrs. Hazel recalls that they found evidence that the first-floor window had been cut in, interrupting the bracing for the corner post. The door in the east bay is also likely to be a later feature as it, too, is positioned in close proximity to the corner post, and would require eliminating another key brace. Prior to 1988, a one-story, shed-roof porch extended across this end of the house.

reconstructed the chimney as an exterior stack, basing that decision on architectural evidence. The four-panel door was replaced with a salvaged six-panel door hung on hand-forged HL hinges and secured with an antique iron rim lock purchased for the project. The salvage sash of the west window was replaced with nine-over-six sash, and each second-story opening was reconfigured with a single nine-light sash mounted as a casement on hand-forged strap hinges. The foundation, siding, window details, and trim match the east and north elevations.

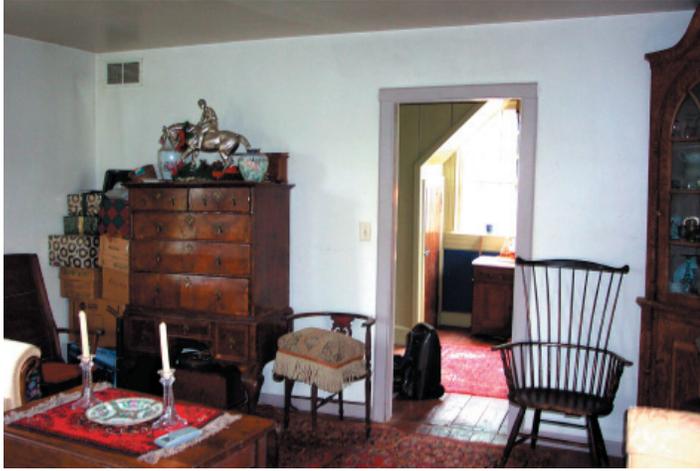
FIGURE 9-5. *First-floor parlor, facing north to stair passage.*

The ceiling joists are exposed in the north room, and a 1988 photograph indicates that the floorboards above them originally were exposed as well and whitewashed. The joists are hewn and pit sawn, measure 2¾" by 7½", and are set on 17" to 19½" centers. They are not eased, chamfered or molded in any fashion. Other framing details may be determined from the crawl space and from photographs taken in 1988. The north gable sill, visible from the crawl space, is hewn and measures 8" deep by 9" wide. The first-floor joists are rough sleepers, 6" to 7" in diameter and hewn flat on the top surface. Photographs taken in 1988 indicate that the walls are framed with L-section corner posts and with T-plan posts at the junctions of the interior partition.

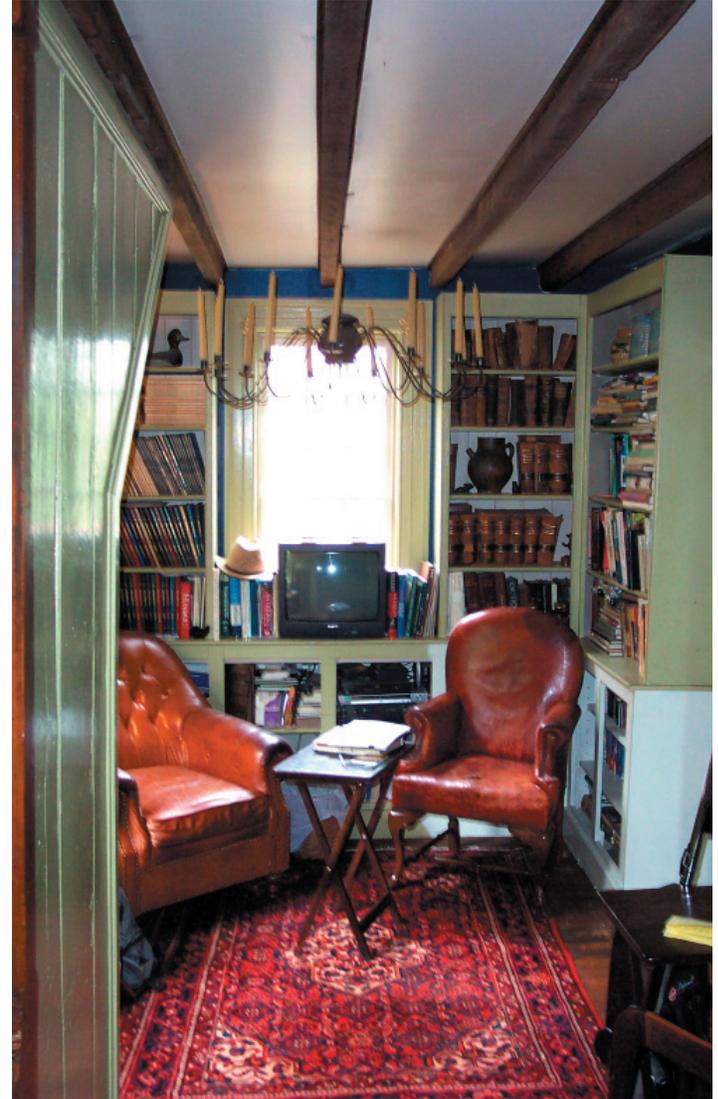
FIGURE 9-6. *Stair passage, facing east. As originally configured, the front door was located in the east end of the passage, and later was altered to a window. The winder stair rises from the northwest corner of the room against the north gable to bedchambers on the second story.*

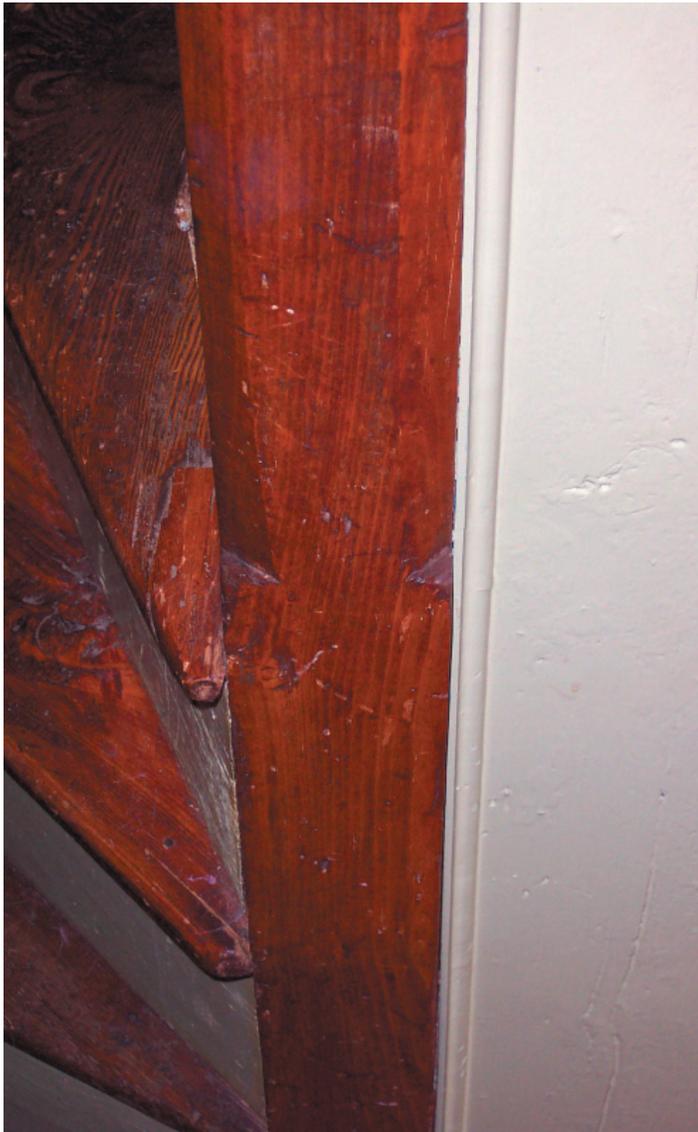
FIGURE 9-7. Stair detail. The enclosed winder stair wraps around a structural post that is handsomely chamfered.

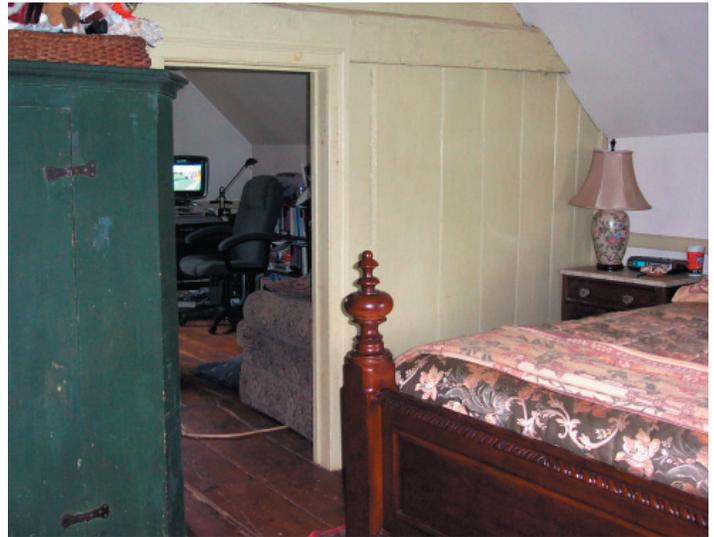
The interior partition is constructed of beaded vertical boards, 7" to 16" wide with tongue-and-groove edges and a 3/8" bead. The door opening is framed with reproduction trim. The partition boards are nailed to the north face of a horizontal tie beam that runs across the room, tying the side walls together. The bottom edge of this beam is 5'-11" above the floor, and the door opening

FIGURE 9-8. Second-story partition and tie beam from south bedchamber. The substantial tie beam visible just above the door serves as an important structural member. It is secured to a pair of rafters that are more robustly proportioned than the rest of the roof, providing added strength near the center points of the side walls. The partition between the chambers is constructed with beaded vertical boards that range up to 16" in width.

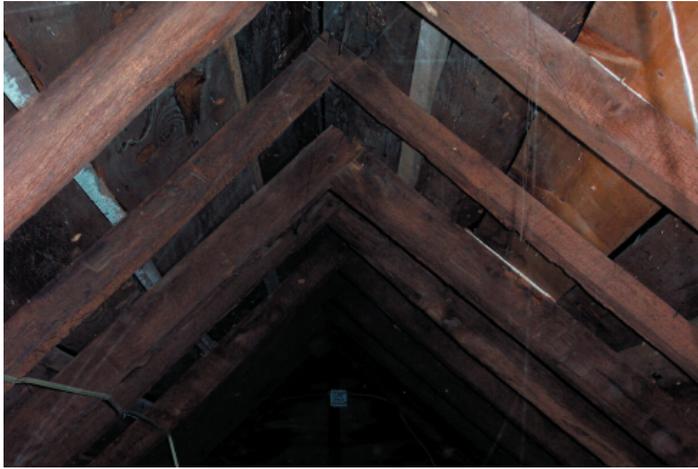
A small hatch in the ceiling of the south room permits access to the crawl space above the collar ties. The roof is constructed of common rafter pairs set at a 40-degree pitch. The rafters are made of oak and perhaps chestnut. They vary considerably in size, some as small as 2¼" by 2½", but the norm being about 2½" by 3". The gable-end pairs and the pair over the upper-floor partition are larger—the latter pair being directly over the tie that holds the story-and-a-half walls together. These rafters measure about 4" by 5". With one exception all rafters are hewn and pit-sawn and are joined at the ridge with pinned mortise-and-tenon joints (one of the gable-end rafters is made from hewn and sash-sawn stock). Collar beams reinforce the rafter pairs and serve as ceiling joists for the second-floor chambers. The collars are hewn and pit-sawn and measure 2½" wide by 4" deep; the joint details are not accessible. Some of the roof nailers are early and are made of wide planks, 1" thick by 11 to 12" wide. The south gable wall is framed

with hewn and riven studs, typically about 2¼” square, mitered and nailed to the gable rafter pair with machine-headed cut nails. The present gable siding has circular-saw marks on the interior face, indicating it post-dates 1850 and may be part of the salvaged material installed during the restoration.

FIGURE 9-9. *Roof construction. The common rafter roof is constructed with hewn and pit-sawn rafters set at 40 degrees and joined at the ridge with pinned mortise-and-tenon joints. The gable studs are riven from hewn stocks, mitered and nailed to the gable rafter pairs with machine-headed cut nails.*
