THE ENTREPRENEURIAL LANDSCAPE
OF A TURNPIKE TOWN:
AN ARCHITECTURAL SURVEY OF
BUCKLAND, VIRGINIA

ORLANDO RIDOUT V, ALFREDO MAUL, AND WILLIE GRAHAM
BUCKLAND, VIRGINIA
2005

A Project of the Buckland Preservation Society

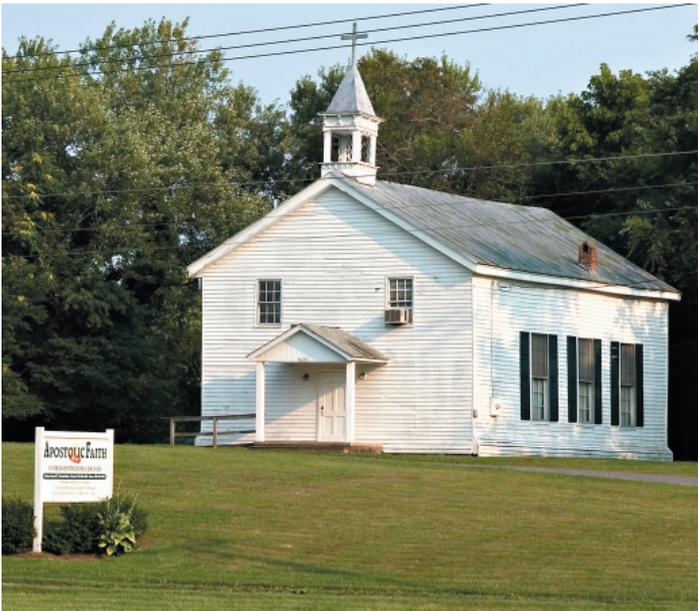
FIGURE 10-1. View from northwest. Constructed in 1856 as St. Mark's Methodist Church, this is one of just three surviving churches in Prince William County that pre-date the Civil War. The 1863 panorama of the town drawn by Alfred Waud indicates there were paired front doors. Architectural evidence supports this configuration, altered at some later date.

The principal elevation of the church is the north gable, facing the turnpike, now Lee Highway. The present entrance is in the center of the first story, but the Waud view of 1863, noted above, indicates there were two entrances, each aligned with a second-story window. Seams in the front siding provide clear evidence for a door under the west window; siding has been extensively replaced in the eastern portion of

this gable. Thus it seems likely that the Waud drawing is accurate on this detail, which in turn suggests that the interior stair has been repositioned at some point. The second-story windows on this gable are fitted with six-over-six sash; these openings provide light to the interior gallery. The gable elevation is covered with plain horizontal siding of 4½" to 5½" exposure. The early siding that survives is weathered, has a significant build-up of paint, and is applied with mature cut nails of a type commonly used from the 1830s to the 1890s. Later siding is crisper in detail, has less paint, and is secured with wire nails. Also note that the siding in the upper gable displays circular saw marks on the back face, visible from the attic.

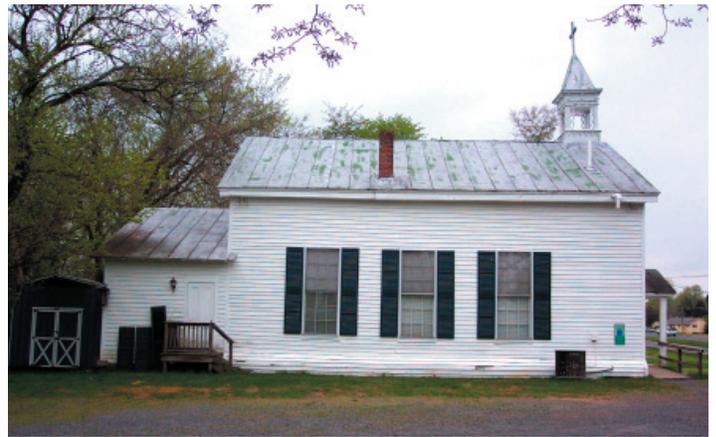
FIGURE 10-2. *East elevation. The building is an important religious landmark in the county and is an important benchmark for local carpentry traditions. Signed by local carpenters Leslie Sanders and Thurston Brown in 1856, the building incorporates circular-sawn timber as well as hewn pole rafters, the latter representing a craft tradition found in Buckland from the 1850s through the end of the nineteenth century.*

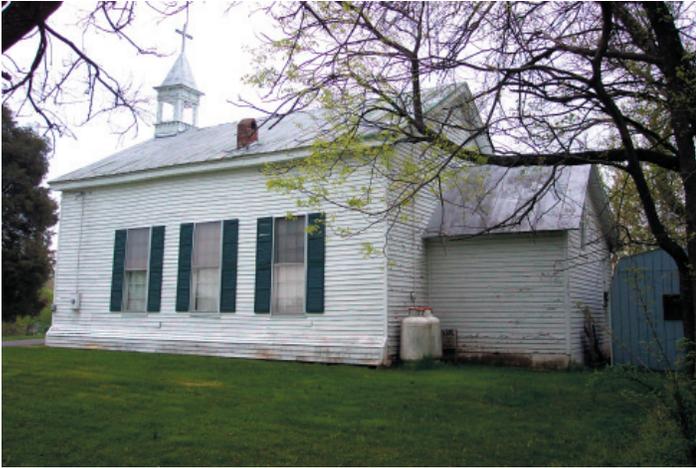
FIGURE 10-3. *The bell cupola and the frame projection at the south end of the sanctuary are later features, probably added in the late nineteenth century, or perhaps in 1907, when the building passed into use as an Episcopal chapel.*

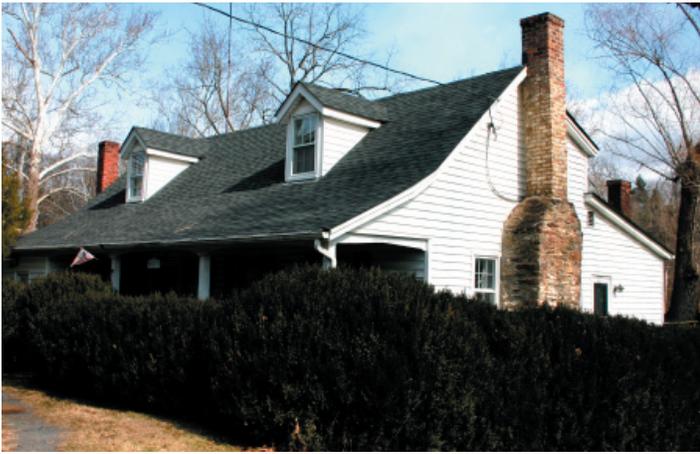
FIGURE 11-1. *View from southwest. Constructed in the first decade of the nineteenth century, this story-and-a-half frame structure served as a store operated first by John Hampton and later by William Brooks.*

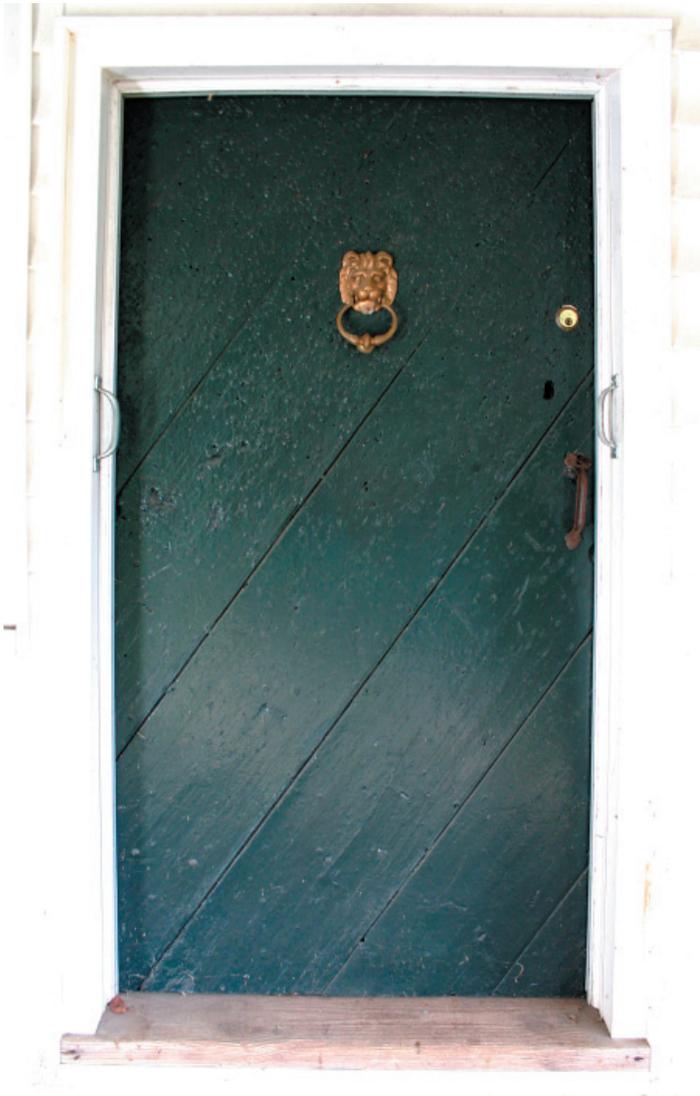
The door opening is the principal entrance for the building, and is fitted with a double-layer batten door. This opening is 2'-11³/₄" wide and just 5'-6 ³/₈" high. The exterior surface consists of random-width beaded boards (10½ to 11" wide with ¼" bead) set on the diagonal, and joined with clinched, hand-forged nails to an interior layer of vertical, random-width beaded boards (6½ to 10" with ¼" bead). Three horizontal battens with beveled edges are secured to the interior face. The door is hung to swing inward from the north jamb on a pair of hand-forged 20" iron strap hinges. A

careful examination of the exterior door surface and the jambs of the opening indicate that the door has been re-mounted, and originally swung from the south jamb. Ghost outlines of two earlier hinge positions are evident on the exterior face of the door, and multiple clues delineate an early lock location on the interior face of the door. These include the ghost outline of a rim lock on the interior face of the door, filled key and spindle holes on the exterior face, and the scar for a lock keeper on the north jamb of the opening.

FIGURE 11-2. *Principal entrance door: An unusual feature is the original double-layer door, with beaded boards laid diagonally on the exterior face and vertically on the interior. The upper part of the door bears the scars of hundreds of tacks used to post public notices on a building that is believed to have served in the nineteenth century as the town post office.*

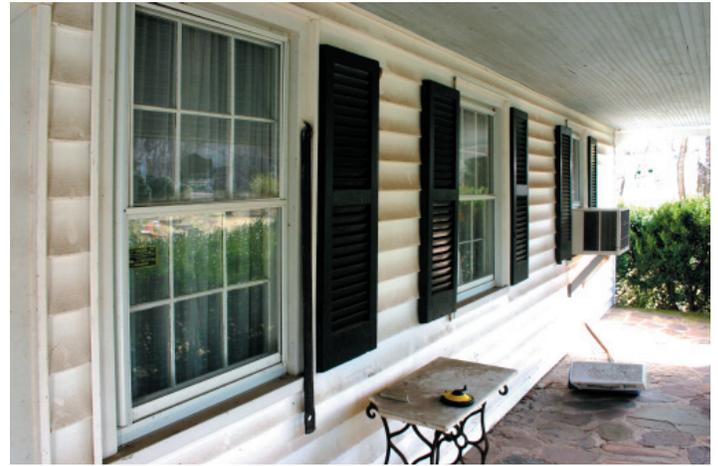
FIGURE 11-3. *The windows flanking the front door on the west elevation retain hand-forged iron bars that could be placed across exterior shutters for security, a feature associated with commercial structures.*

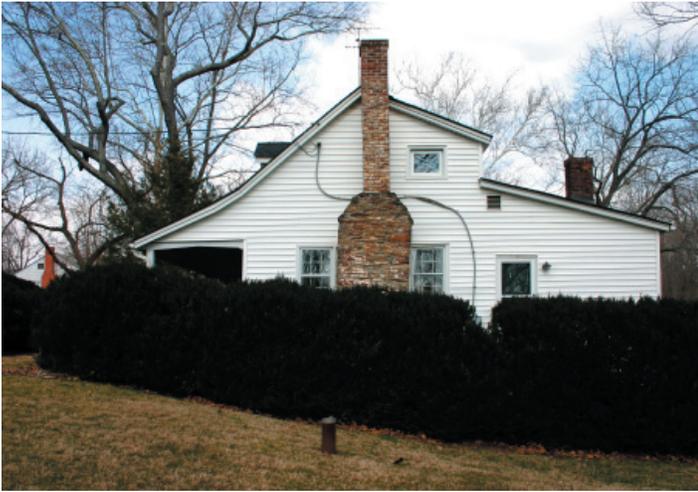
brick chimney is centered on the gable, flanked by six-over-six windows on the first story and a smaller window with modern, single-light sash to the east of the chimney in the upper gable. The foundation and chimney shaft are rubble stone construction repointed in the mid-twentieth century with Portland-based mortar. The shaft tapers in just above garret floor level and to this point is engaged to the gable wall. Above the shoulders, the chimney is brick, large enough to provide a single flue for the first story fireplace, and stands proud of the gable siding by 7 or 8". The siding, window trim, and oversailing eaves are encased with modern vinyl.

FIGURE 11-4. *South elevation. The southern ten feet of this structure and the southern portion of the east lean-to (on the right in this image) date to a mid nineteenth-century expansion. The chimney dates to that expansion and serves a single fireplace on the first floor—the chamber above is unheated.*

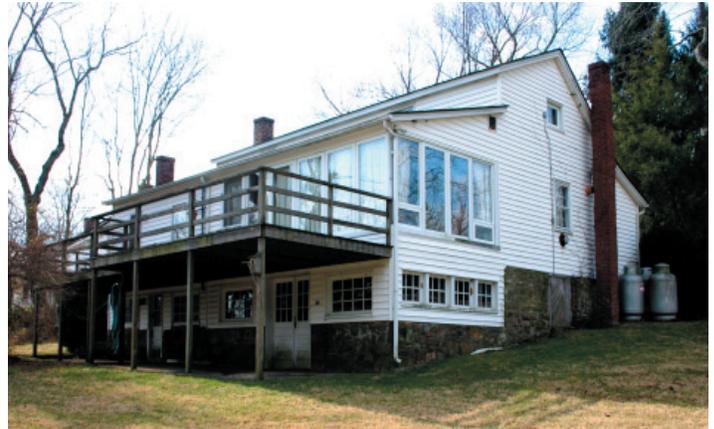
FIGURE 11-5. *View from northeast. Lean-to additions conceal much of the east elevation, facing Broad Run. The southern portion of the lean-to (to the left) dates to the 1850s while the northern part was added in the 1970s.*

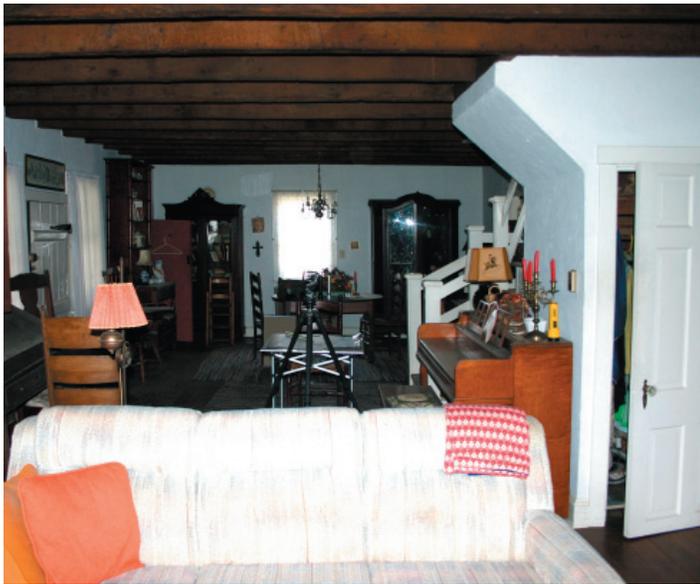
FIGURE 11-6. *First-floor interior, facing north. The interior plan originally consisted of a heated counting room to the south and an unheated commercial store to the north. In the mid-nineteenth-century, the building was extended an additional ten feet to the south, and an outshut was added to the east. In 1953, Martha Leitch opened up the plan, exposed the ceiling joists, and rebuilt the stair.*

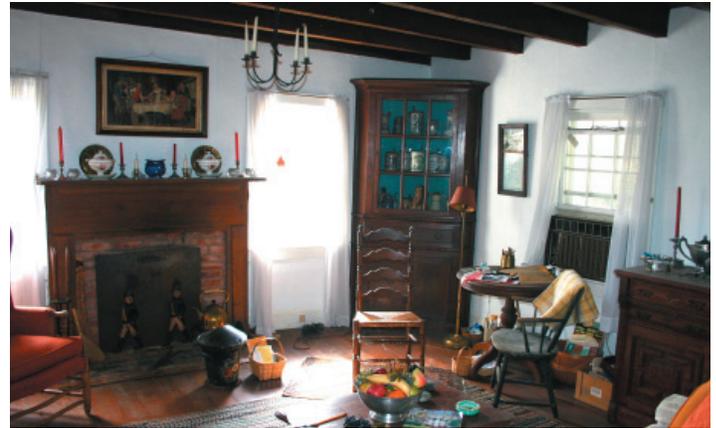
FIGURE 11-7. *Interior view facing southwest. The building was enlarged ten feet to the south in the mid-nineteenth century and a new chimney was constructed on the south gable.*

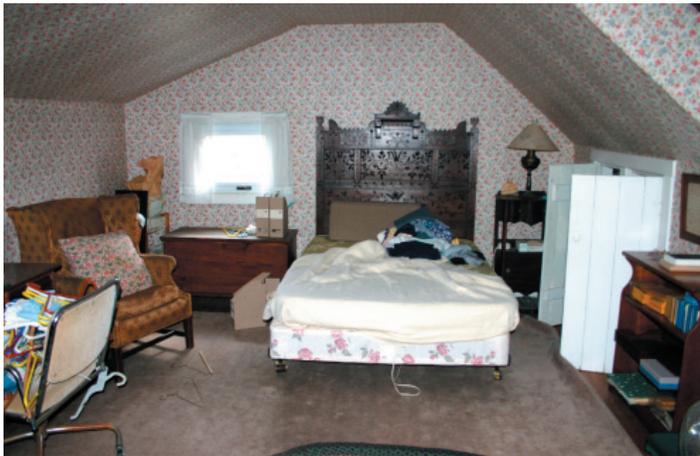
FIGURE 11-8. *South bedchamber. The second story was extensively renovated in 1953, but early fabric survives in the kneewalls and in the crawl space above the lean-to.*

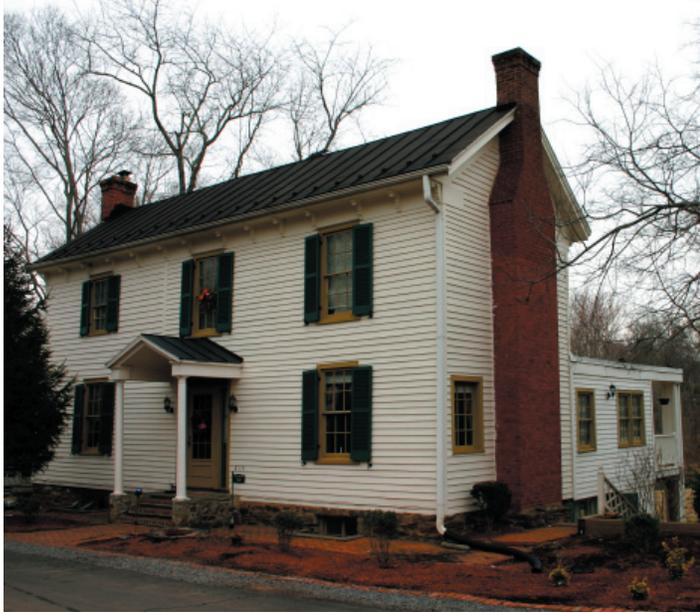
FIGURE 12-1. *View from southwest. The southern two-thirds of this house (the center and right bays) was constructed in the 1850s. The northern third was built after the Civil War, incorporating material from an early nineteenth century building.*

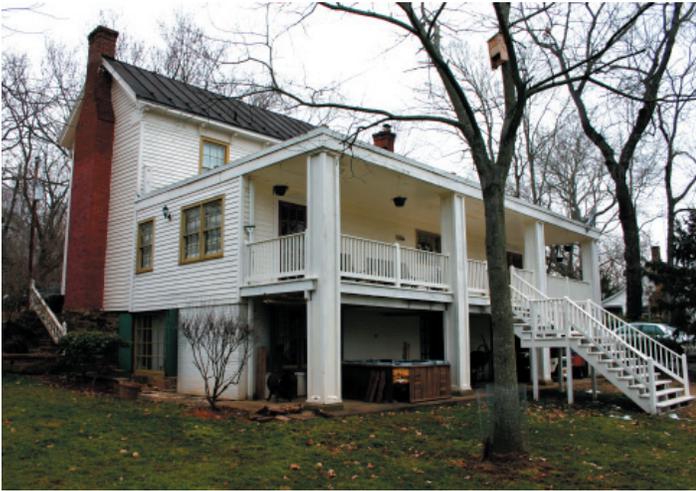
FIGURE 12-2. *View from the southeast, with 1970s addition in the foreground.*

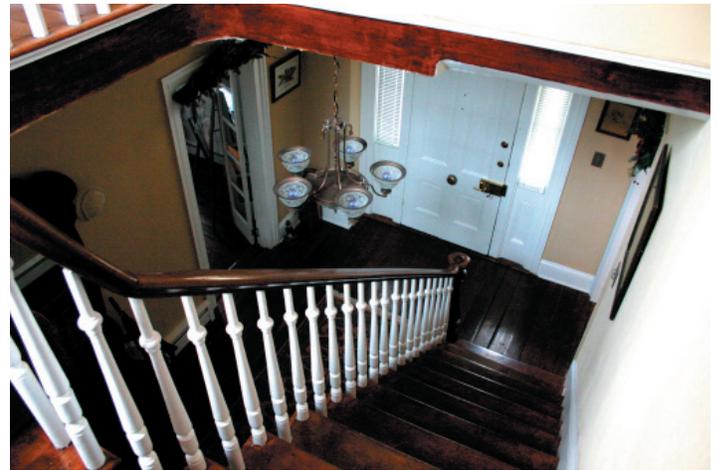
FIGURE 12-3. *Staircase and passage. The stair rises against the north wall of the passage, originally serving a bedchamber to the south and an unheated chamber at the west end of the second-story passage. When the house was enlarged to the north, a second set of steps was added, rising to the north from the landing to a new bedchamber.*
